Floodwood Pond

Survey Date: June 25, 2020

Survey Team: C. Lloyd, C. Vara

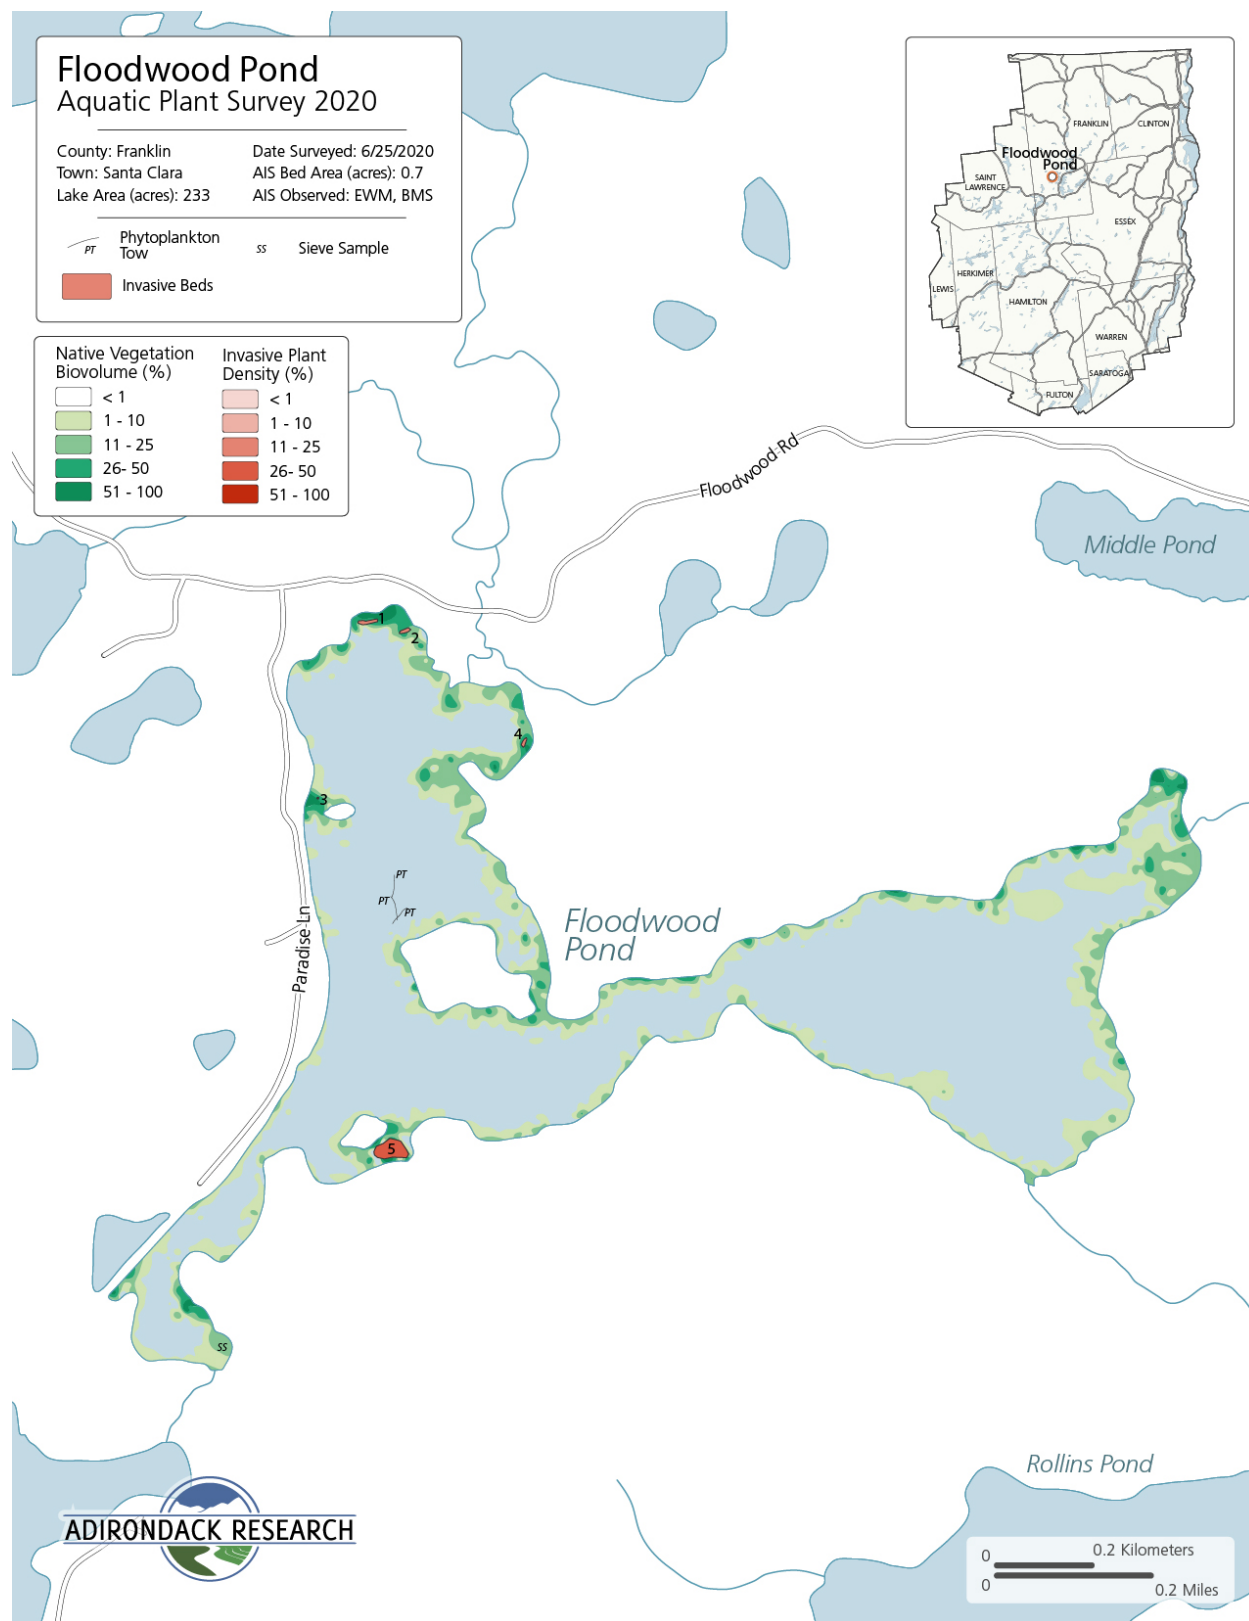
Floodwood Pond Invasive Species Percent Cover (See map on adjacent page)

Two moderately dense beds of *Myriophyllum spicatum* (Eurasian watermilfoil) were detected in the pond.

Bed	Eurasian watermilfoil			Asian Clam	Spiny
	Size (Ac.)	Size (Sq. Ft.)	% Cover	Present	Present (Y/N)
1	0.07	2881.21	11-25	No	No
2	0.04	1611.62	11-25		
3	0.00	15.17	11-25		
4	0.03	1238.67	11-25		
5	0.52	22847.17	26-50
