## Lake Flower

Survey Date: July 7-8, 2020

Survey Team: C. Lloyd, S. Aveson

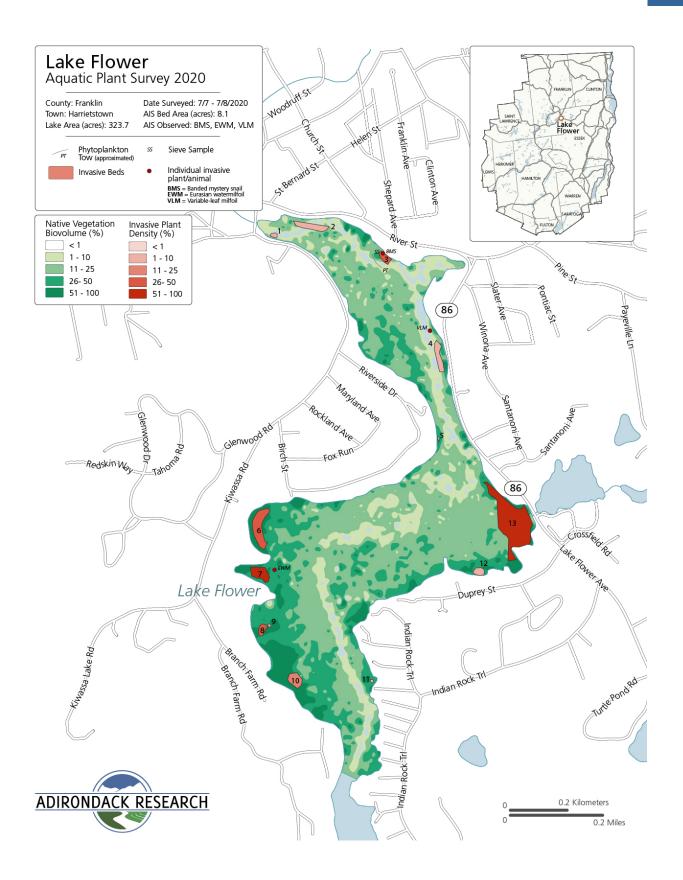
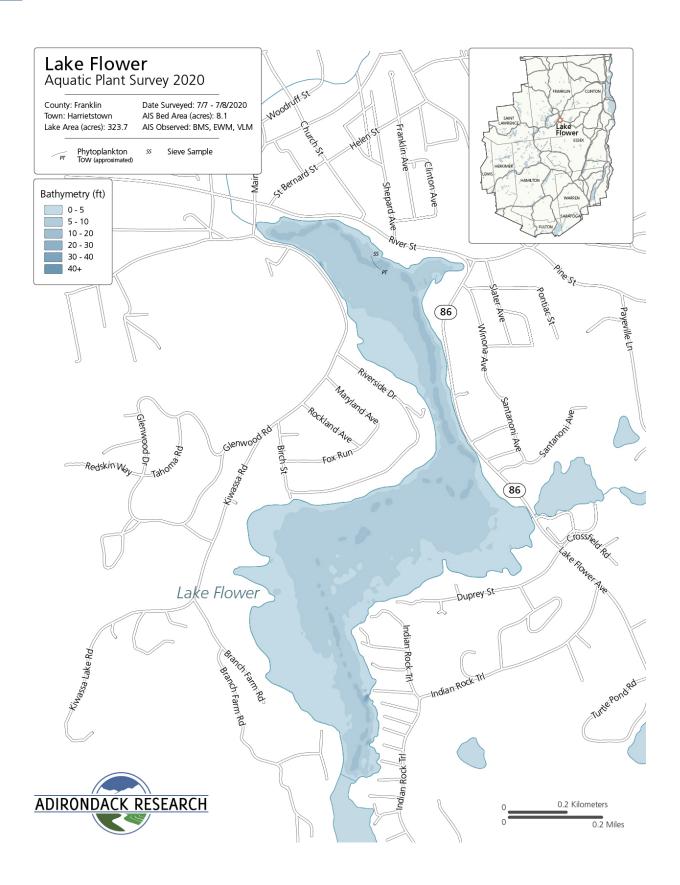
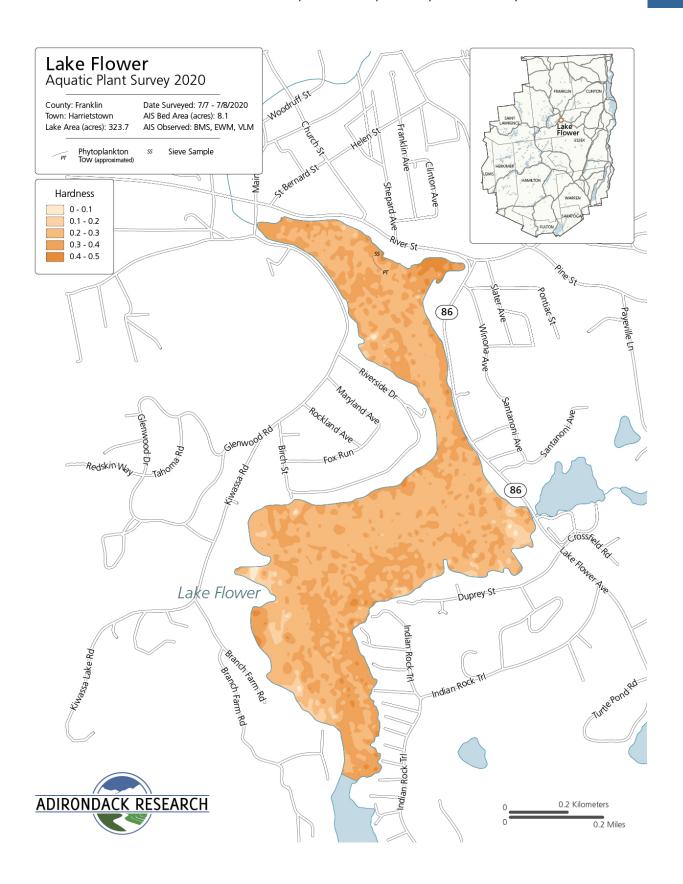
# Invasive Species Percent Cover (See map on adjacent page)

A total of 12 moderately dense beds of *Myriophyllum heterophyllum* (variable-leaf milfoil) were detected and mapped. One location with lightly scattered *Myriophyllum spicatum* (Eurasian watermilfoil) were also detected.

Species					Asian Clam	Spiny
Bed	Species	Size (Ac.)	Size (Sq. Ft.)	% Cover	Present	Present (Y/N)
1	VLM	0.08	3319.97	1-10		
2	VLM	0.52	22696.68	1-10	No	No
3	VLM	0.25	10762.19	26-50		
4	VLM	0.46	20224.70	1-10		
5	VLM	0.02	765.04	1-10		
6	VLM	1.10	47784.54	26-50		
7	VLM	0.58	25234.45	51-100		
8	VLM	0.21	9087.09	26-50		
9	EWM	0.02	964.74	1-10		
10	VLM	0.45	19514.76	11-25		
11	VLM	0.03	1169.62	1-10		
12	VLM	0.21	9057.24	1-10		
13	VLM	4.15	180573.50	51-100
