## Lake Narrative

## Caroga Lake, West

Survey Date: June 19, 2018

# West Caroga Lake Aquatic Plant Survey 2018

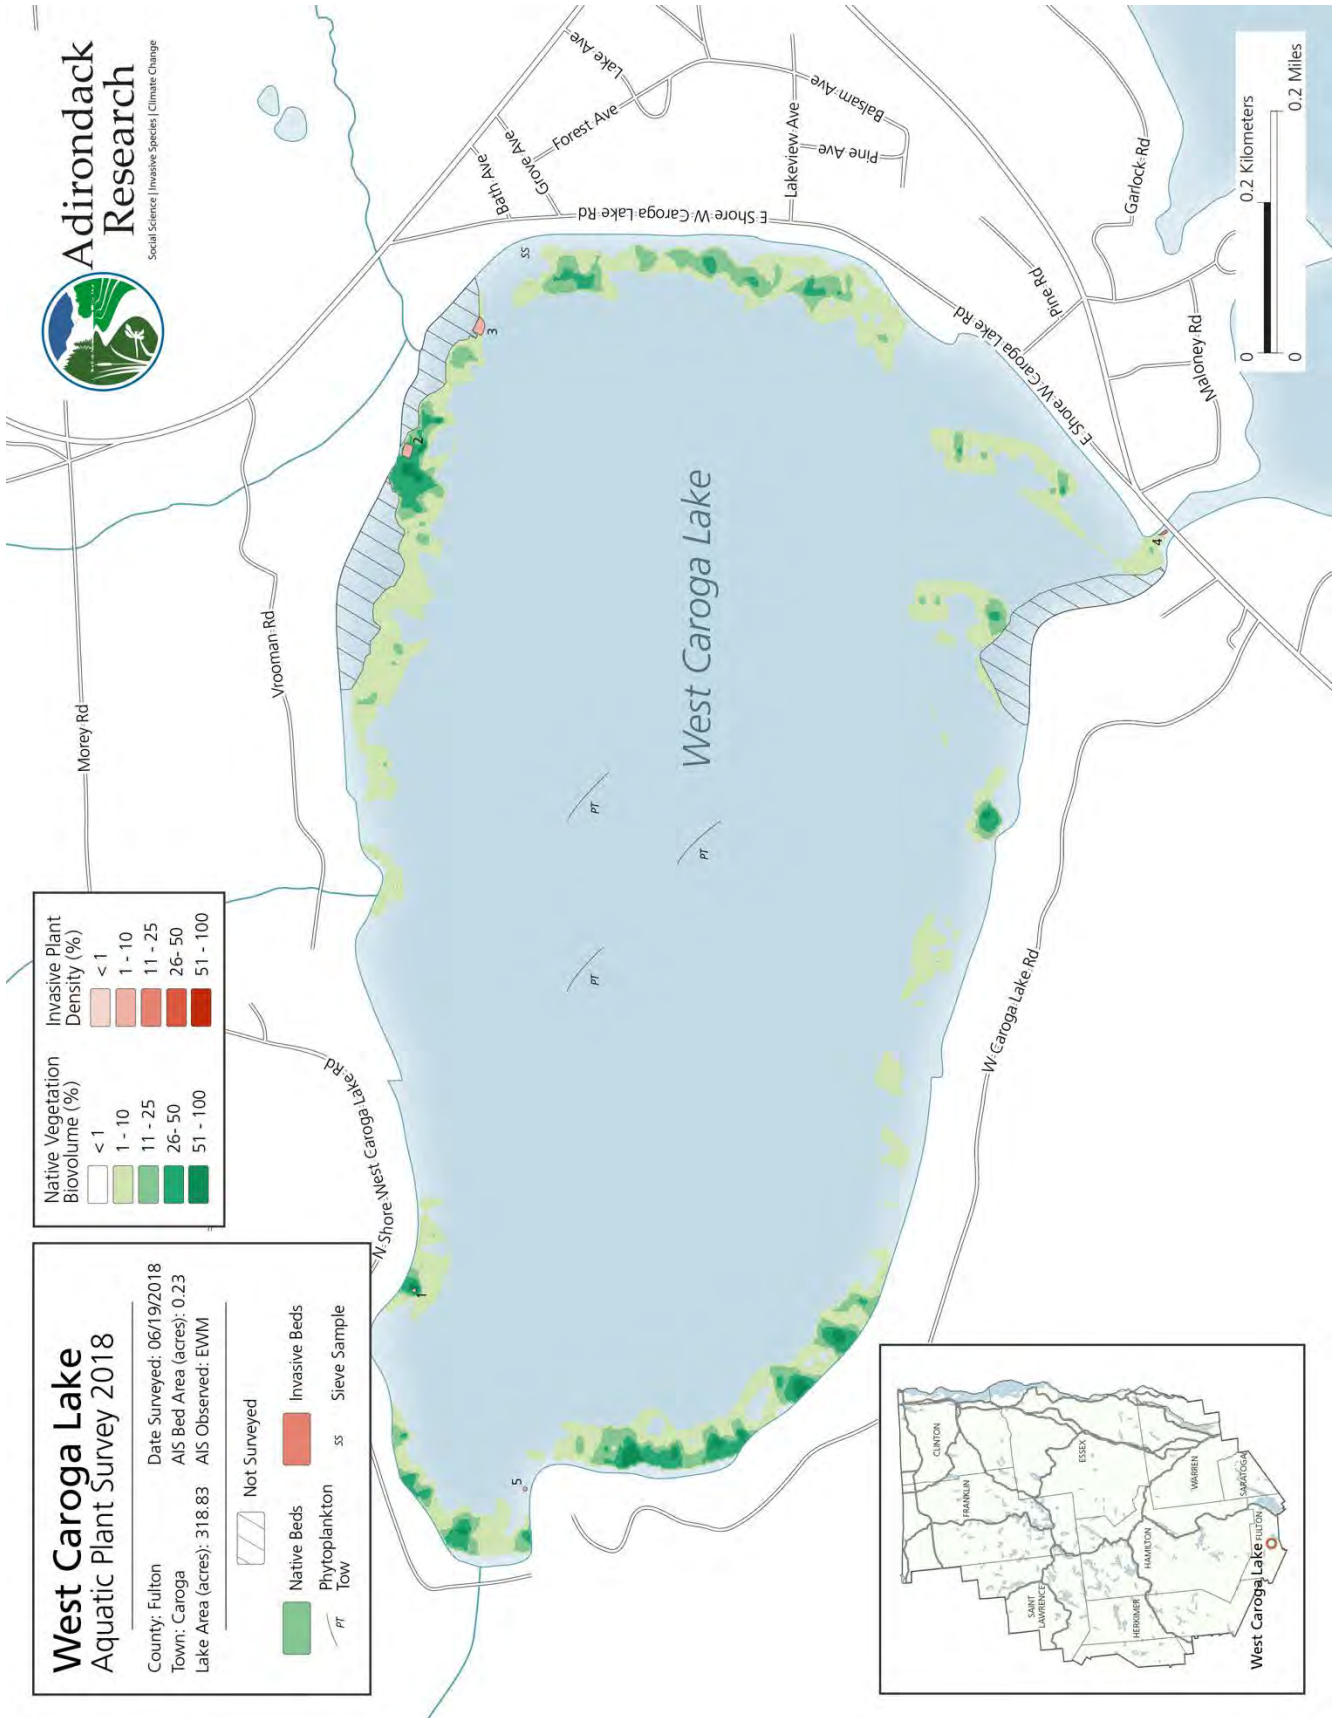
Different from East Caroga, West Caroga is much deeper and rockier, resulting in a lower abundance of aquatic plants, both native and invasive. A total of 5 invasive *Myriophyllum spicatum* (Eurasian watermilfoil) plant beds were mapped.

*Invasive Species Percent Cover (See map on adjacent page)*

County: Fulton Date Surveyed: 06/19/2018  
 Town: Caroga AIS Bed Area (acres): 0.23  
 Lake Area (acres): 318.83 AIS Observed: EWM
