## Clear Pond- Lewis County

**Survey Date:** August 12, 2019

### Clear Pond Aquatic Plant Survey 2019

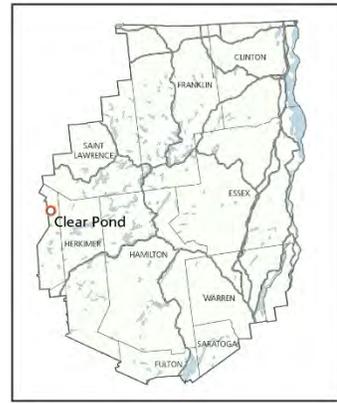
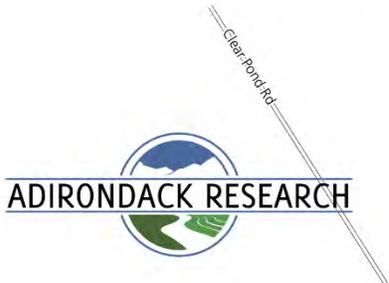
County: Lewis                      Date Surveyed: 08/12/2019  
 Town: Croghan                      AIS Bed Area (acres): 0  
 Lake Area (acres): 9.44              AIS Observed:

Native Vegetation Biovolume (%)	Invasive Plant Density (%)

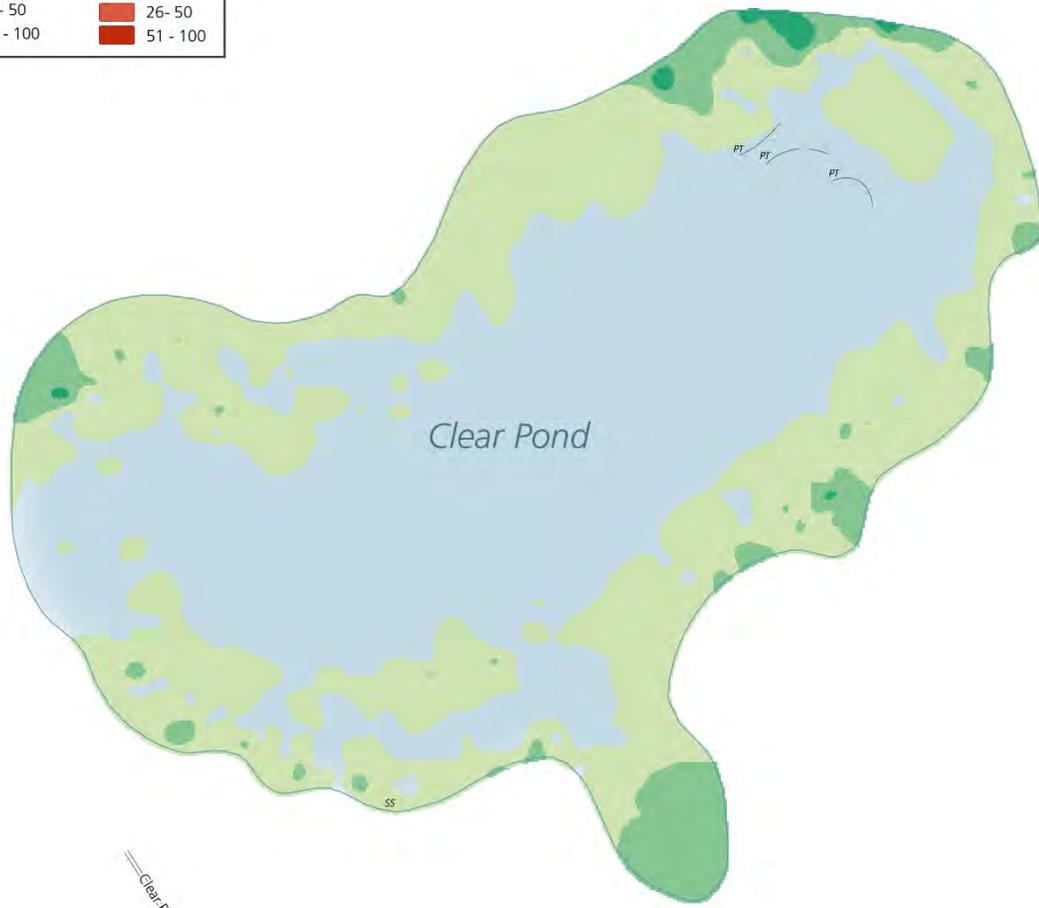
No invasive plants were detected.

Comprehensive surveys of all native plants found within the pond were not prioritized in 2019. A combination of native floating and emergent plants was detected. These species include: *Nuphar variegata* (yellow pond lily), *Vallisneria americana* (eelgrass), and *Pontederia* spp. (pickerel weed).

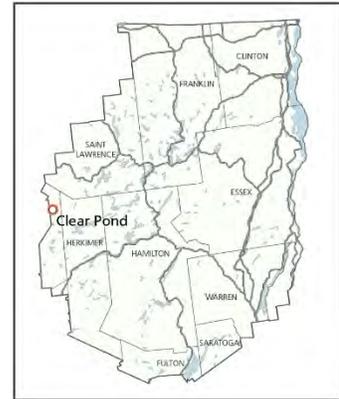
# Clear Pond Aquatic Plant Survey 2019

County: Lewis      Date Surveyed: 08/12/2019  
Town: Croghan      AIS Bed Area (acres): 0  
Lake Area (acres): 9.44      AIS Observed:

## Hardness

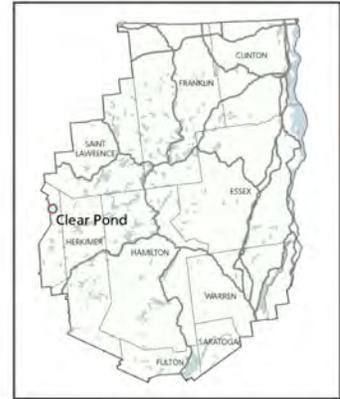
### Clear Pond Aquatic Plant Survey 2019

County: Lewis      Date Surveyed: 08/12/2019  
 Town: Croghan      AIS Bed Area (acres): 0  
 Lake Area (acres): 9.44      AIS Observed:

#### Bathymetry (ft)
