## Lake Narrative

### East Stoner Lake

Survey Date: June 20, 2018

### East Stoner Lake Aquatic Plant Survey 2018

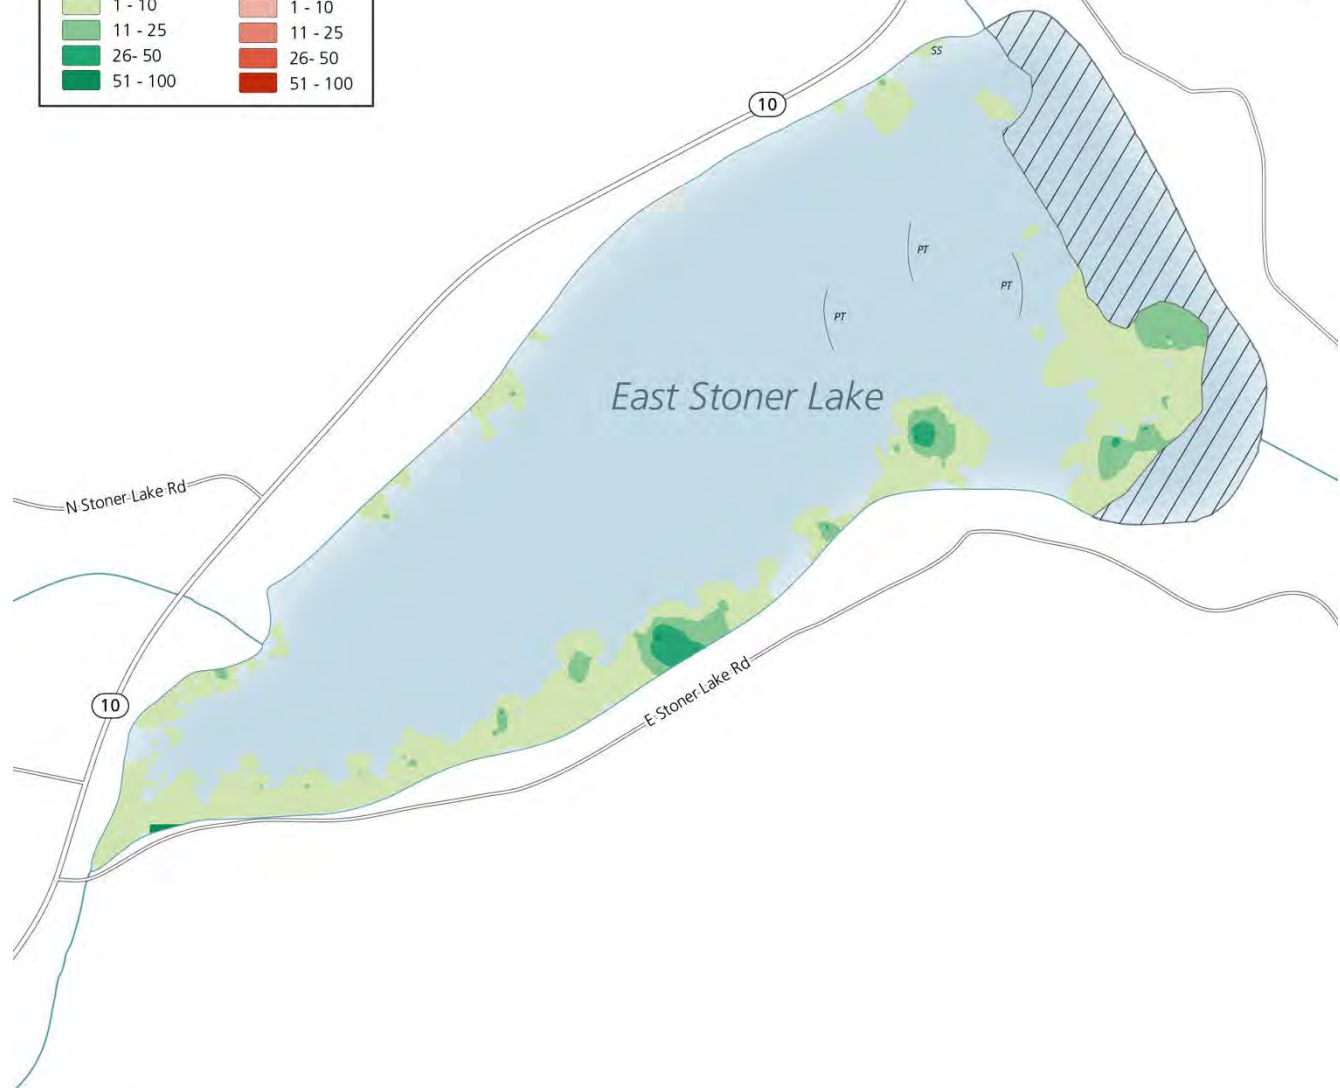
Comprehensive surveys of all native plants found within the pond were not prioritized in 2018, as this data had been previously collected in 2015 when the lake was first surveyed. East Stoner Lake is essentially shaped like a bowl and is deeper along the northern shoreline. The southern shoreline is shallow and the bottom substrate consists of hard sand and gravel. *Brasenia schreberi* (watershield) and *Nymphaea odorata* (white water lily) were abundant in the northeast corner of the lake, where the water was shallow. In the southwest corner of the lake, *Utricularia purpurea* (large purple bladderwort) dominated the lake bottom.

County: Fulton      Date Surveyed: 06/20/2018  
 Town: Caroga / Arietta      AIS Bed Area (acres): 0  
 Lake Area (acres): 82.14      AIS Observed:

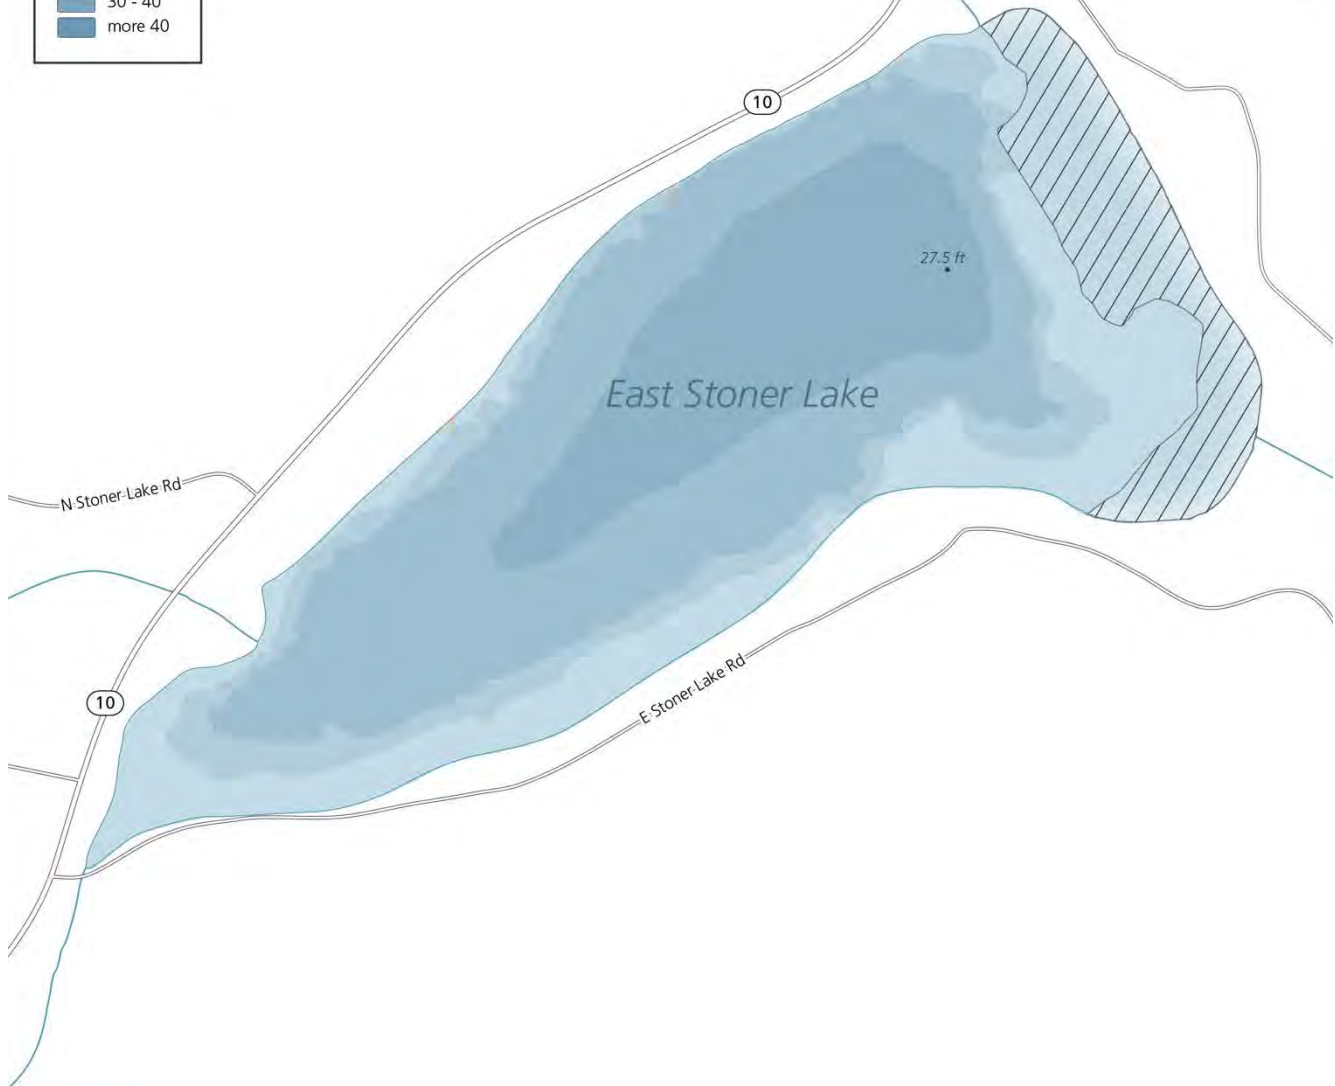
**East Stoner Lake**  
Bathymetry Survey 2018

County: Fulton      Date Surveyed: 06/20/2018  
Town: Caroga / Arietta      AIS Bed Area (acres): 0  
Lake Area (acres): 82.14      AIS Observed:
