Meacham Lake

Survey Date: July 31, 2019

Meacham Lake Aquatic Plant Survey 2019

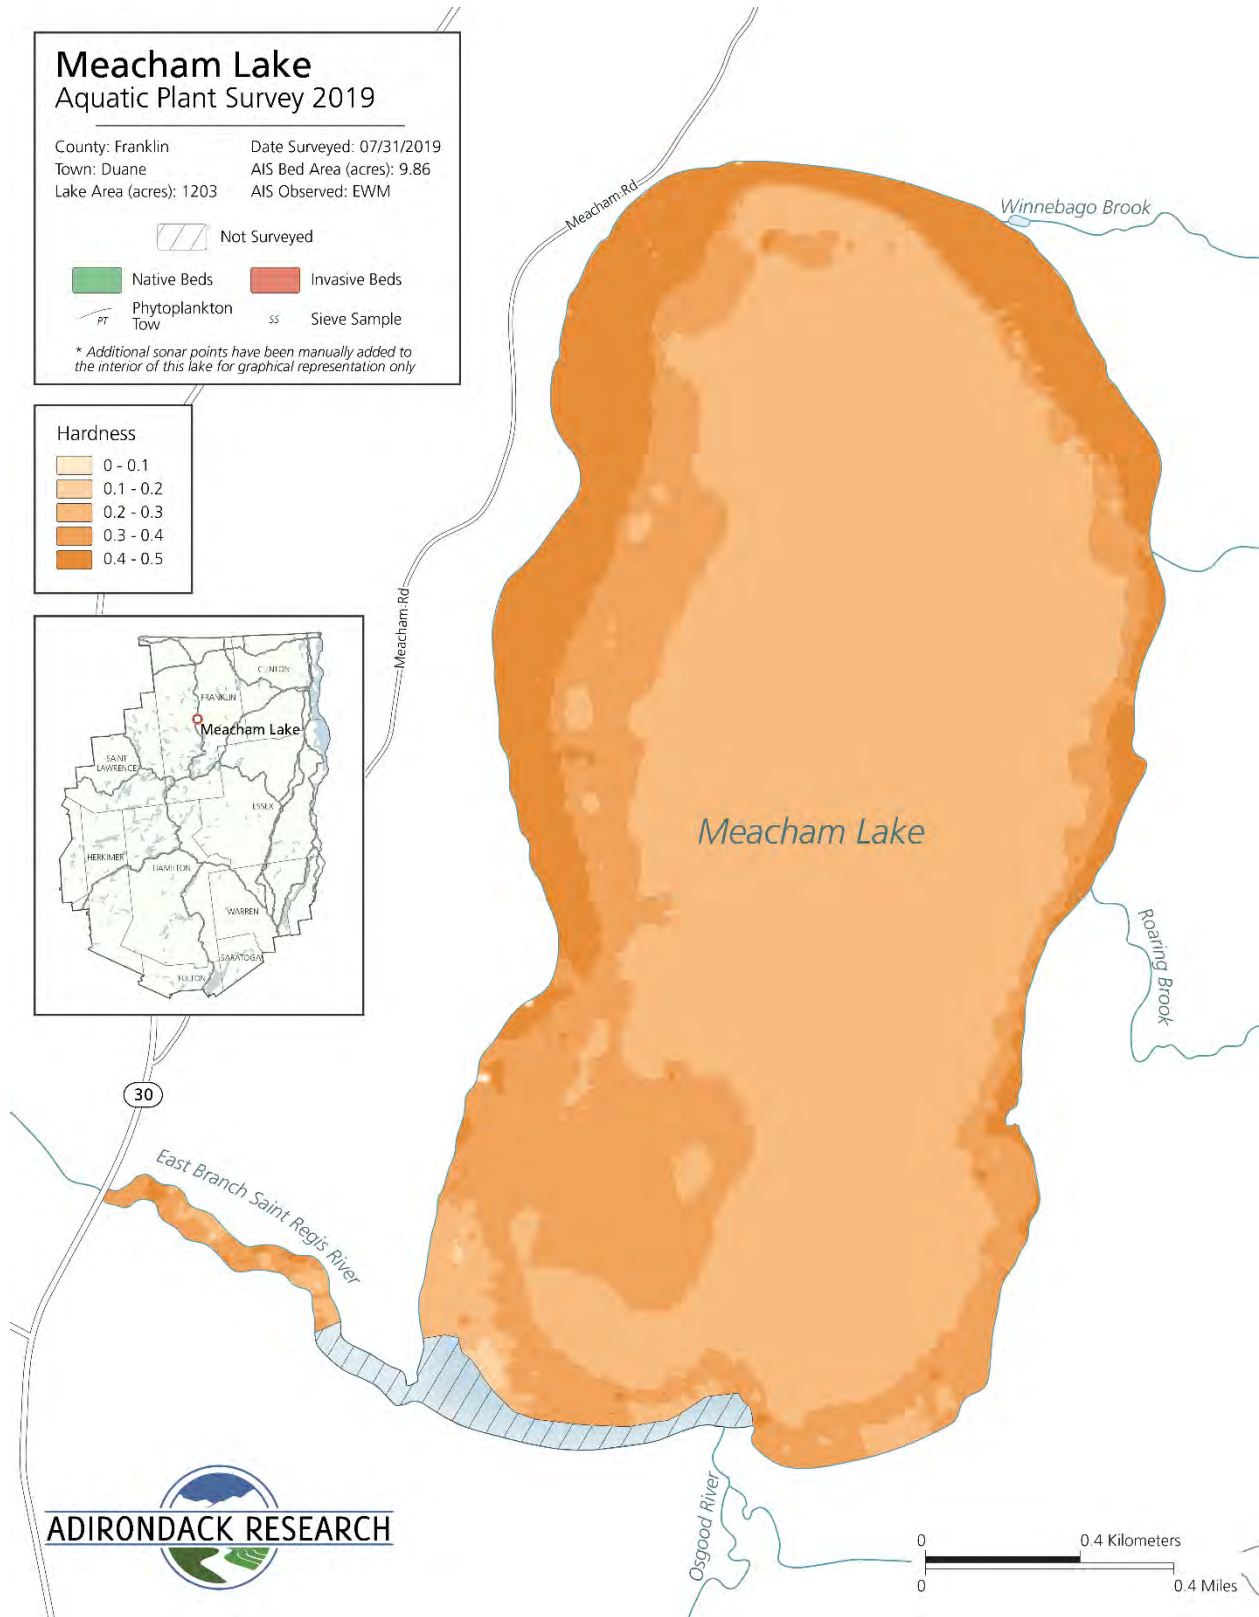
Meacham Lake Aquatic Plant Survey 2019

County: Franklin Date Surveyed: 07/31/2019
Town: Duane AIS Bed Area (acres): 9.86
Lake Area (acres): 1203 AIS Observed: EWM

* Additional sonar points have been manually added to the interior of this lake for graphical representation only

Hardness
