Lake Narrative

Piseco Lake

Survey Date: August 28, 2018

Piseco Lake Aquatic Plant Survey 2018

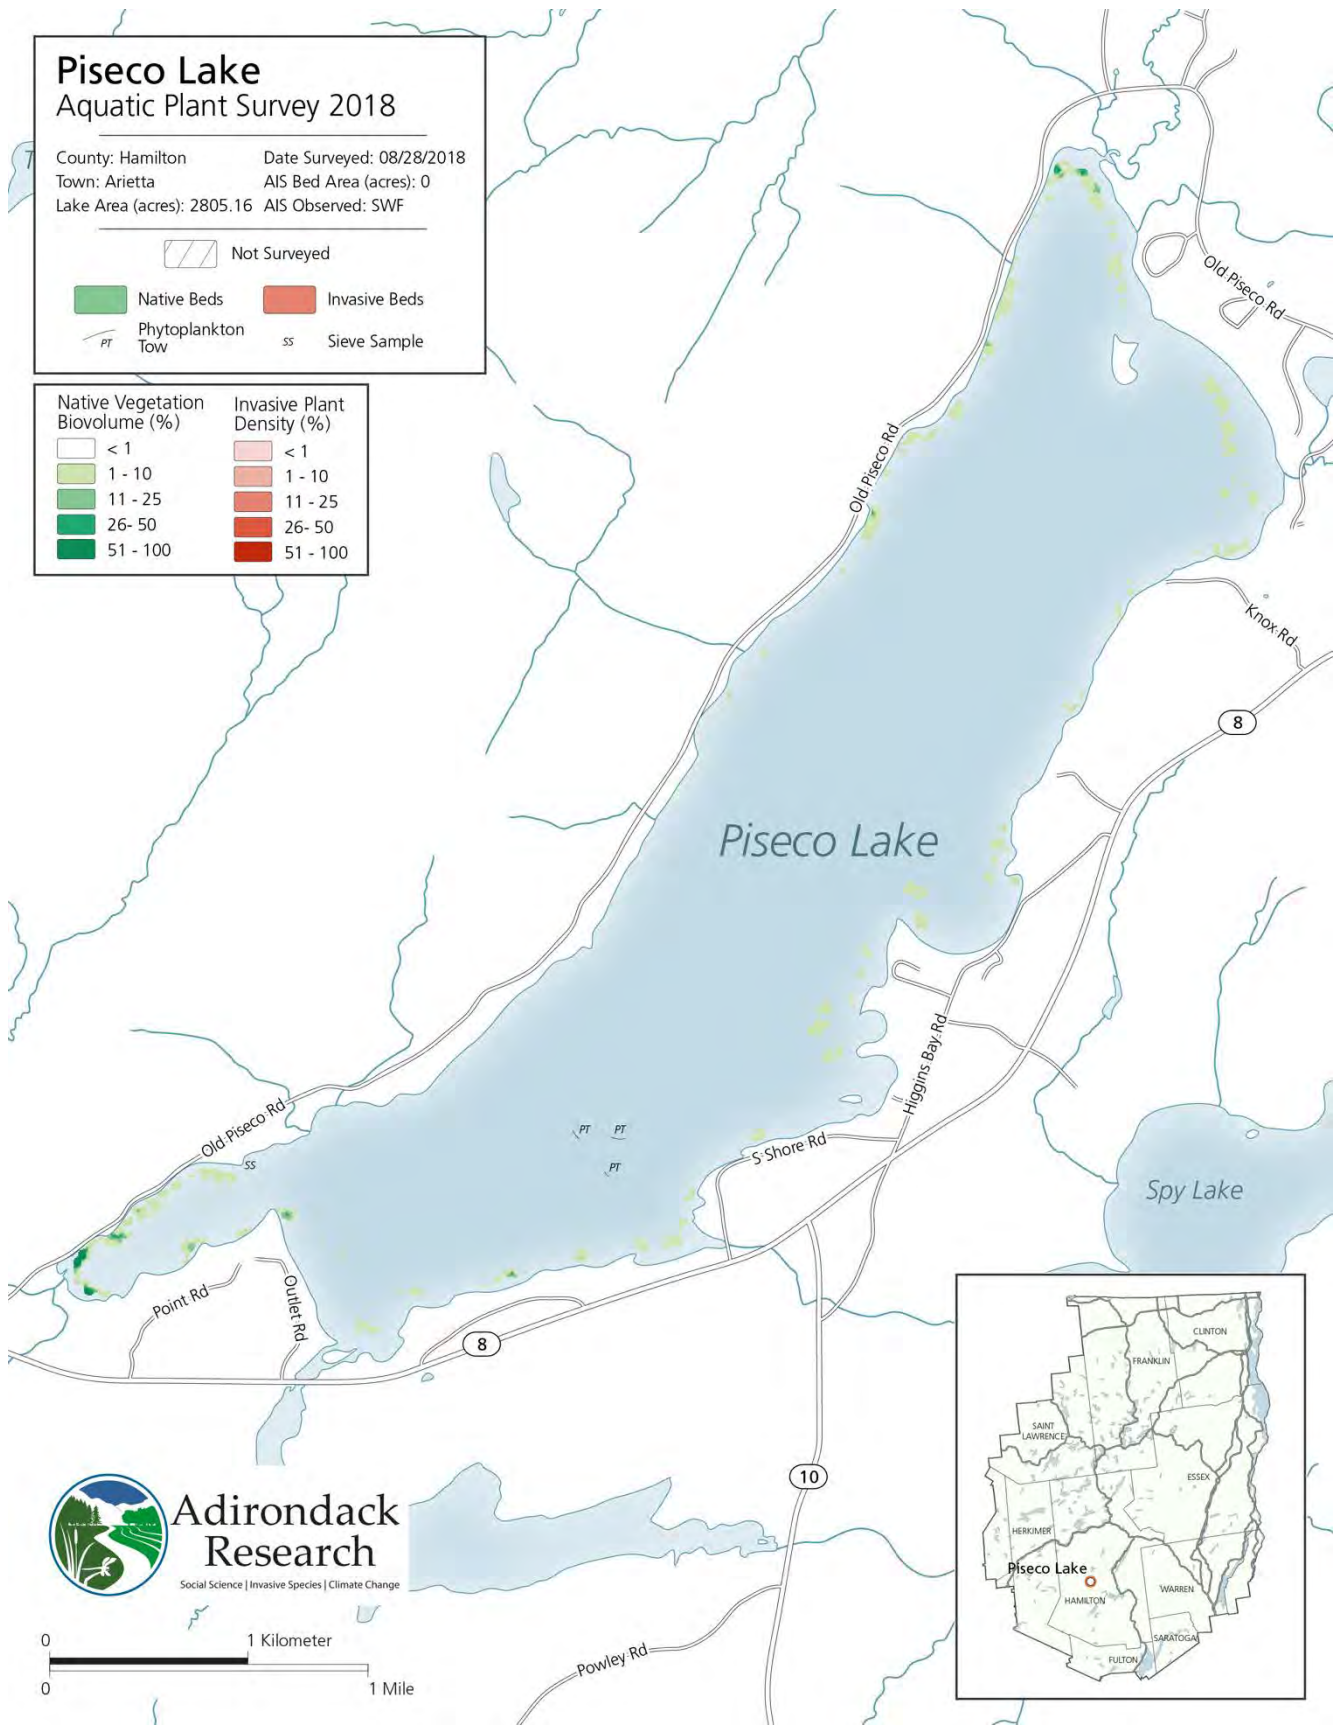
County: Hamilton Date Surveyed: 08/28/2018
 Town: Arietta AIS Bed Area (acres): 0
 Lake Area (acres): 2805.16 AIS Observed: SWF
