## Rock Pond

**Survey Date:** August 12, 2019

# Rock Pond Aquatic Plant Survey 2019

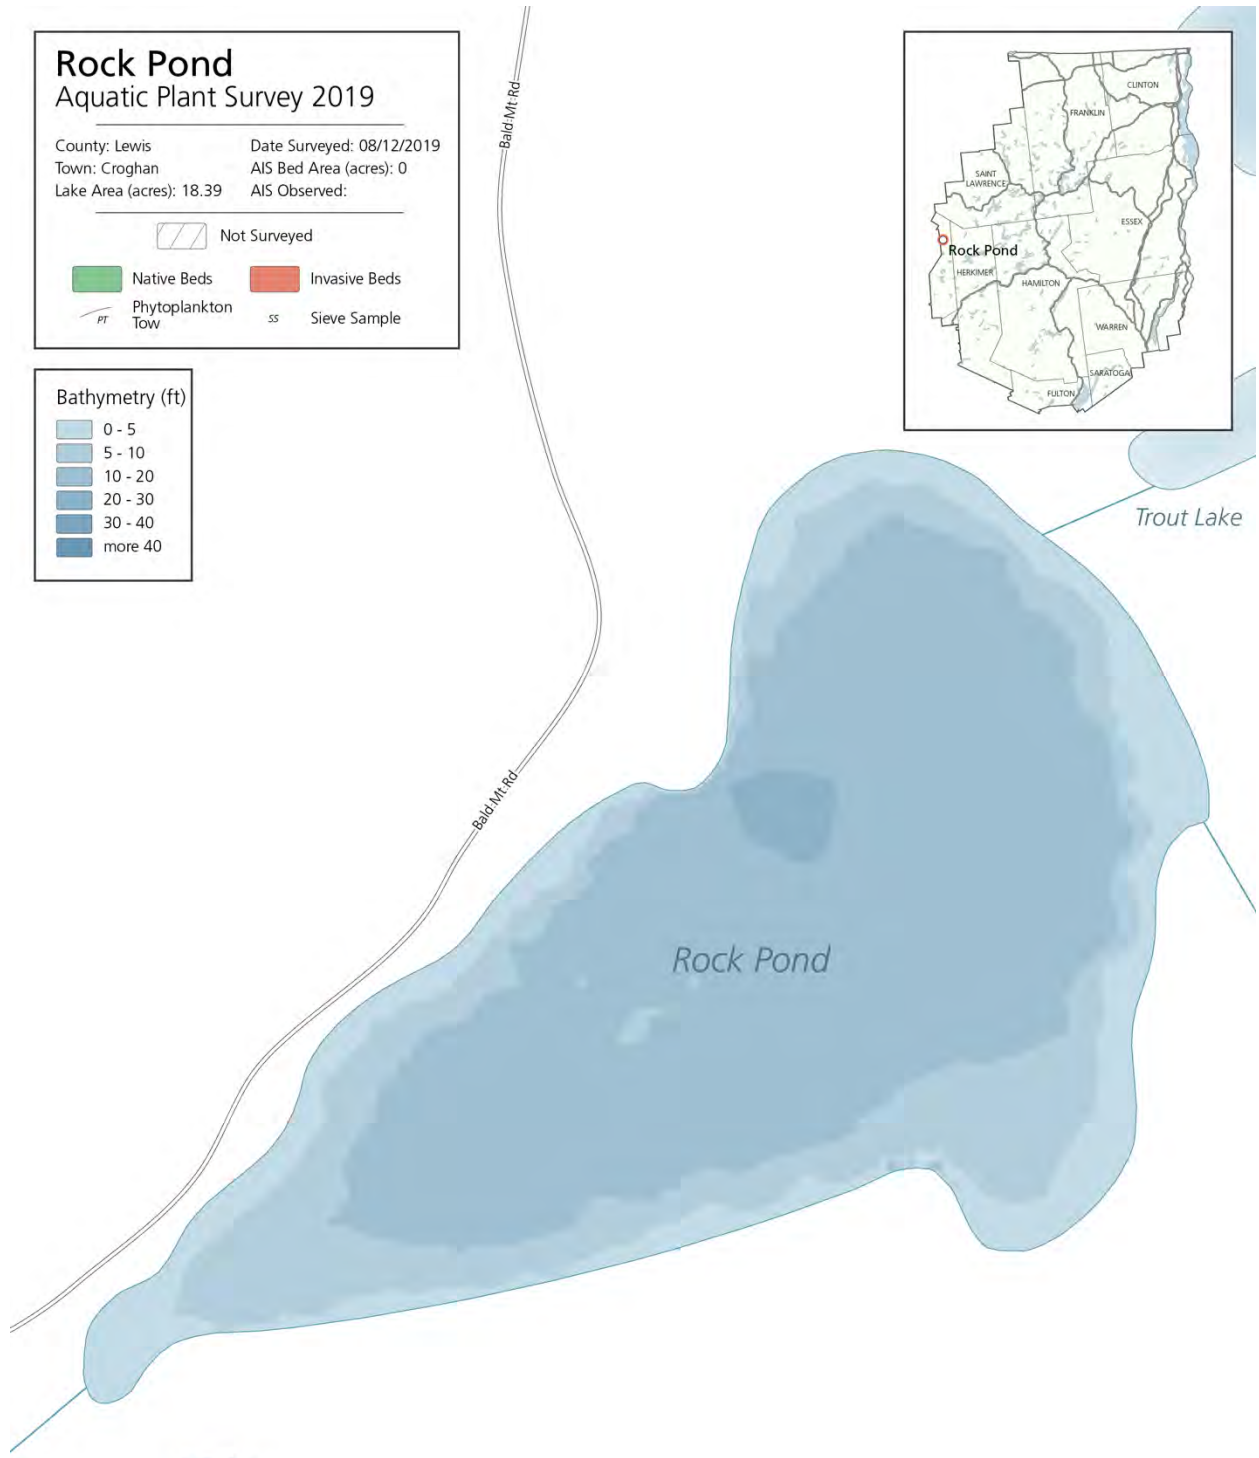
### Rock Pond Aquatic Plant Survey 2019

County: Lewis      Date Surveyed: 08/12/2019  
 Town: Croghan      AIS Bed Area (acres): 0  
 Lake Area (acres): 18.39      AIS Observed:

#### Bathymetry (ft)
