## Valentine Pond

**Survey Date:** August 4, 2021

**Valentine Pond**  
Aquatic Plant Survey 2021

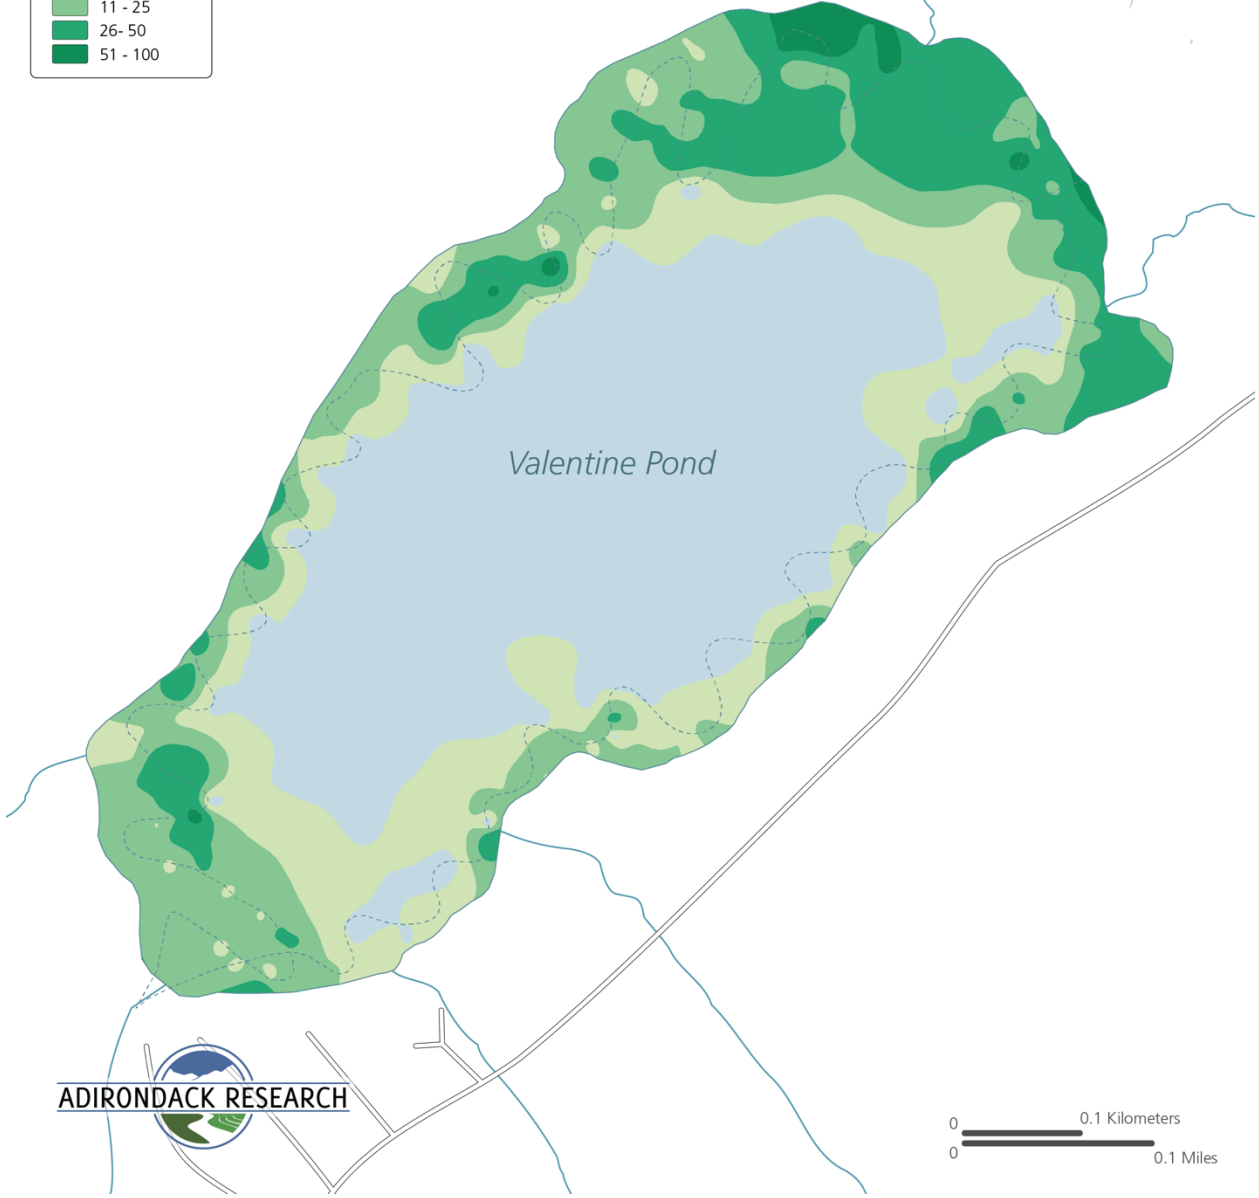
County: Warren      Date Surveyed: 08/04/2021  
Town: Horicon      AIS Bed Area (acres): 0  
Lake Area (acres): 98.8      AIS Observed: None
