Adirondack Park

Terrestrial Invasive Species Steward

Survey & Management Report

2019

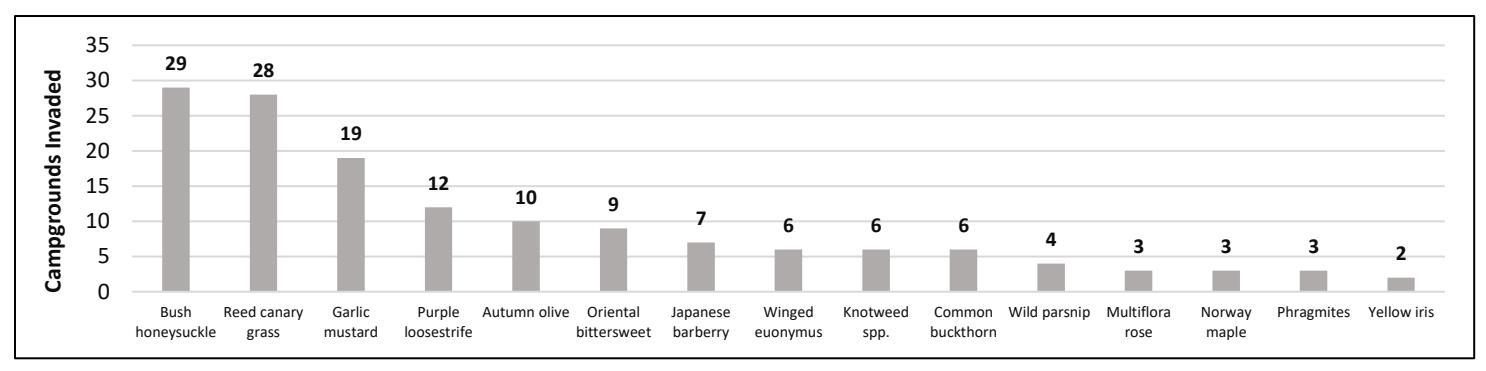
Figure 1. Summary of invasive plant species mapped in 2019 at DEC administered campgrounds.

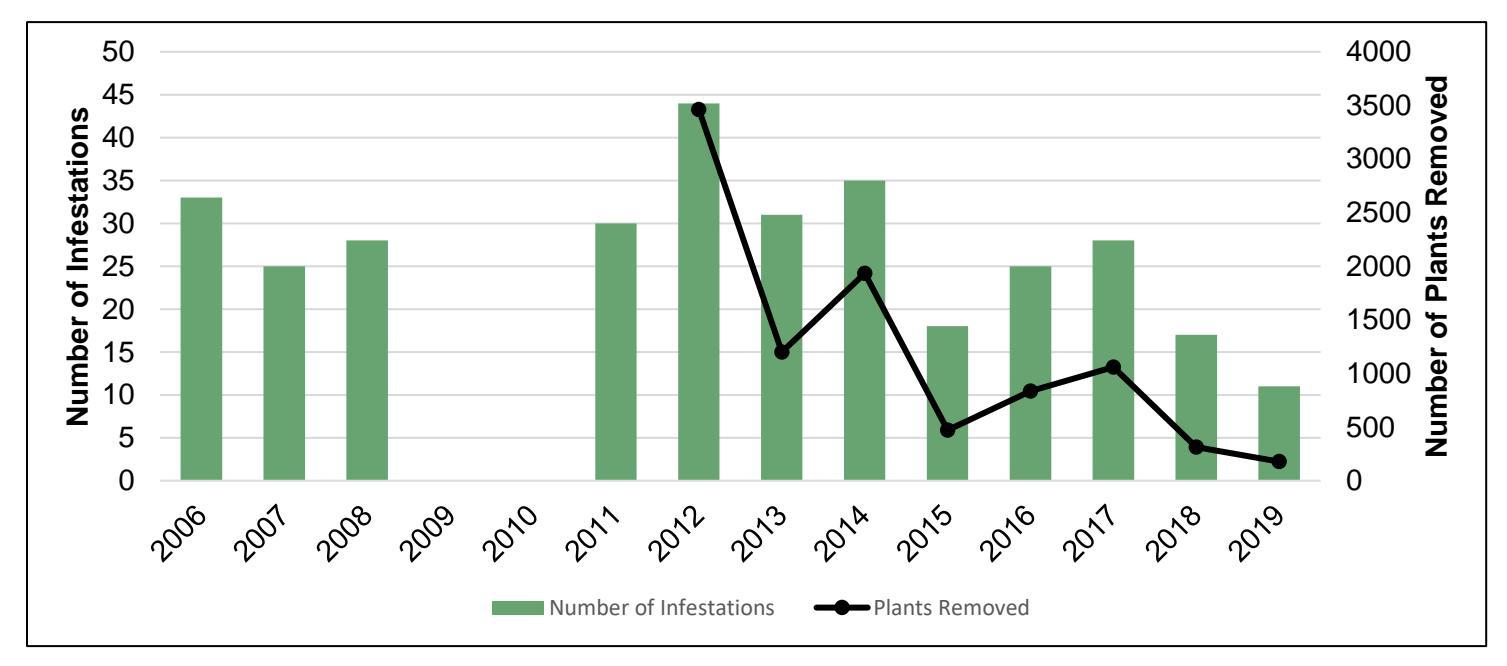
Garlic mustard was mapped and removed from sites 7, 30, 37, 73, 87, 95, 97, and around the maintenance garage. The campground caretaker has been actively managing the infestations by pulling and bagging plants. A few sites that had a high-density last year were found to have no plants this year. In total, 178 plants were removed from 11 locations in the campground (Figure 4). This marks a significant decrease from peak infestation levels observed in

Figure 4. Garlic mustard distribution and management progress at Eighth Lake Campground.

Garlic mustard distribution and abundance has decreased by 95% from peak infestation levels observed in 2012. Through the combined efforts of campground and APIPP staff, local eradication of garlic mustard is likely. Infestations of garlic mustard and reed canary grass were found growing immediately adjacent to a fill source that is used for construction and maintenance projects within the campground. Future management efforts should focus on these infestations to prevent inadvertent spread via contaminated fill. Once target invasives have been eradicated, bush honeysuckle should be pulled using a leverage tool or treated with a basal bark application of herbicide. After mature shrubs are treated, surveys should focus on finding small outliers.

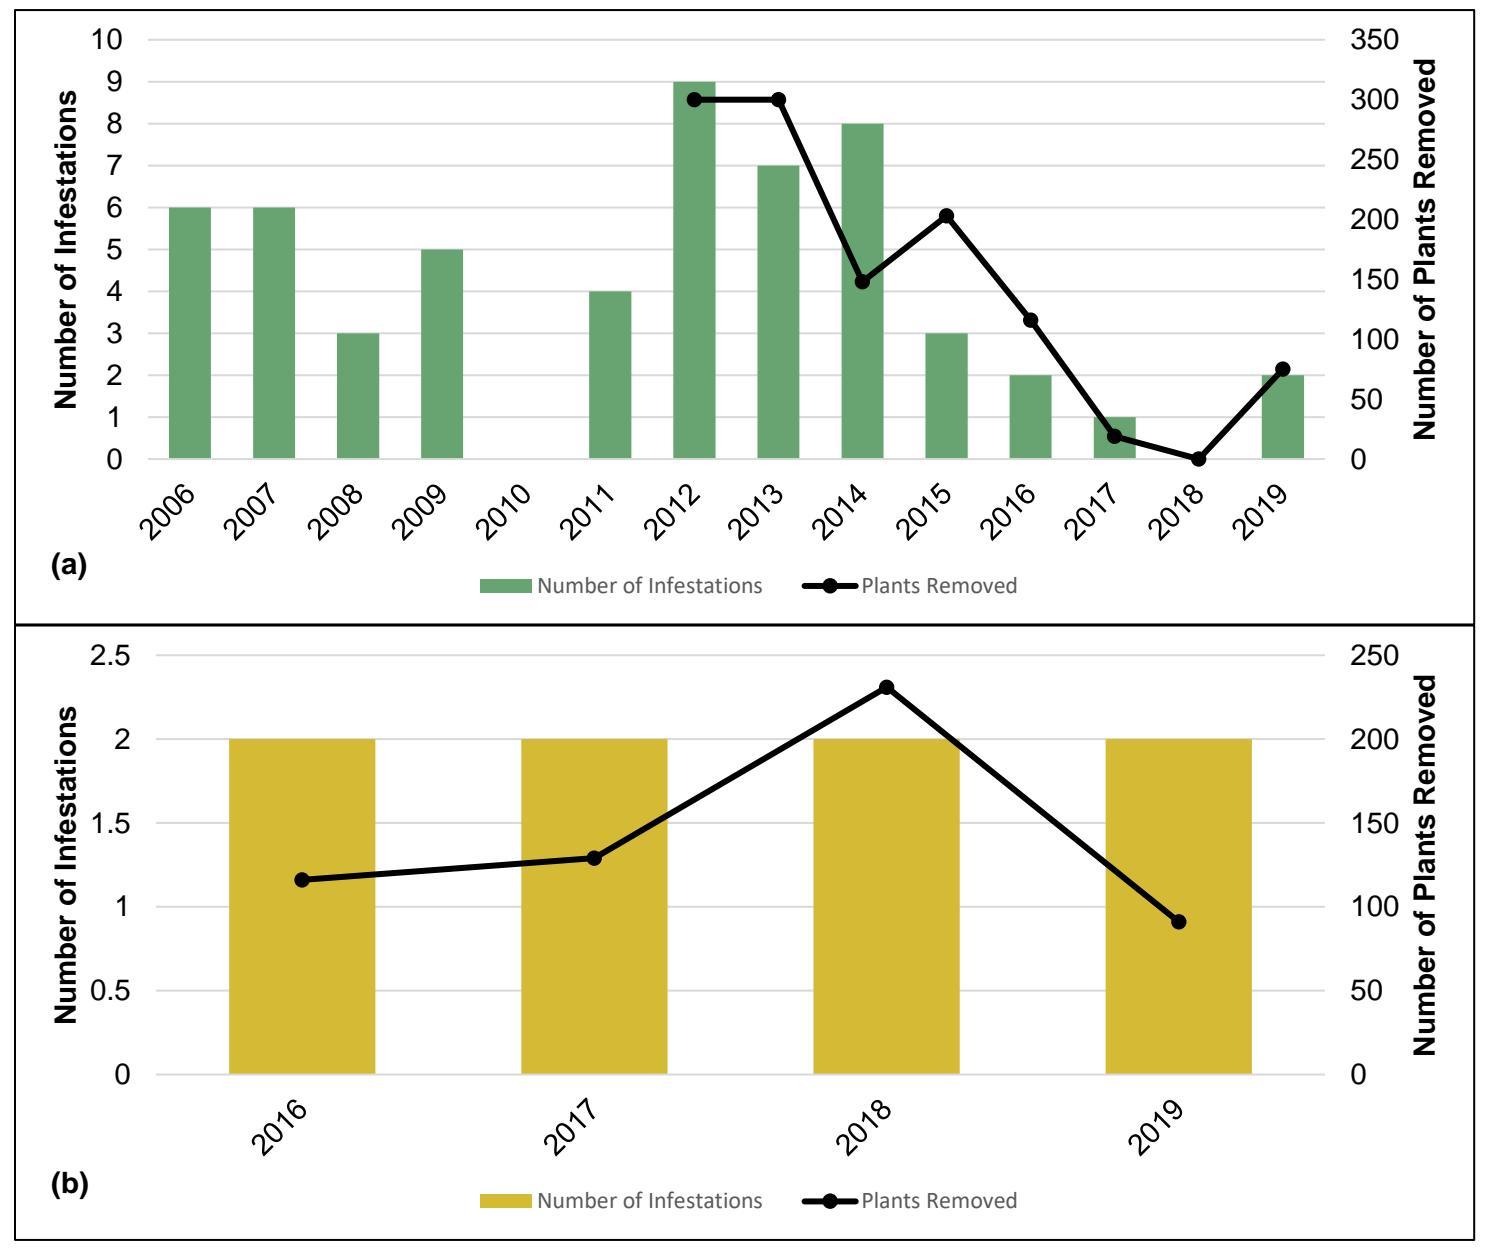
Garlic mustard was mapped and removed from sites 36 and 58. In total, 75 plants were removed from two locations in the campground (Figure 6a). This marks a significant decrease from peak infestation levels observed in 2012 when 300 plants were removed from nine locations.

campground road. The Steward pulled a total of 91 plants, a decrease from the 231 plants removed in 2018 (Figure 6b).

Figure 6 a-b. Garlic mustard (a) and wild parsnip (b) distribution and management progress at Lake Durant Campground.

Garlic mustard should remain a top survey and management priority for this facility. This species was not observed in 2018 but reemerged during the 2019 field season. However, garlic mustard abundance remains 75% lower than peak infestation levels observed in 2012. Care should be taken to remove all stages of garlic mustard in the coming seasons, including rosettes. The number of wild parsnip plants removed decreased for the first time this season. This is likely attributed to APIPP's manual removal efforts and continued mowing by campground staff to suppress infestations. Bush honeysuckle is widespread throughout the campground and should be addressed only after management of higher priority species is complete. However, since this species can be spread long distances via bird dispersed seed, reintroduction is likely.

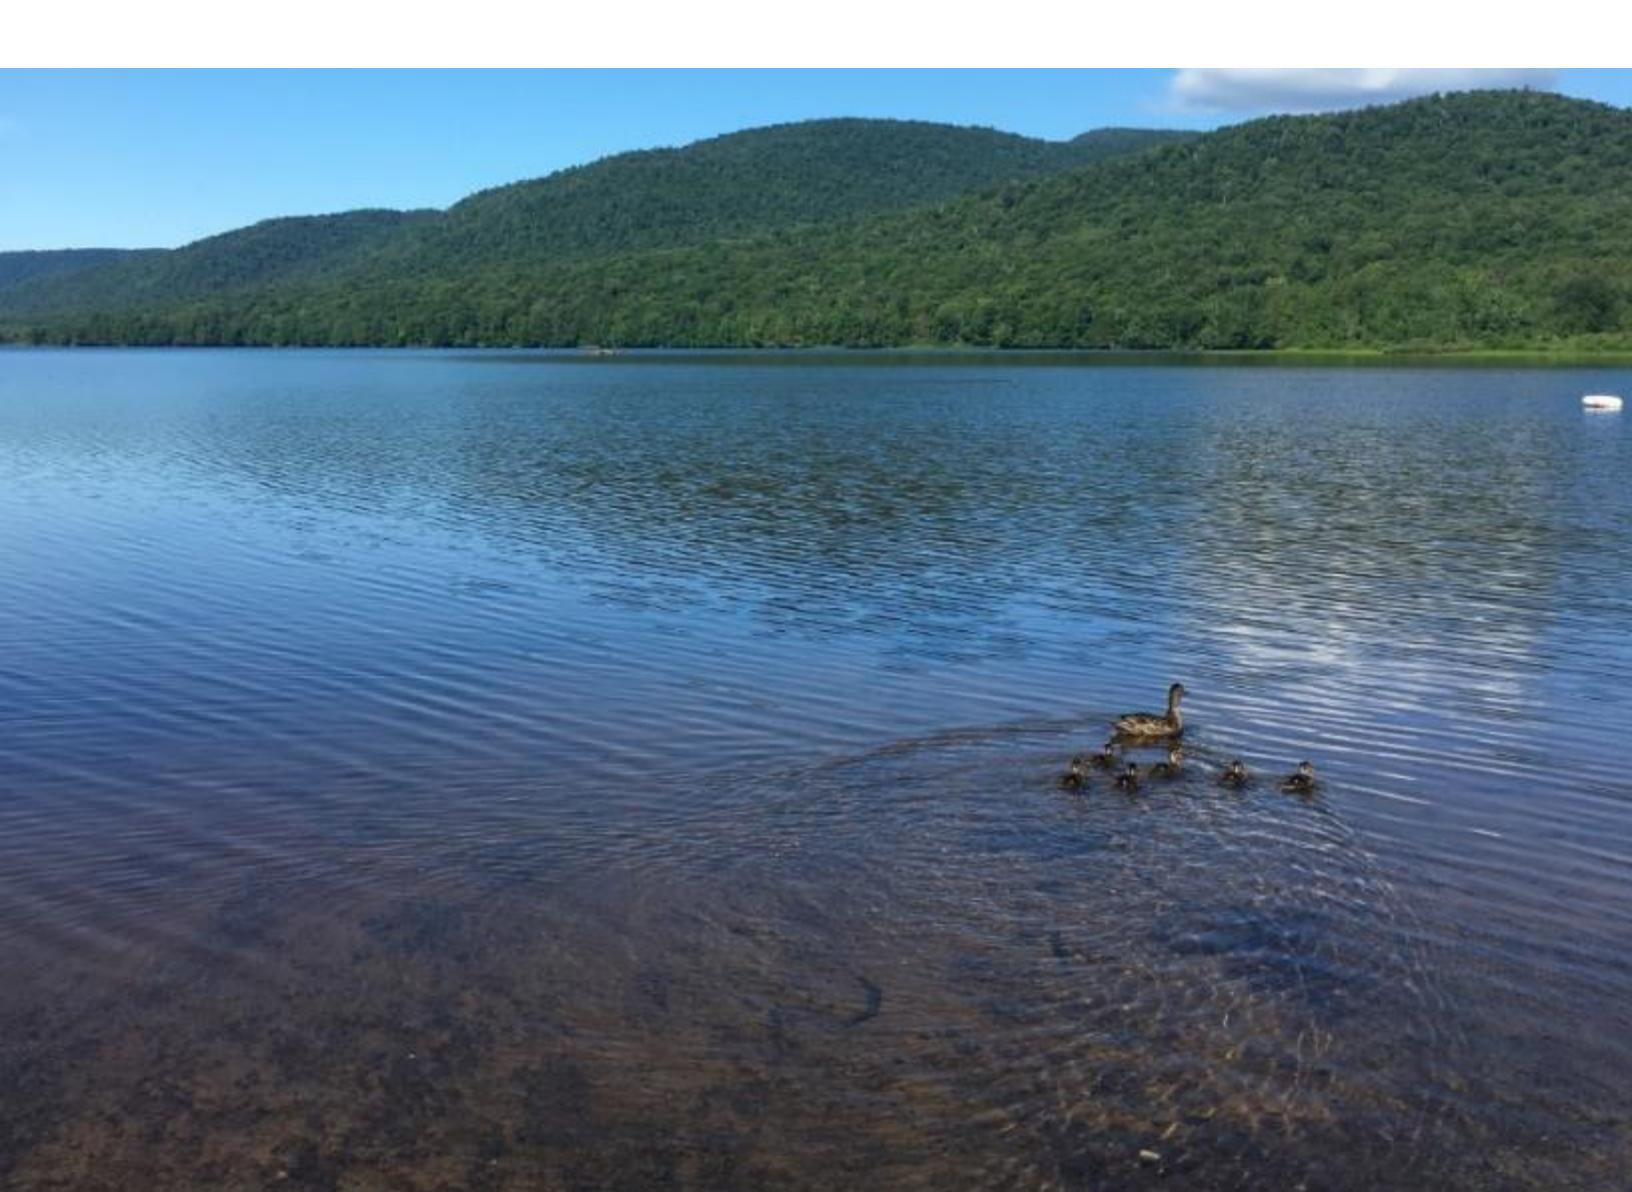
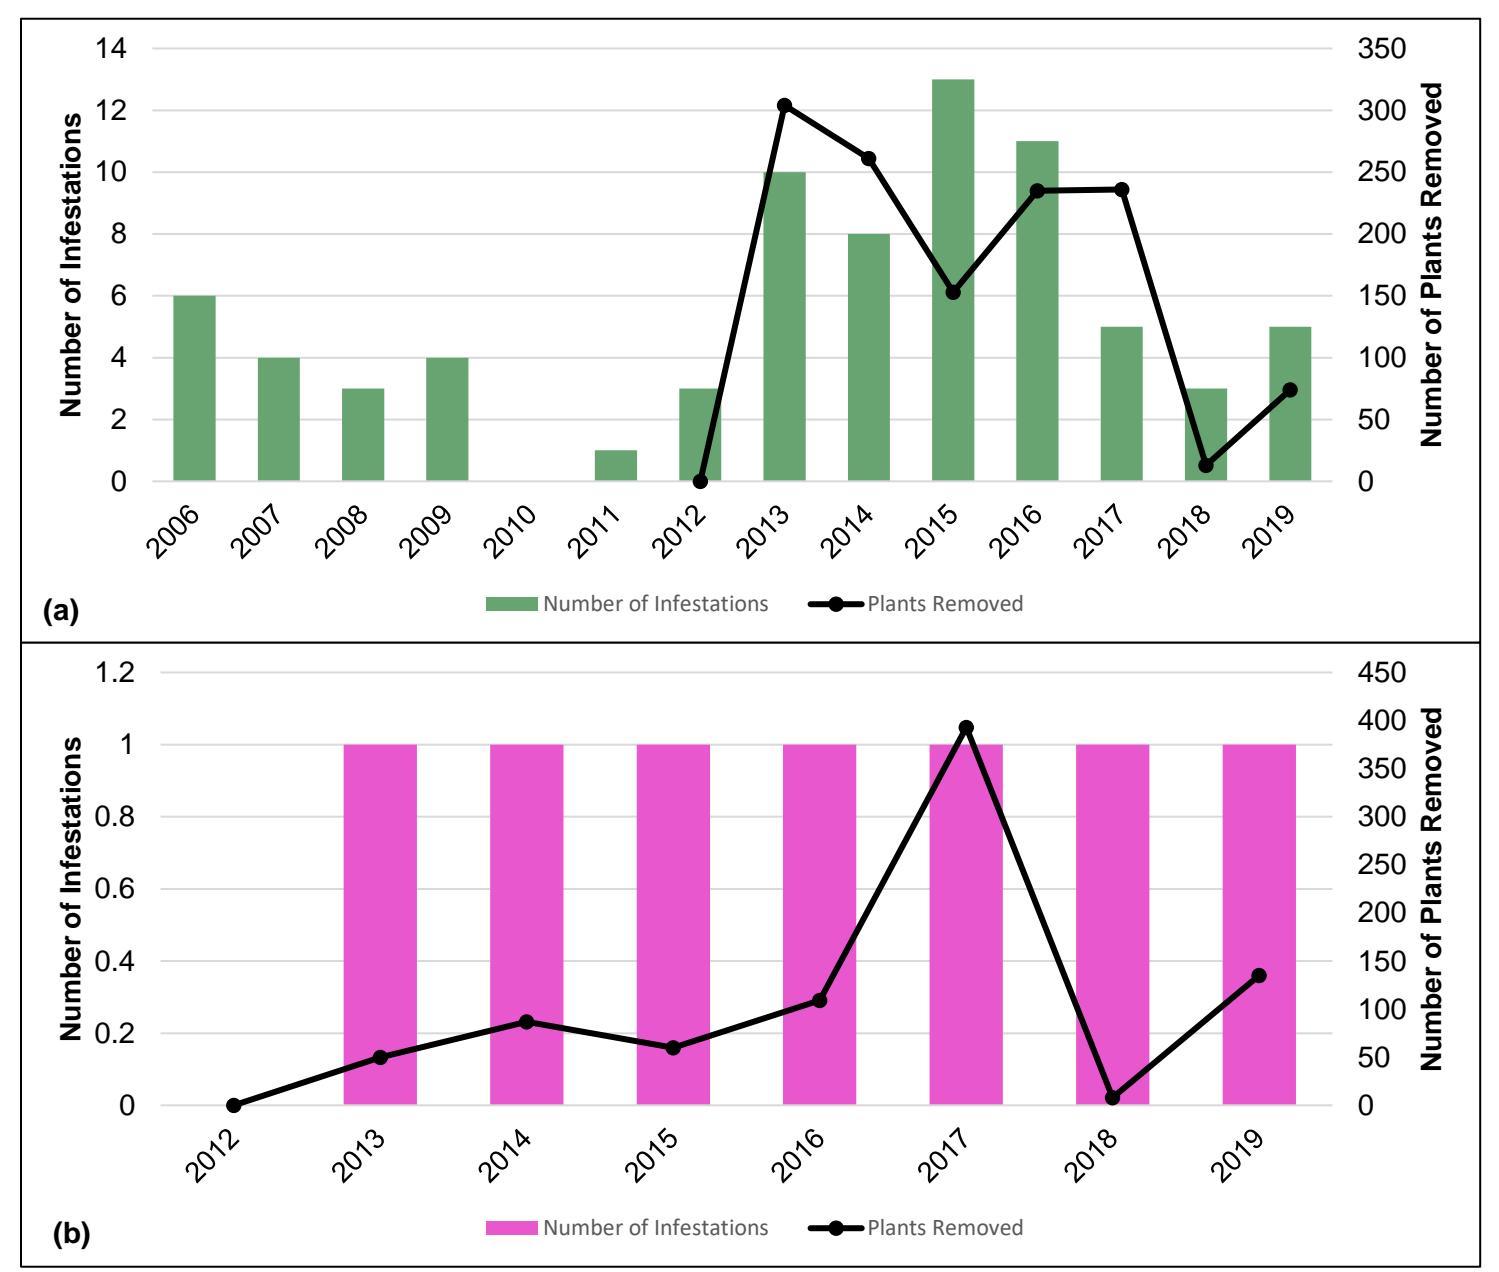
Garlic mustard was mapped and removed from sites 36, 47, 59, 149, and 187. A total of 74 plants were removed, marking an increase compared to 2018 (Figure 7a).

Purple loosestrife was found growing along Indian Lake below sites 23 and 24, plants were pulled and bagged. The number of plants removed this year was 135, a significant increase from last year's report. Historically, the number of plants removed by Stewards has fluctuated greatly (see Figure 7b). This could be attributed to ongoing efforts of campground staff who are also managing the infestation(s).

Figure 7 a-b. Garlic mustard (a) and purple loosestrife (b) distribution and management progress at Lewey Lake Campground.

Garlic mustard should remain a top survey and management priority for this facility. The increase in total number of plants removed in 2019 is partly due to the inclusion of the rosettes in management tallies. In previous years, only second-year plants were counted. Despite this small increase, the overall abundance of garlic mustard has decreased by 76% from peak infestation levels observed in 2013. A surge in purple loosestrife abundance was also observed, increasing from eight plants removed in 2018 to 135 in 2019. Surveillance and mechanical management efforts soul continue for this species. If the population continues to increase, a biocontrol release should be considered. As of 2019, autumn olive was only present in one location near the assistant caretaker's cabin. This species should be managed to prevent additional spread throughout the facility. Bush honeysuckle and reed canary grass are abundant throughout the campground and surrounding landscape. Given their widespread distribution and likelihood for reintroduction, management is not currently recommended.

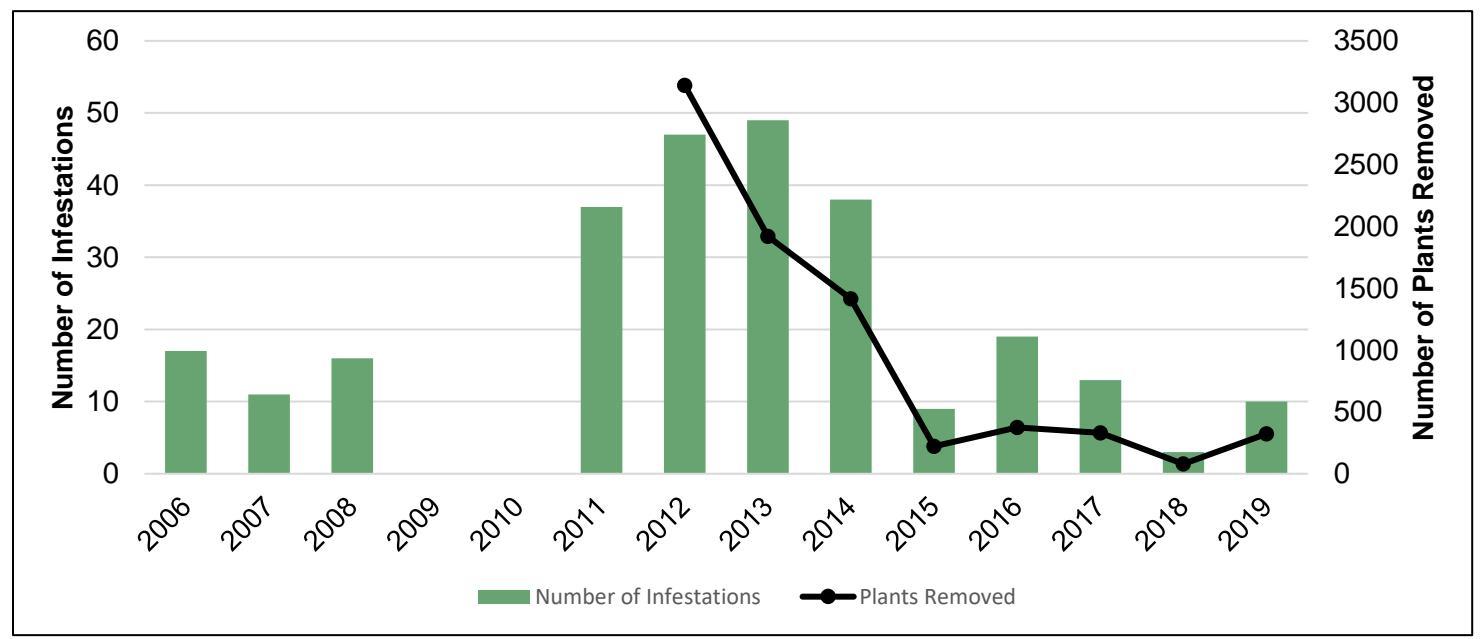
Garlic mustard was mapped and removed from sites 28, 36, 141, 149, 168, 190, 193, and 210. An increase in the number of plants removed was noted, rising from 79 in 2018 to 323 in 2019 (Figure 8).

Figure 8. Garlic mustard distribution and management progress at Limekiln Lake Campground.

Despite a slight increase in garlic mustard abundance, significant management progress has been achieved. The total number of garlic mustard plants removed in 2019 remains 90% less than peak infestation levels observed in 2012. The small increase from 2018 to 2019 is likely attributed to the inclusion of rosettes in management tallies. In previous years, only second-year plants were counted. Bush honeysuckle and reed canary grass are abundant throughout the campground and surrounding landscape. Given their widespread distribution and likelihood for reintroduction, management is not currently recommended. Autumn olive was only documented near the boat launch area and appears to be under mechanical management by campground staff. Manual control should continue to ensure this species does not produce fruit and spread further into the campground.

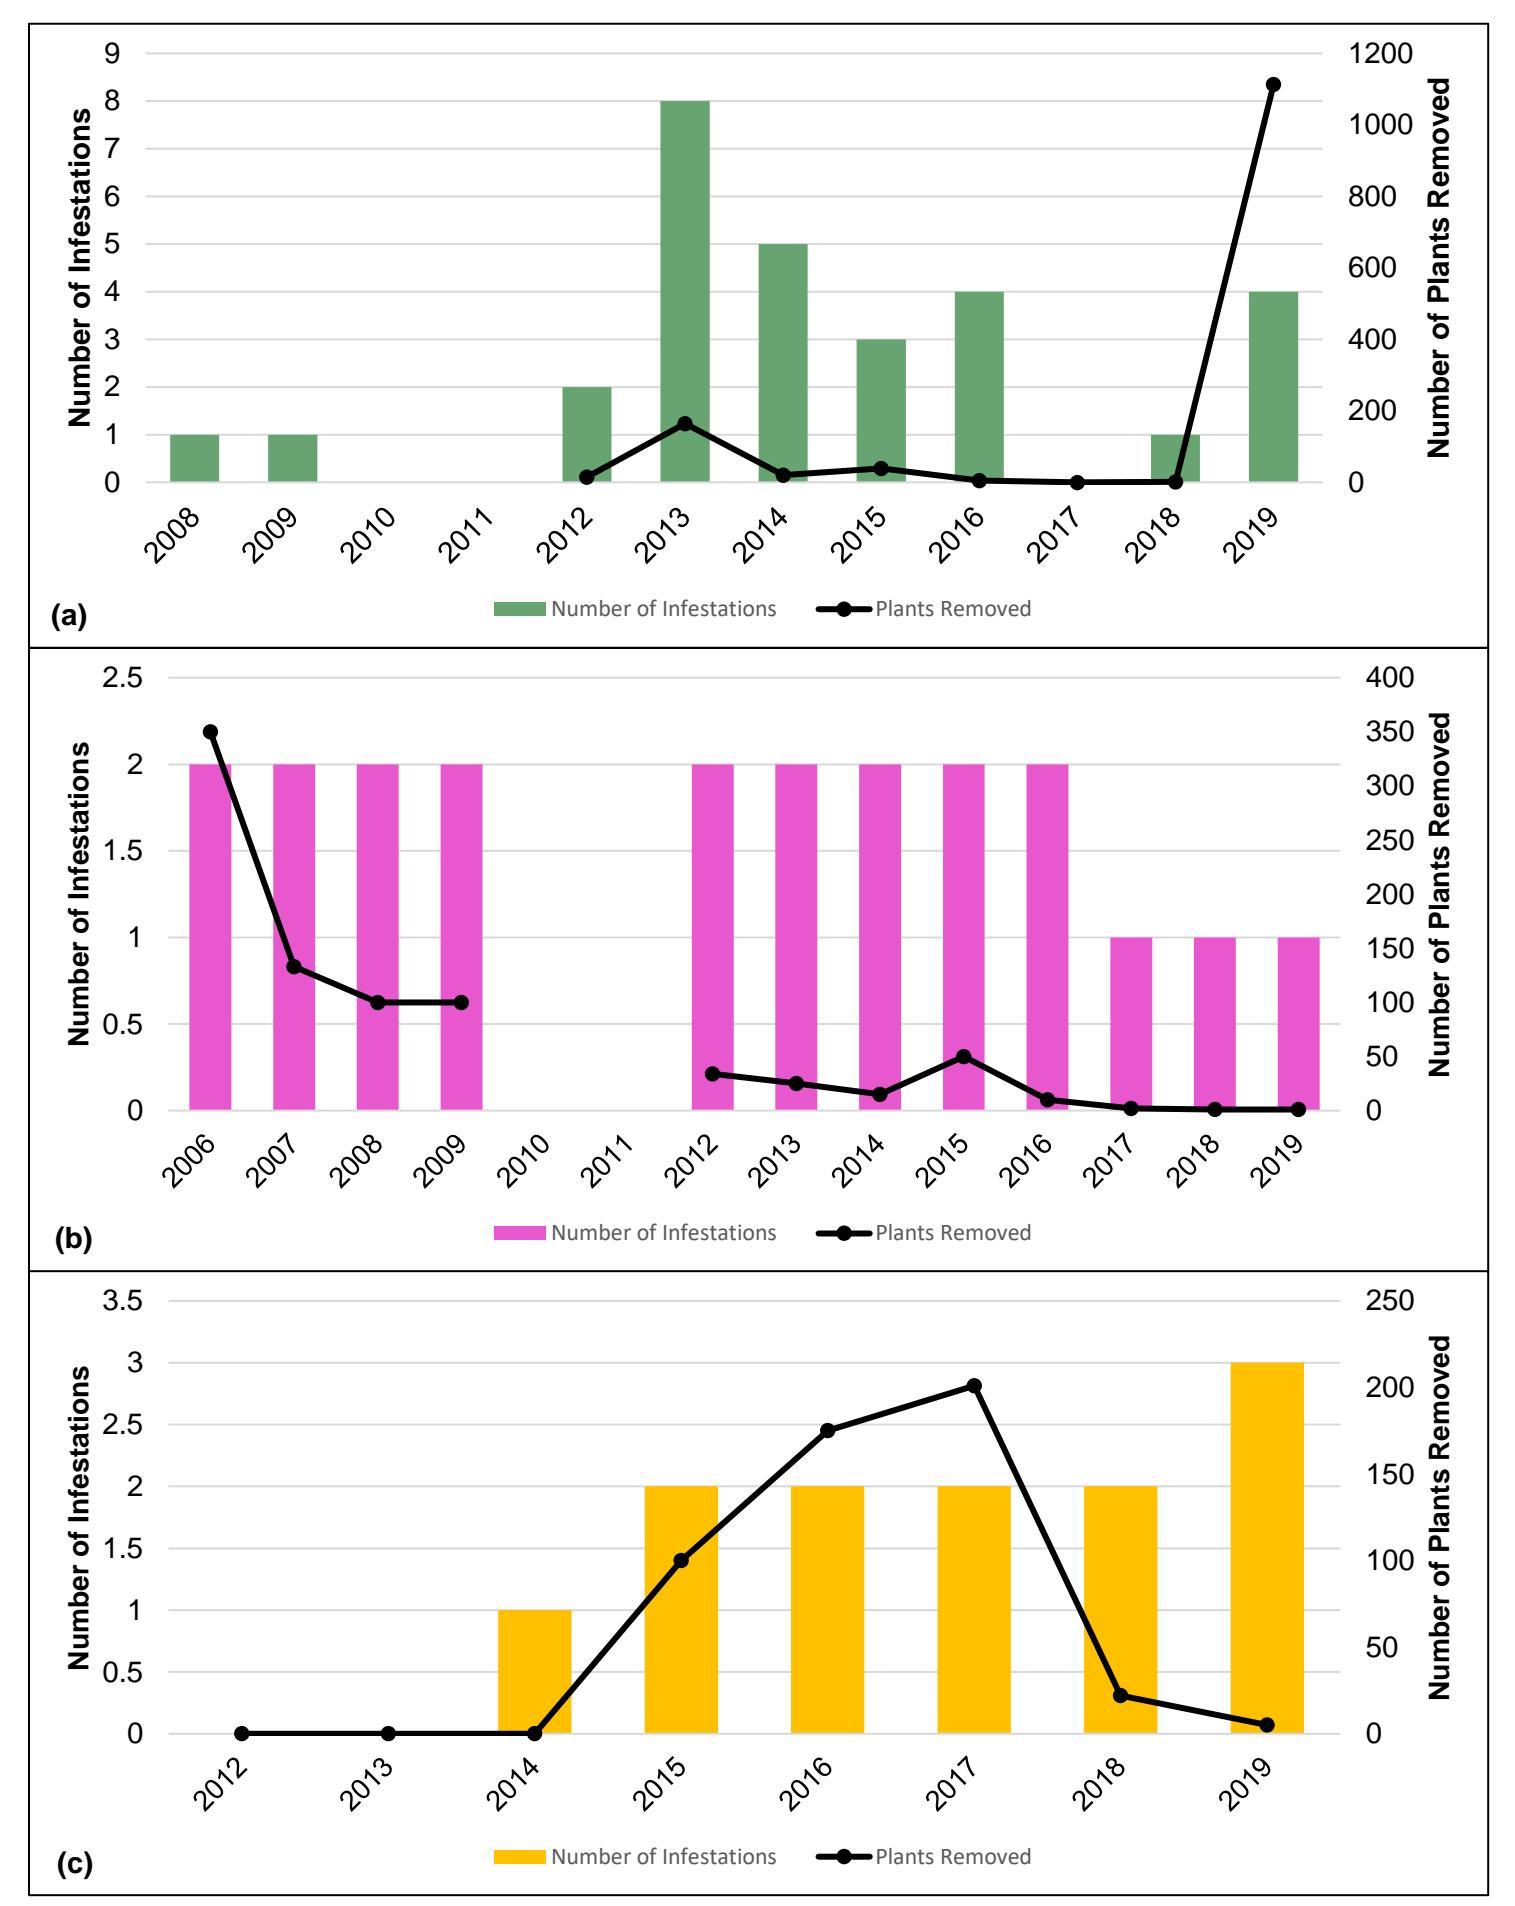
Garlic mustard was mapped and removed from sites 17 and 64. A new, large infestation was mapped and managed on the sanitary sewer cap. In total, 1,121 plants were removed from four locations in the campground (Figure 9a). This marks a significant increase from the historic peak infestation levels observed in 2013 when 164 plants were removed from eight locations.

Purple loosestrife was present at the end of the culvert drainage by the swimming area, but plants showed signs of biocontrol beetle presence and were not removed. In addition, a single plant was mapped and removed in a wet area behind site 85 (Figure 9b).

Yellow iris was mapped along the lake shoreline by the boat launch, swimming area, and picnic area. A new population was mapped and removed by the swimming area. A historic infestation located near the boat launch had been mowed and could not be controlled manually. In total, five large plants were dug out and bagged this season (Figure 9c).

Figure 9 a-c. Garlic mustard (a), purple loosestrife (b) and yellow iris (c) distribution and management progress at Caroga Lake Campground.

Garlic mustard should remain a top survey and management priority for this campground. With the discovery of a large new infestation in 2019, the total number of plants removed within the campground increased by approximately 98% compared to 2018. The new occurrence managed at the sanitary sewer cap could have potentially been serving as a source for spread to the interior campground. Yellow iris should also remain a priority at this facility. One historic infestation could not be managed in 2019 due to mowing by the campground staff. Special attention should be dedicated to this site in 2020 to address potential reemergence. Nevertheless, significant progress has been made at reducing yellow iris extent within the campground. However, additional infestations of yellow iris were mapped by APIPP staff along the shoreline of East Caroga Lake in 2019. These infestations should also be managed by APIPP staff or its Terrestrial Early Detection and Rapid Response Team. Purple loosestrife – and the presence of biocontrol beetles – should be monitored. Unless there is a decrease in *Galerucella* population, purple loosestrife should be left to provide habitat for the beetles. Isolated purple loosestrife plants can be removed manually. *Phragmites* and knotweed species should be prioritized for chemical treatment in 2020. The remaining woody species and reed canary grass are lower priorities and should not be considered for management at this time.

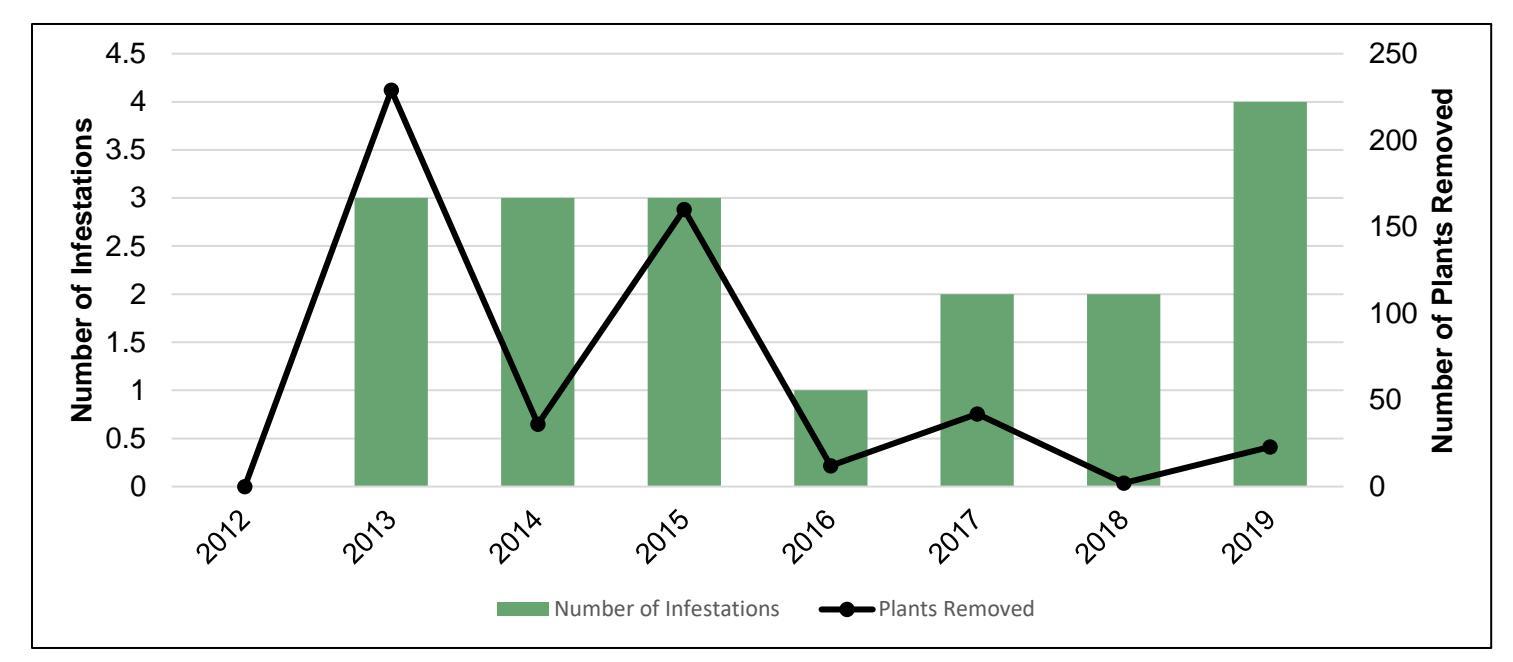
Garlic mustard was mapped and removed from sites 7, 12, 22A and 23. In total, 23 plants were removed from four locations in the campground. This marks a significant decrease from peak infestation levels observed in 2013 when 229 plants were removed from three locations (Figure 10).

Figure 10. Garlic mustard distribution and management progress at Little Sand Point Campground.

Despite a 74% increase from the total number of garlic mustard plants removed in 2018, a long-term decline in abundance is still present. Overall garlic mustard has decreased by 90% from peak infestation levels observed in 2013. With continued surveillance and management, local eradication can likely be achieved at this facility. Infestations of knotweed spp. are also in decline as a result of chemical treatments performed by APIPP's Terrestrial Early Detection and Rapid Response Team. Chemical treatments should continue to facilitate local eradication. Bush honeysuckle and reed canary grass are abundant throughout the campground and surrounding landscape. Given their widespread distribution and likelihood for reintroduction, management is not currently recommended.

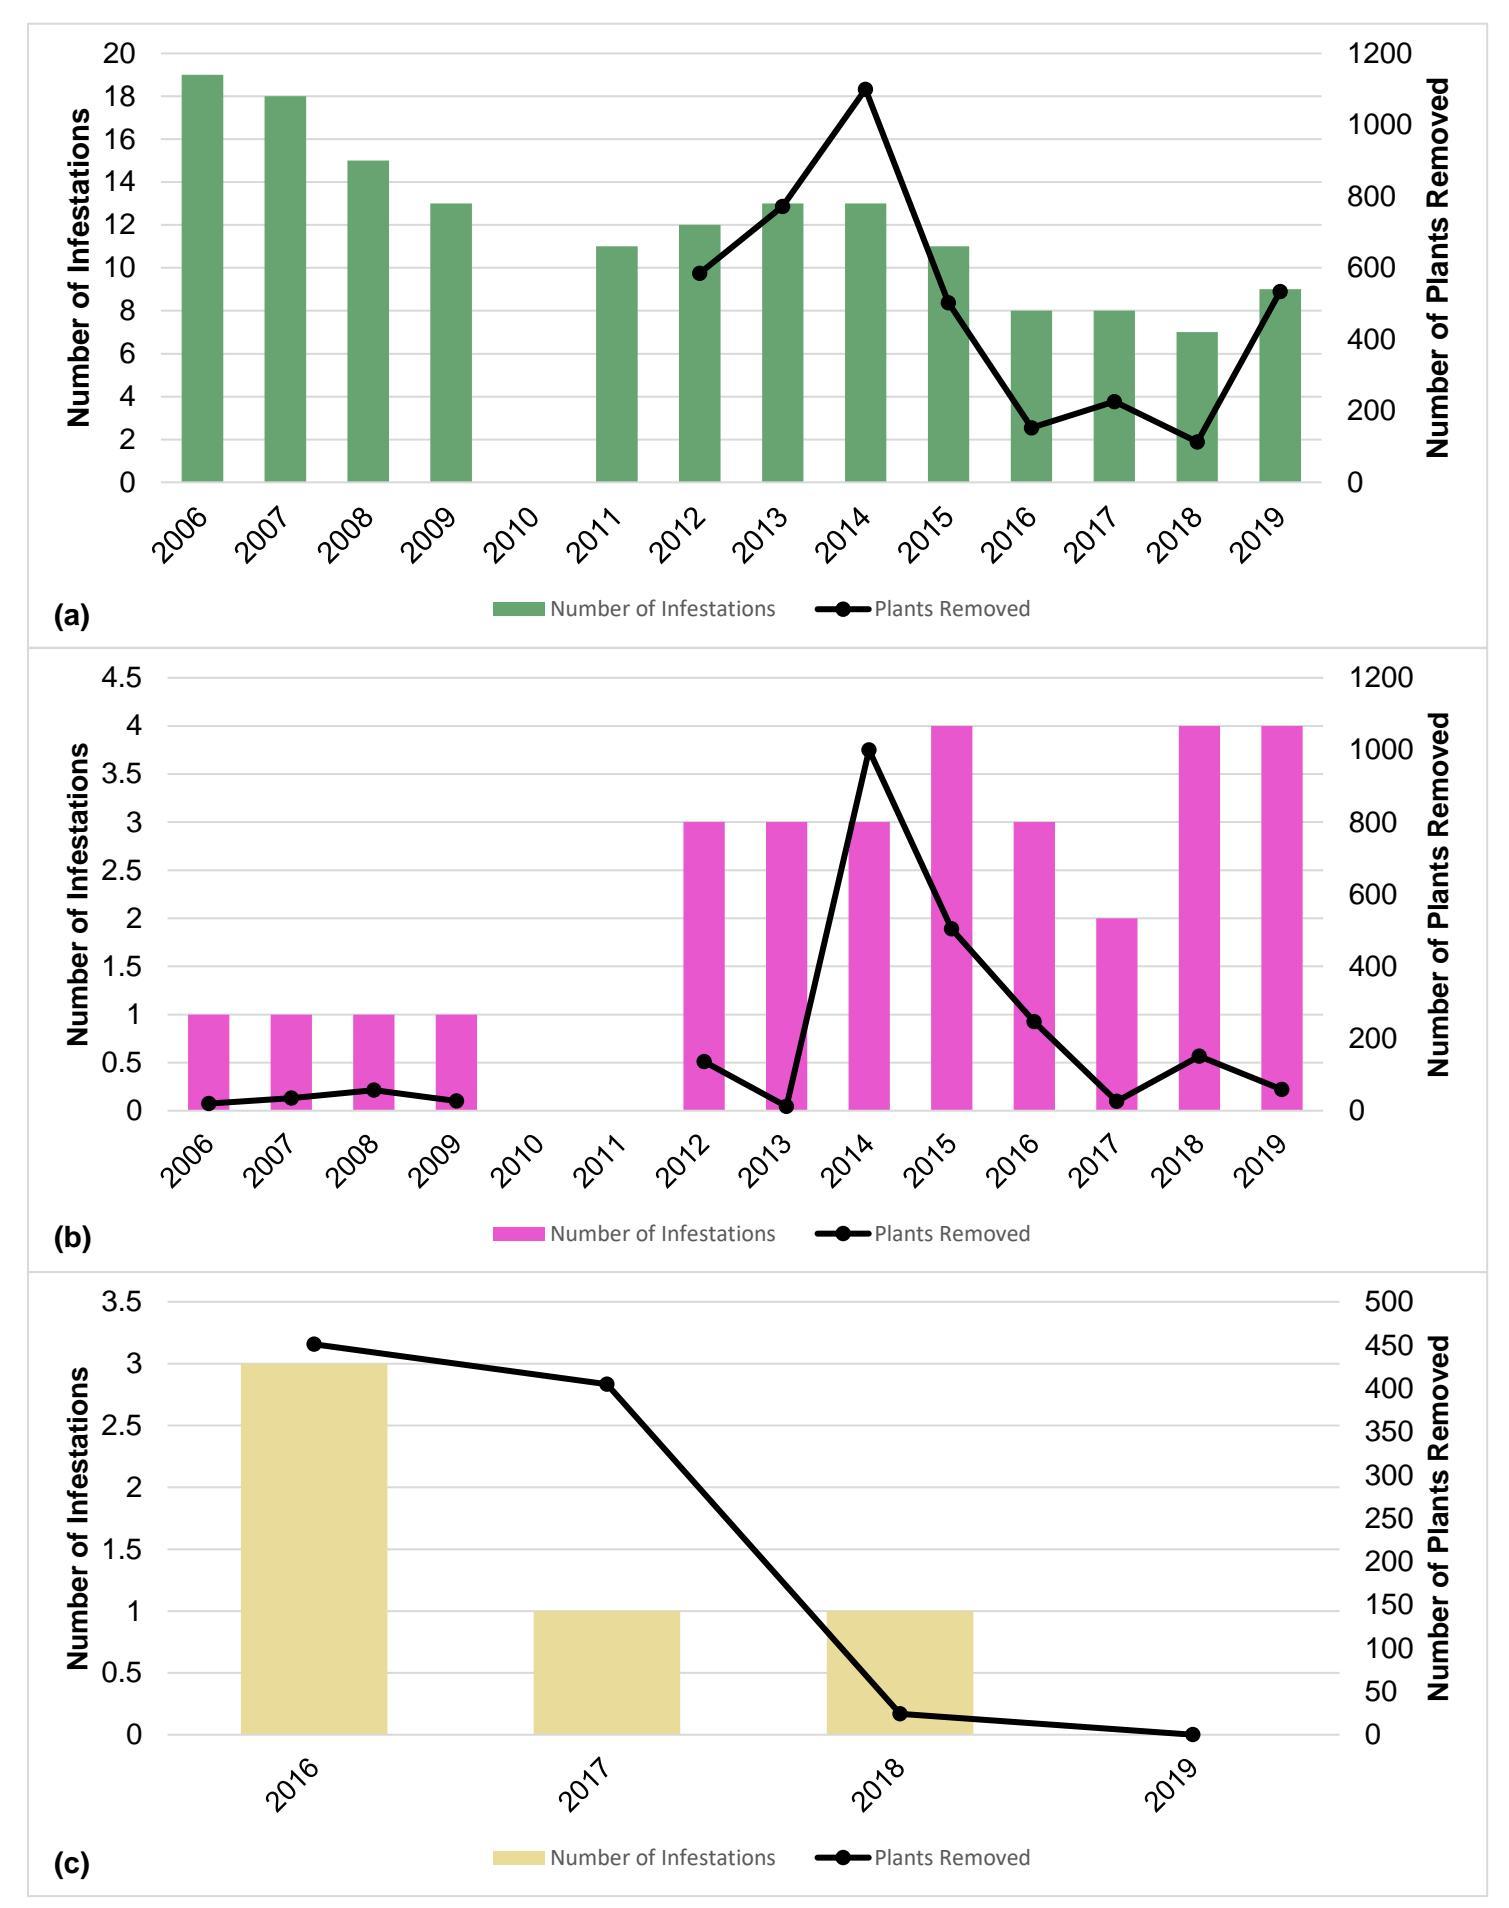
bathroom located near site 249. Two infestations were mapped and managed for the first time in 2019. In total, 534 plants were removed from nine locations in the campground (Figure 11a). This marks a significant decrease from peak infestation levels observed in 2014 when 1,100 plants were removed from 13 locations.

Wild parsnip was managed in 2018, but no plants were detected for the first time in 2019 (Figure 11c).

Figure 11 a-c. Garlic mustard (a), purple loosestrife (b), and wild parsnip (C) distribution and management progress at Moffit Beach Campground.

Garlic mustard surveillance and management should remain a high priority for this campground. There was a 46% increase in total plants removed compared to 2018. However, the total quantity of plants removed throughout the campground remains 75% lower than peak infestation levels observed in 2014. The increase observed in 2019 results from the discovery of two new infestations and including rosettes in management tallies. In previous years, only second-year plants were counted. Monitoring purple loosestrife – and its biocontrol beetles – should also remain a high priority. Many historic infestations were covered by fill as part of a regrading project. Other populations were in a swamp with standing water and could not be accessed. A biocontrol release is recommended if purple loosestrife grows through the new fill in the spoils pit area. Wild parsnip was not found at the campground for the first time this year. It is possible that the area had been mowed prior to the survey, so continued surveillance is recommended.

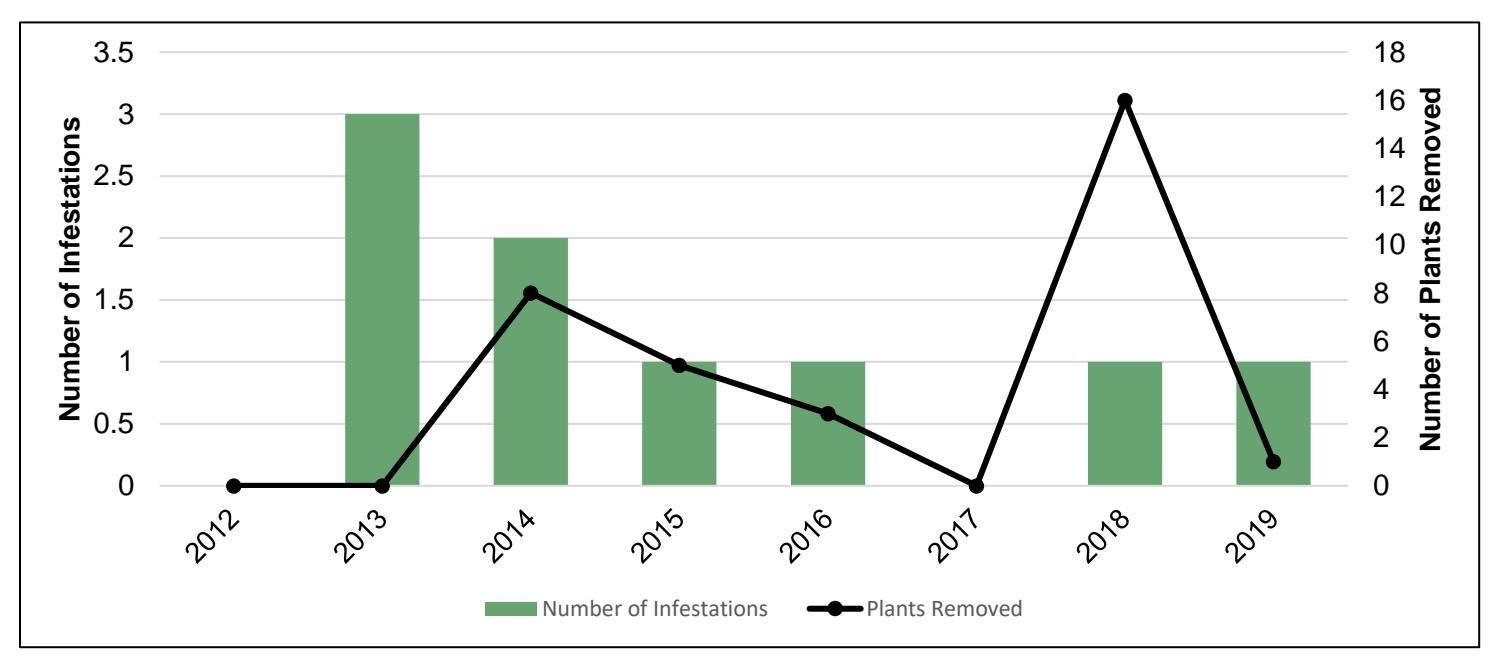
Garlic mustard was mapped and removed near the boat launch and a small building at the edge of the tree line. A single, large plant was removed before going to seed. This marks a decrease from last year's peak infestation levels of 16 plants removed from three locations (Figure 13).

Figure 13. Garlic mustard distribution and management progress at Point Comfort Campground.

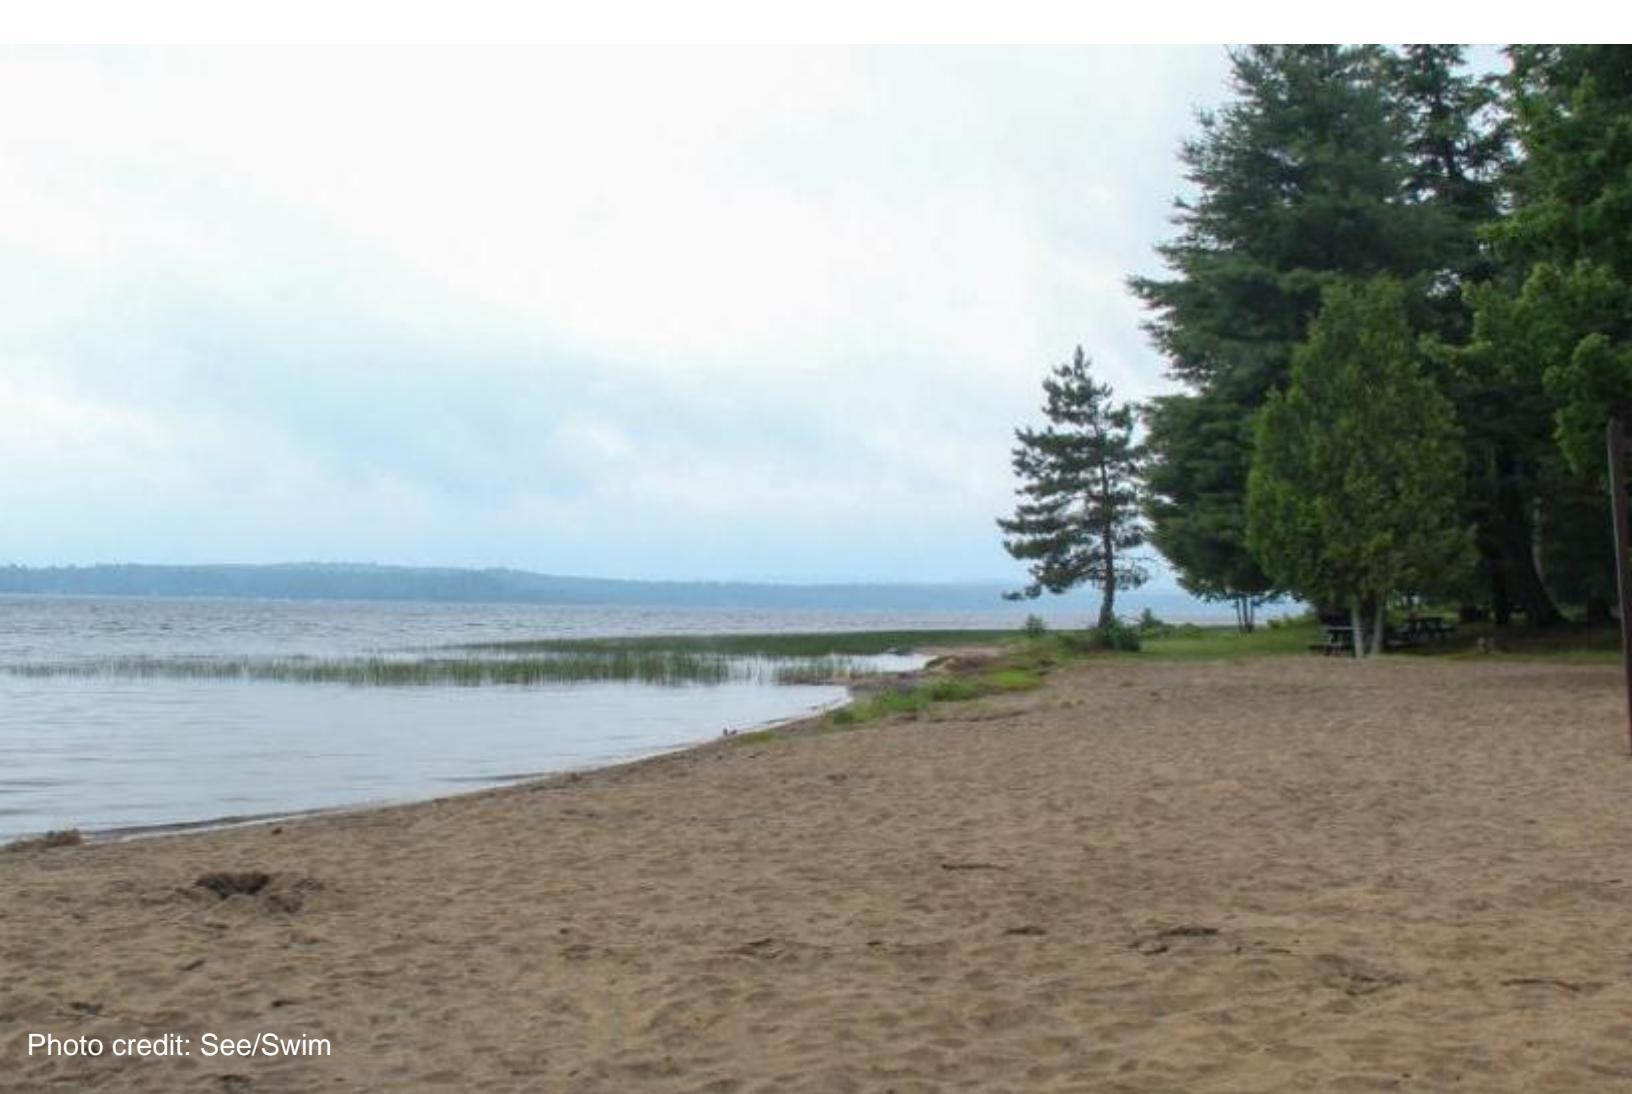
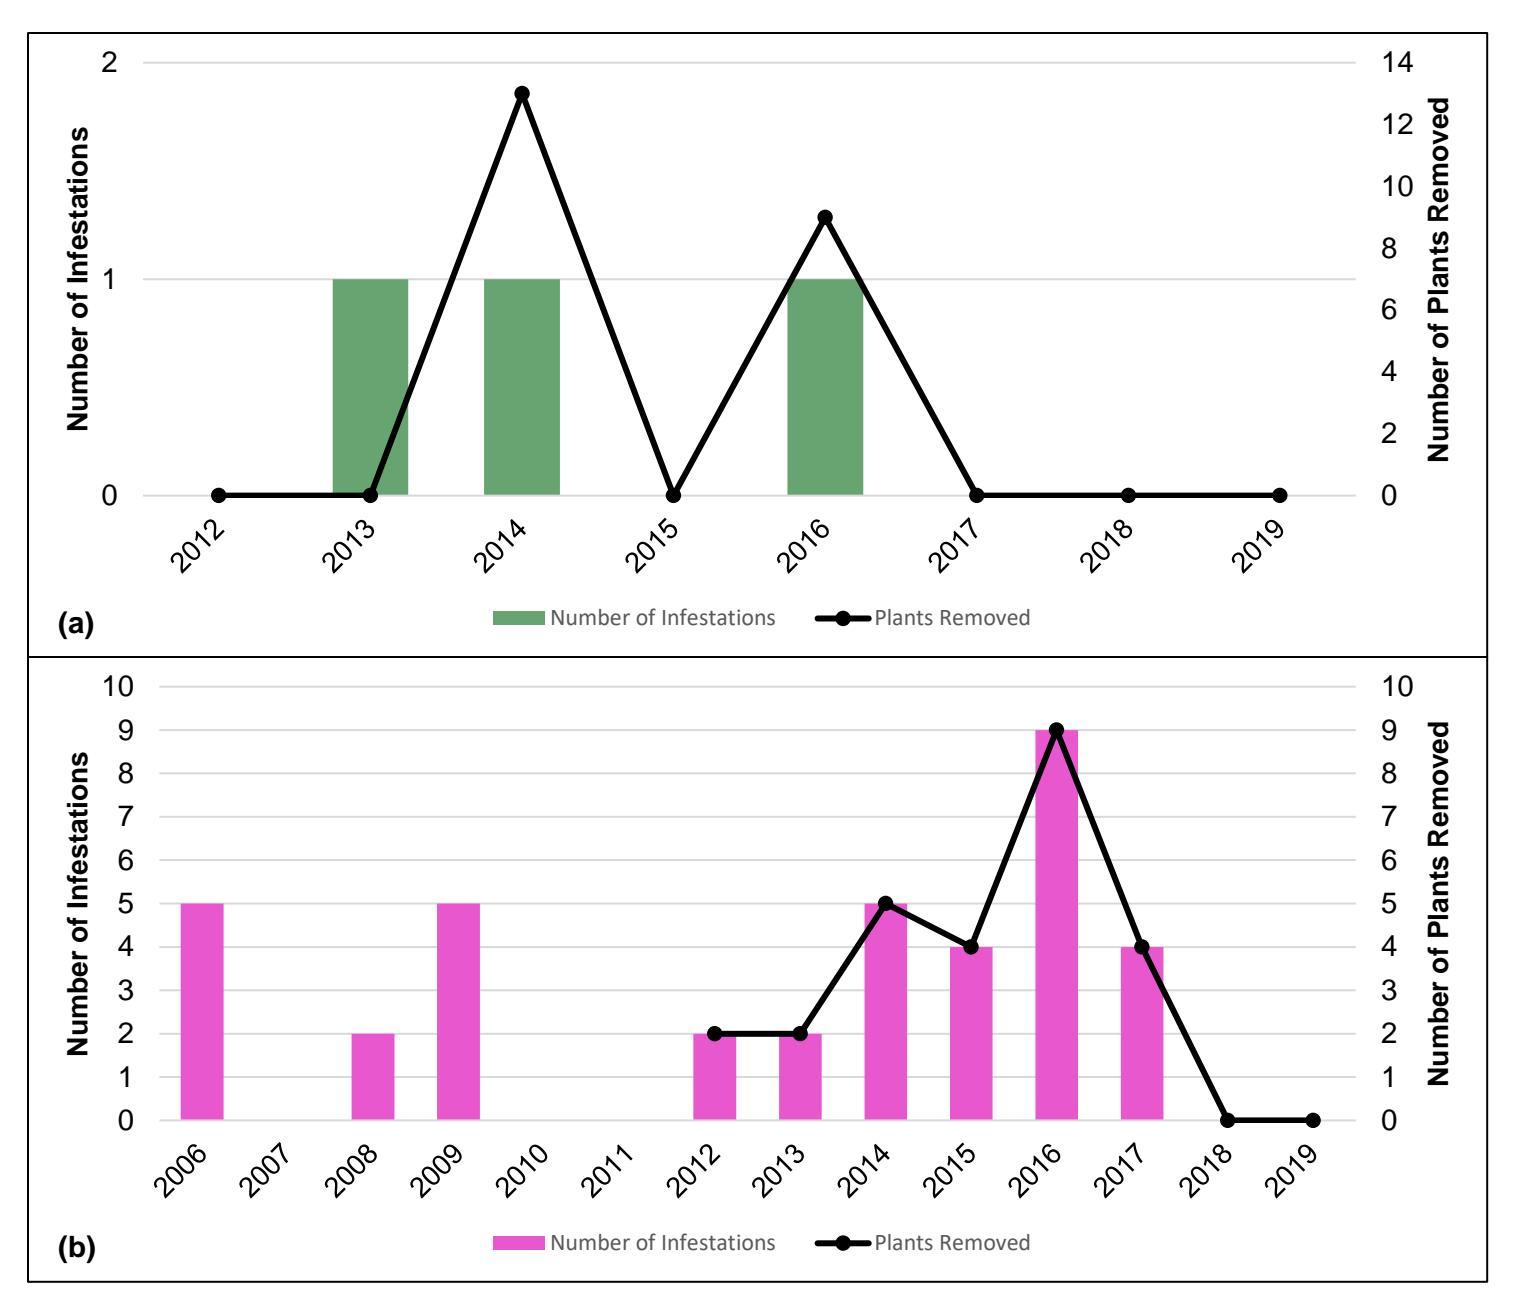
Figure 14 a-b. Garlic mustard (a) and purple loosestrife (b) distribution and management progress at Poplar Point Campground.
