Adirondack Park

Terrestrial Invasive Species Steward

Survey & Management Report

2019

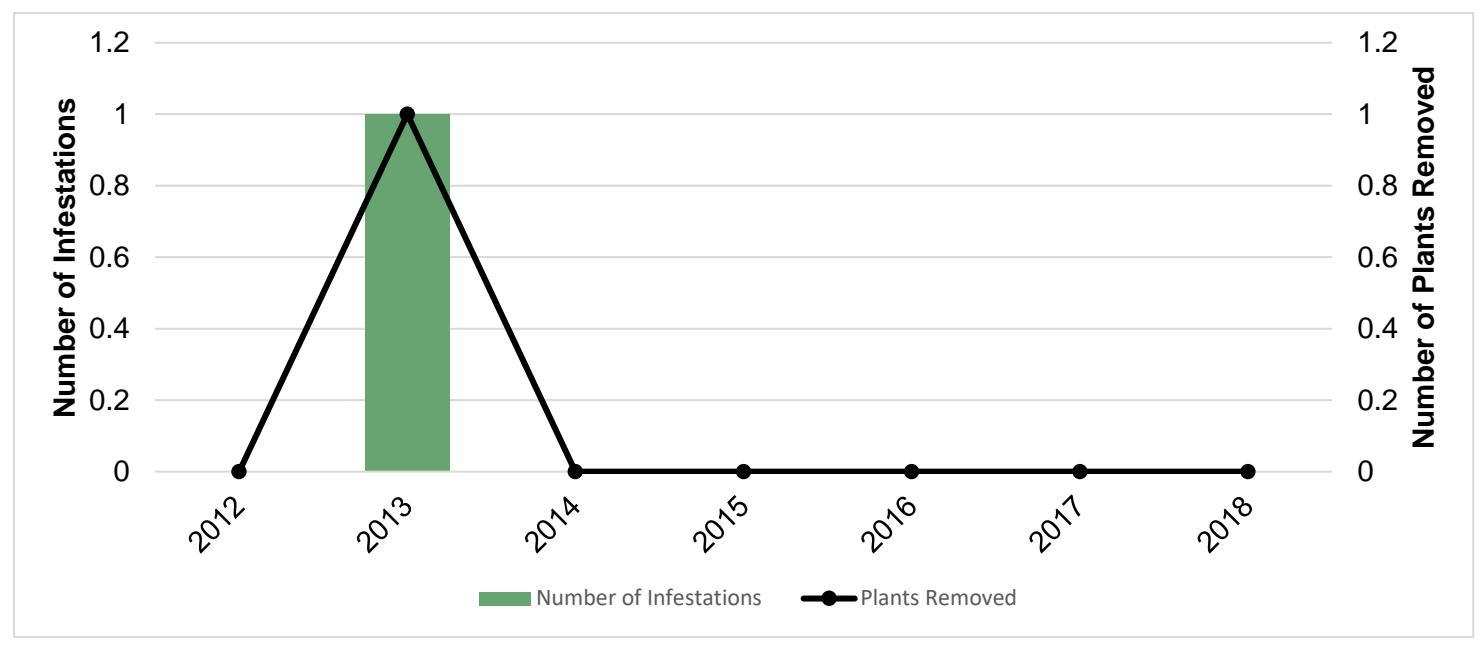
Figure 15. Garlic mustard distribution and management progress at Sacandaga Campground.

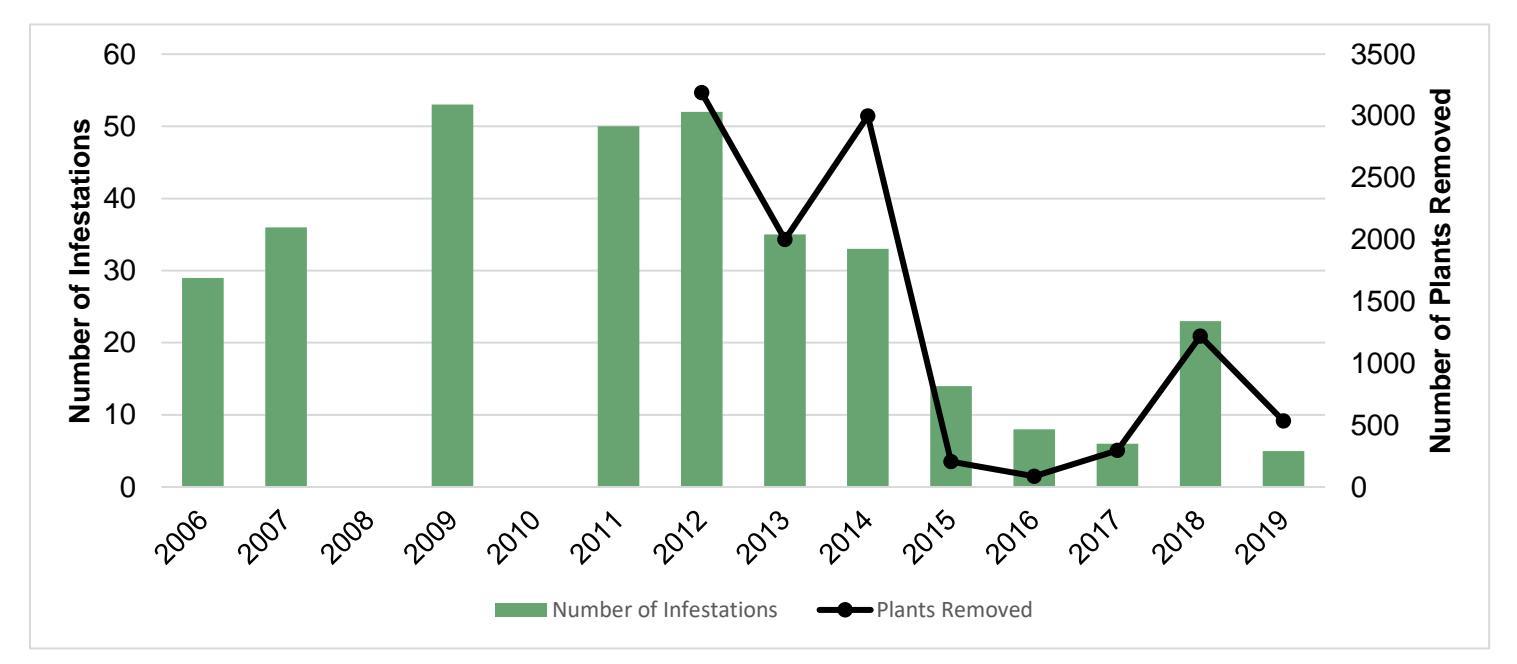
Figure 16. Garlic mustard distribution and management progress at Cranberry Lake Campground.

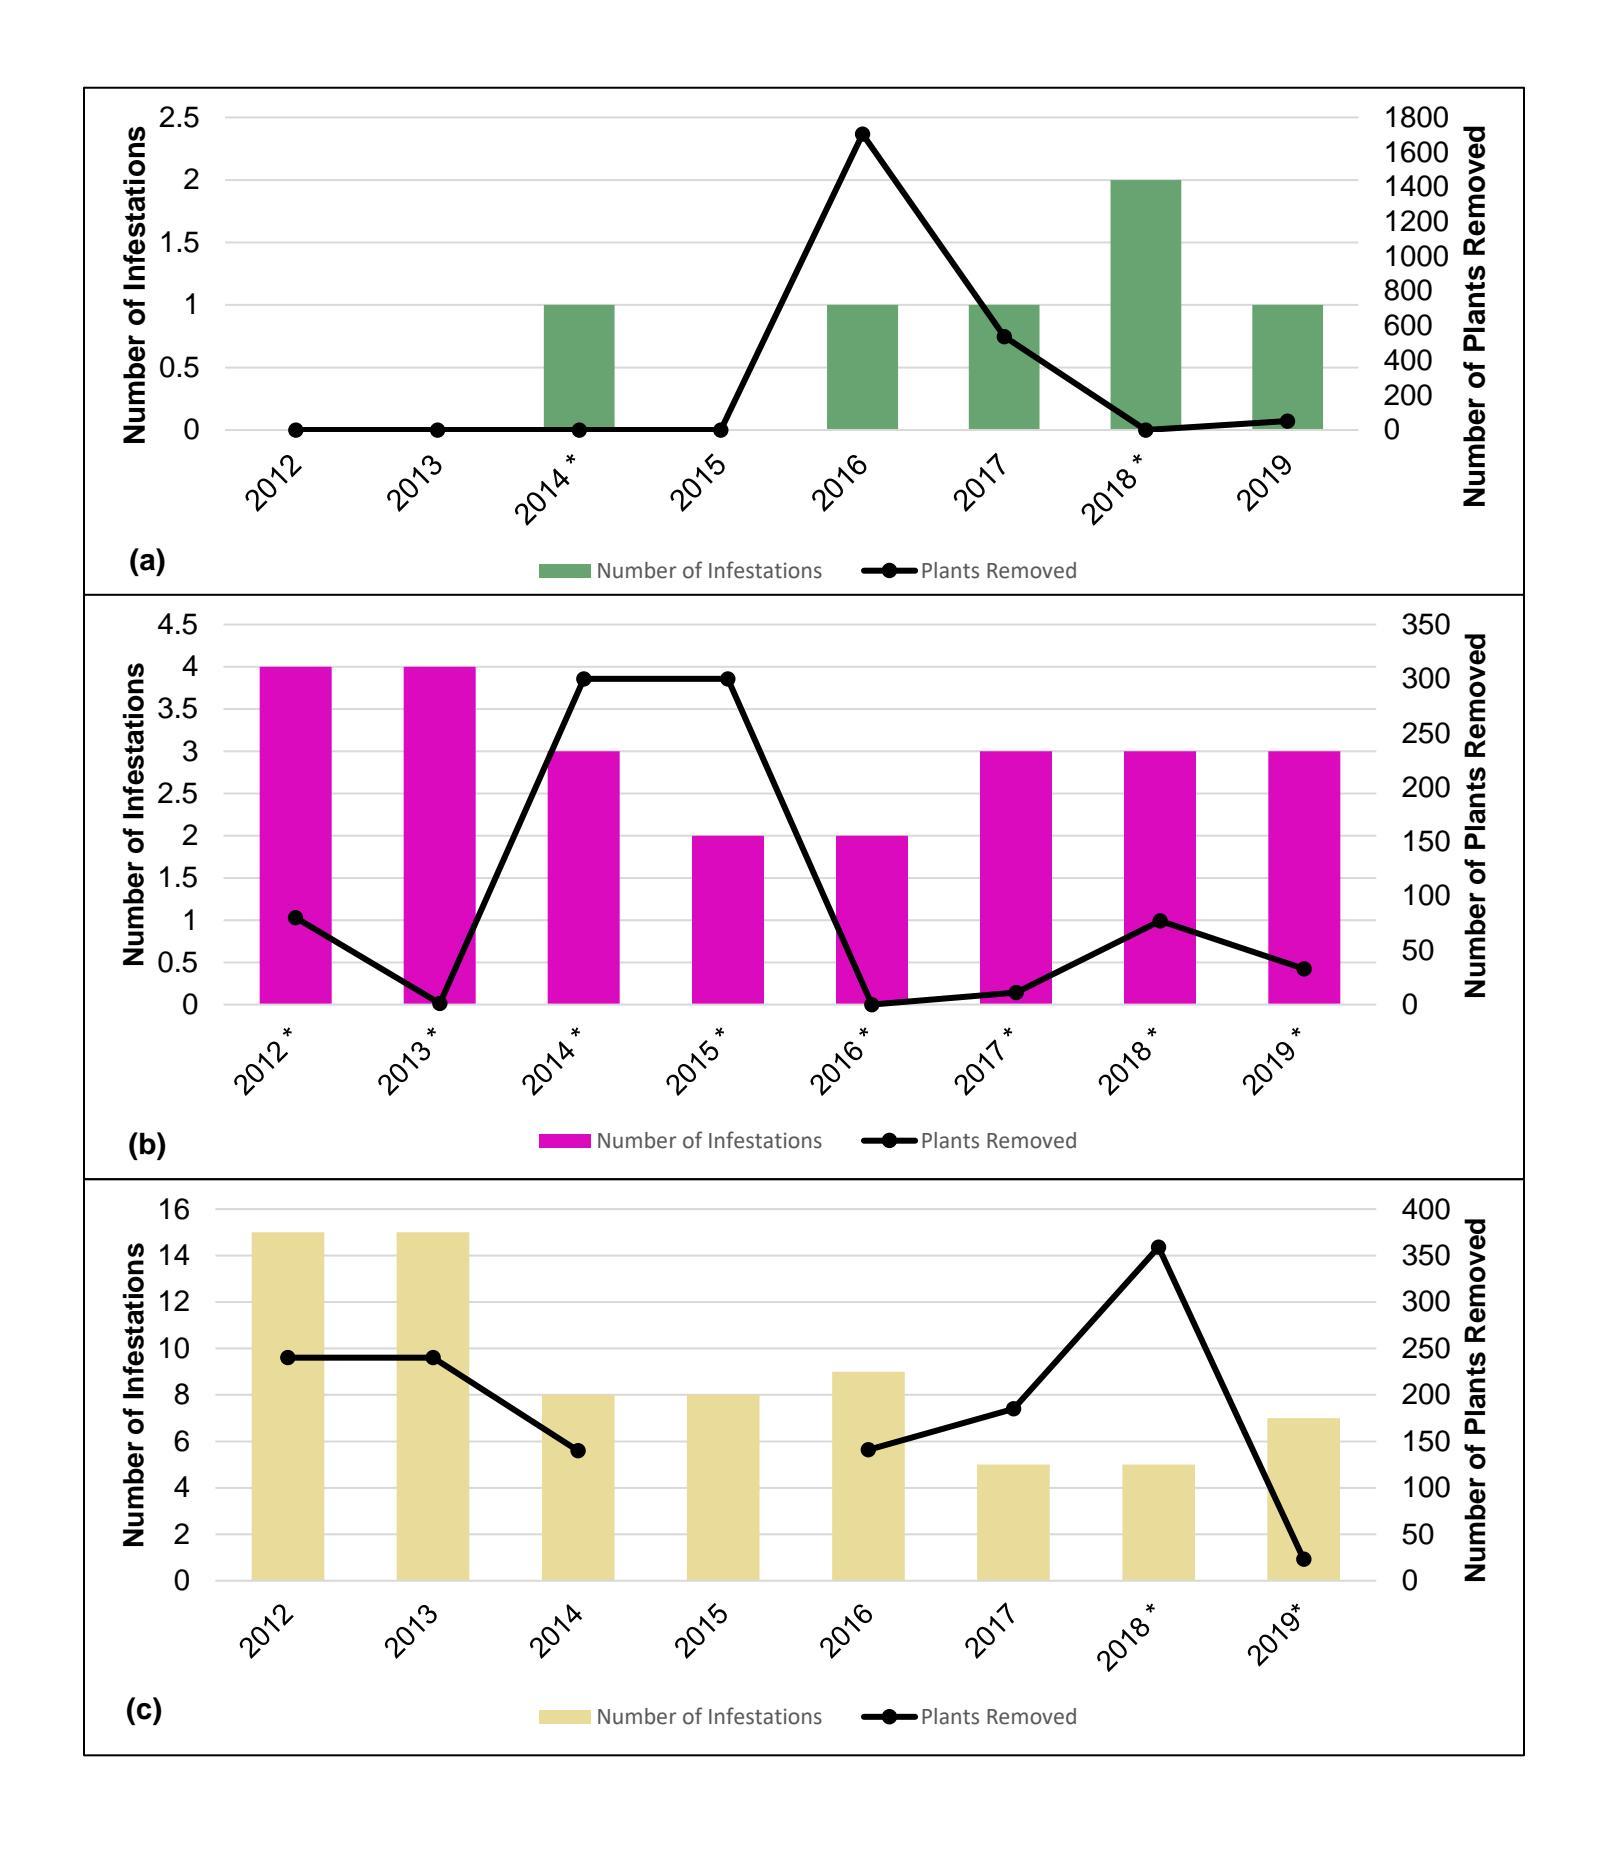
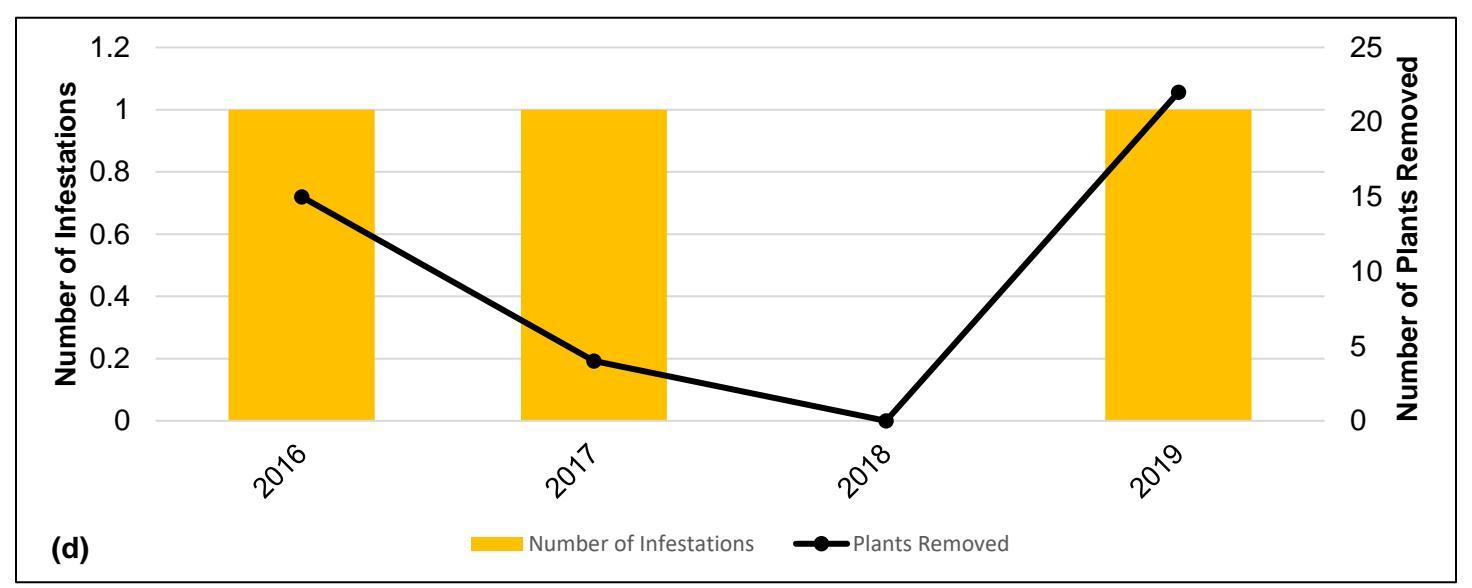
Figure 18 a-d. Garlic mustard (a), purple loosestrife (b), wild parsnip (c) and yellow iris (d) distribution and management progress at Crown Point Campground. * indicates years in which control of all known infestations was not completed.

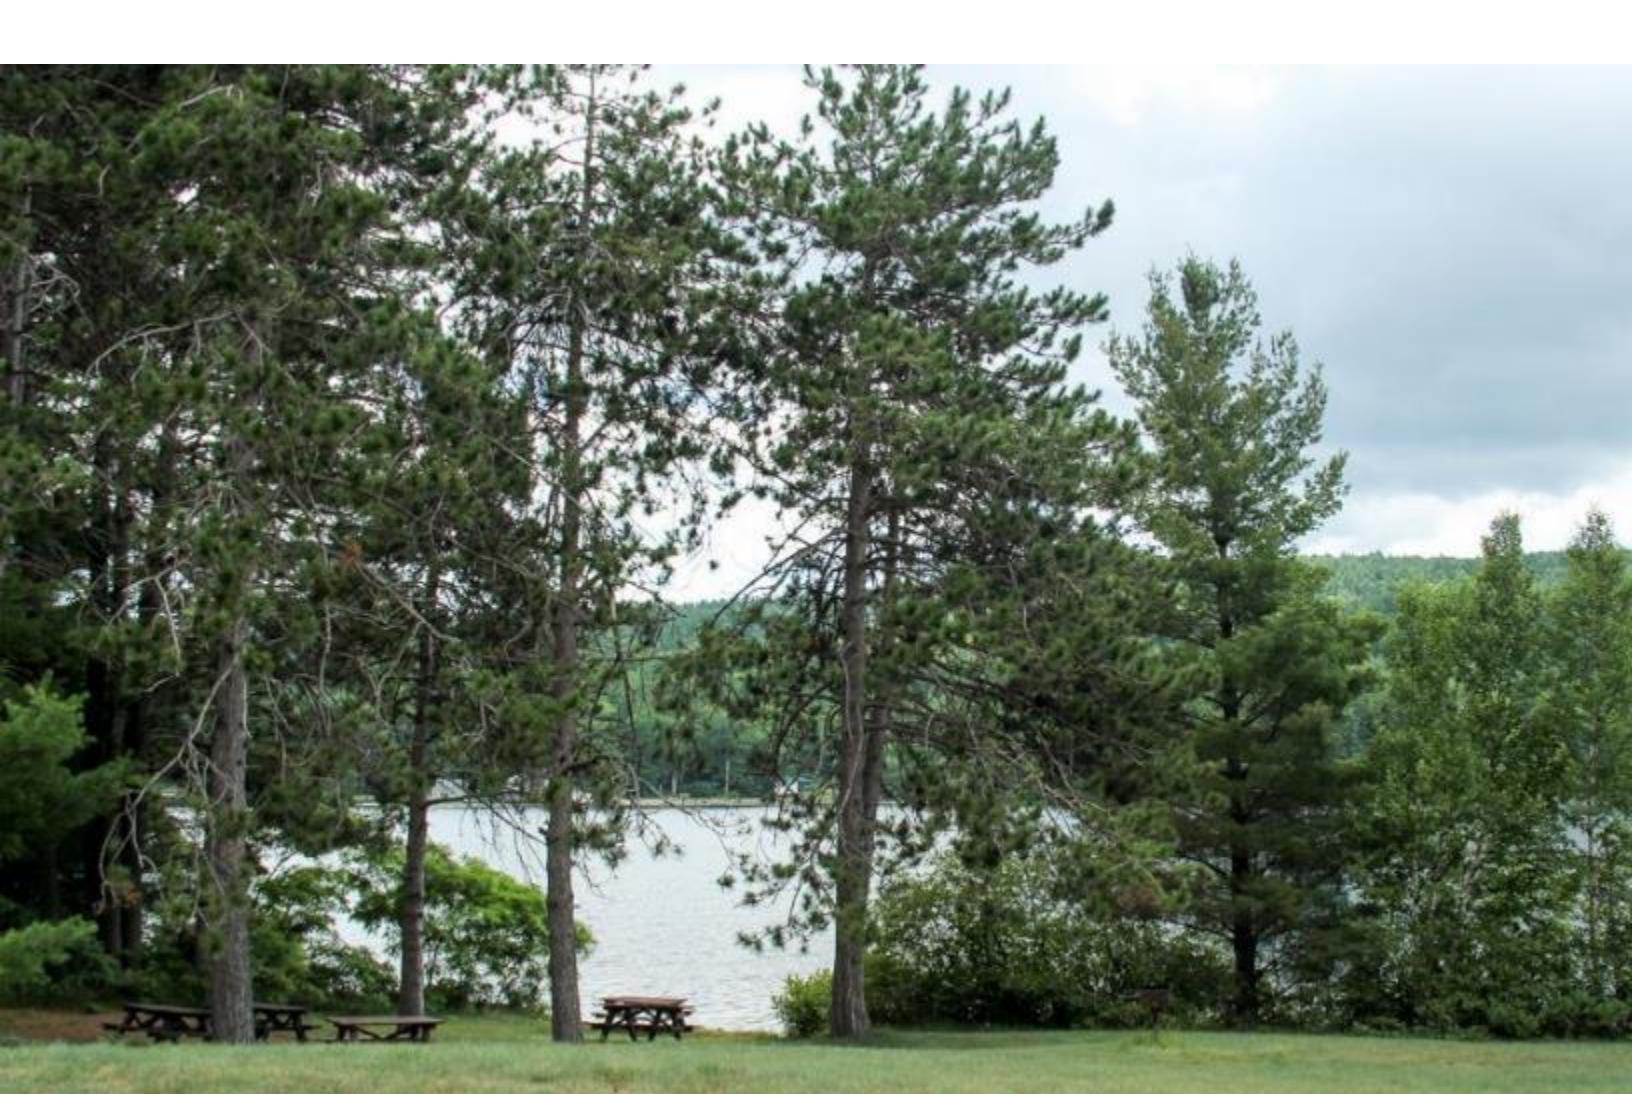
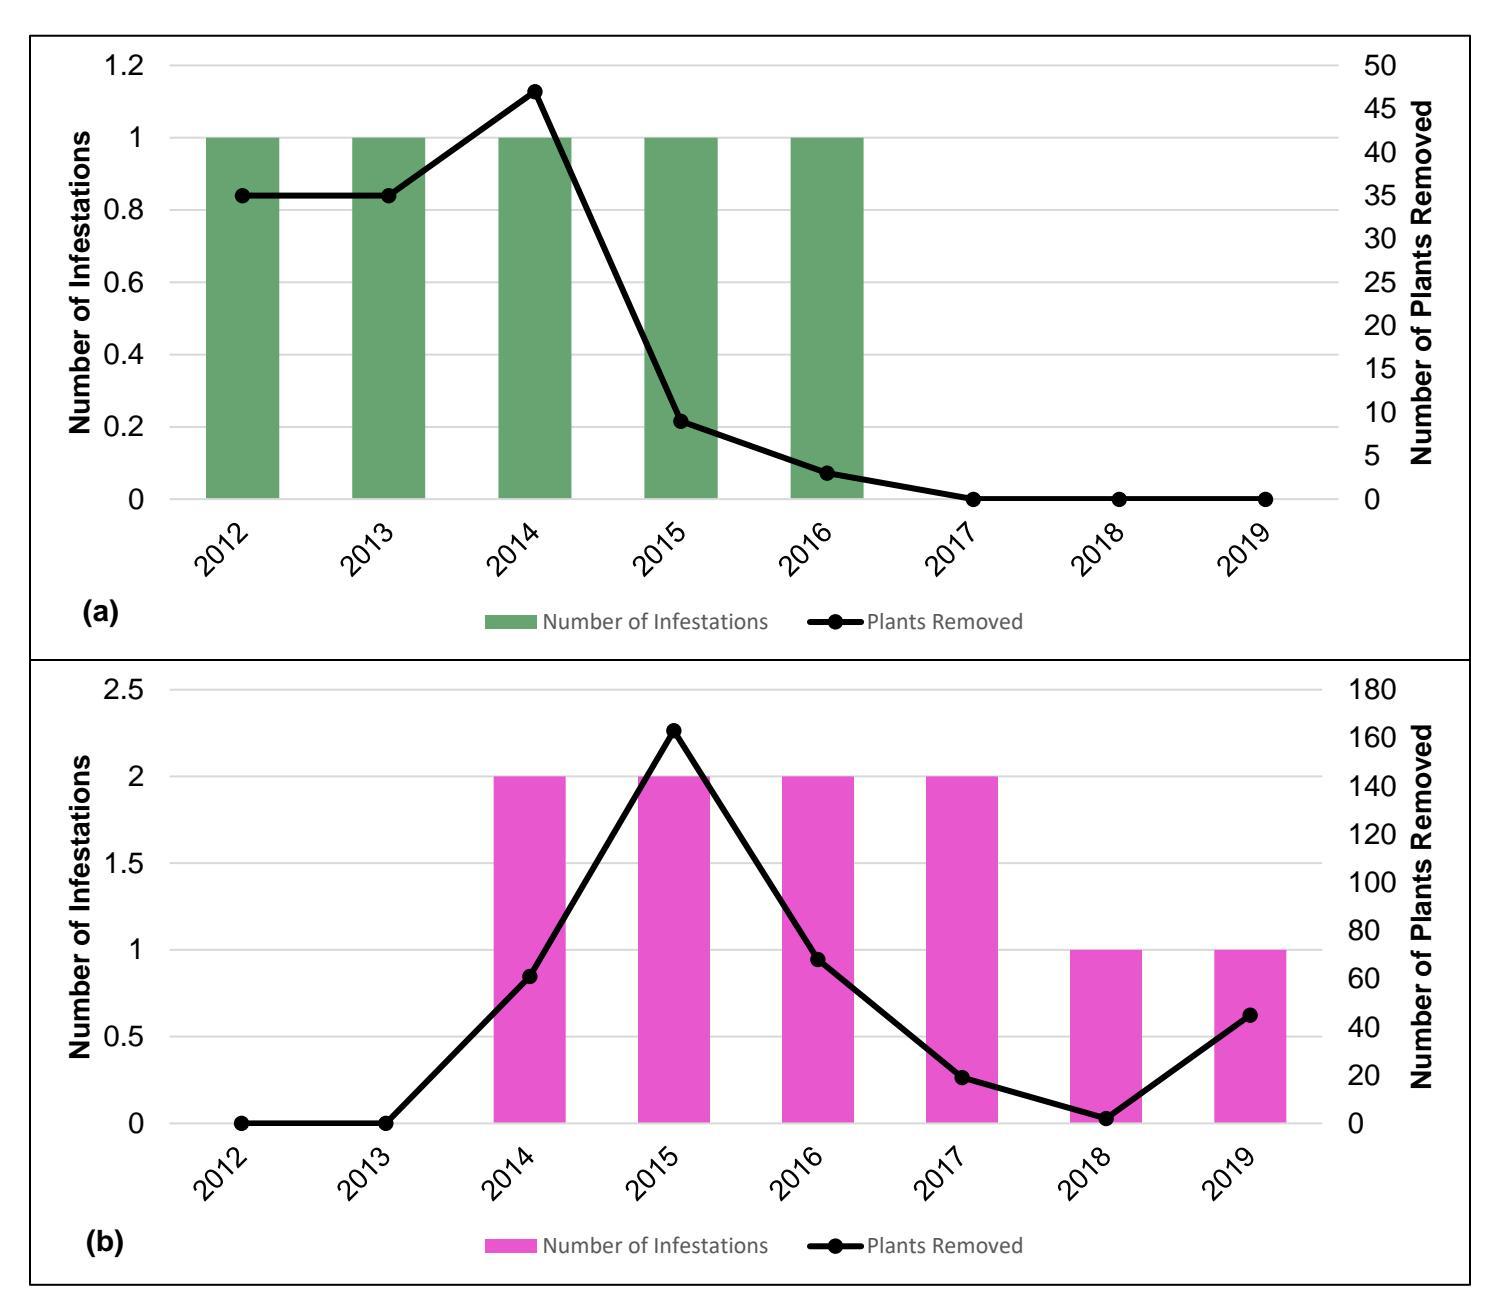
Figure 22 a-b. Garlic mustard (a) and purple loosestrife (b) distribution and management progress at Lincoln Pond Campground.

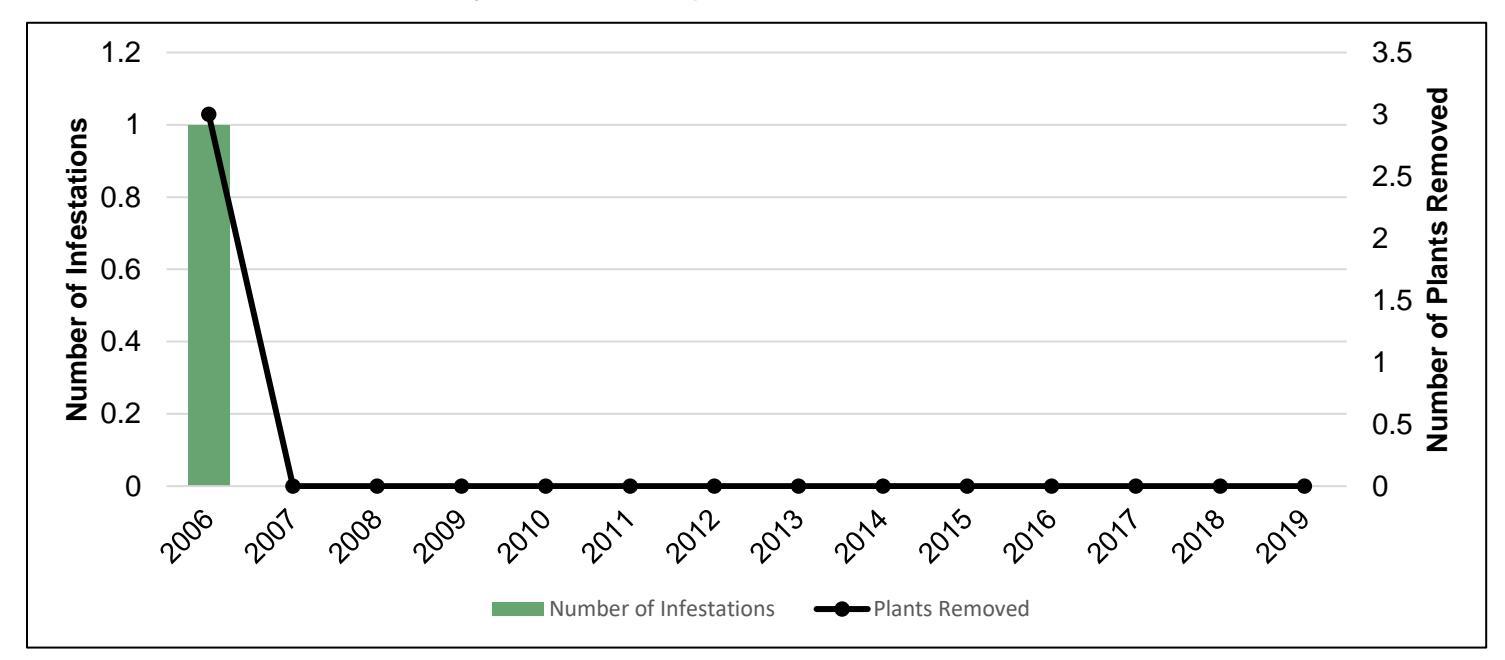
Figure 23. Garlic mustard distribution and management progress at Meacham Lake Campground.

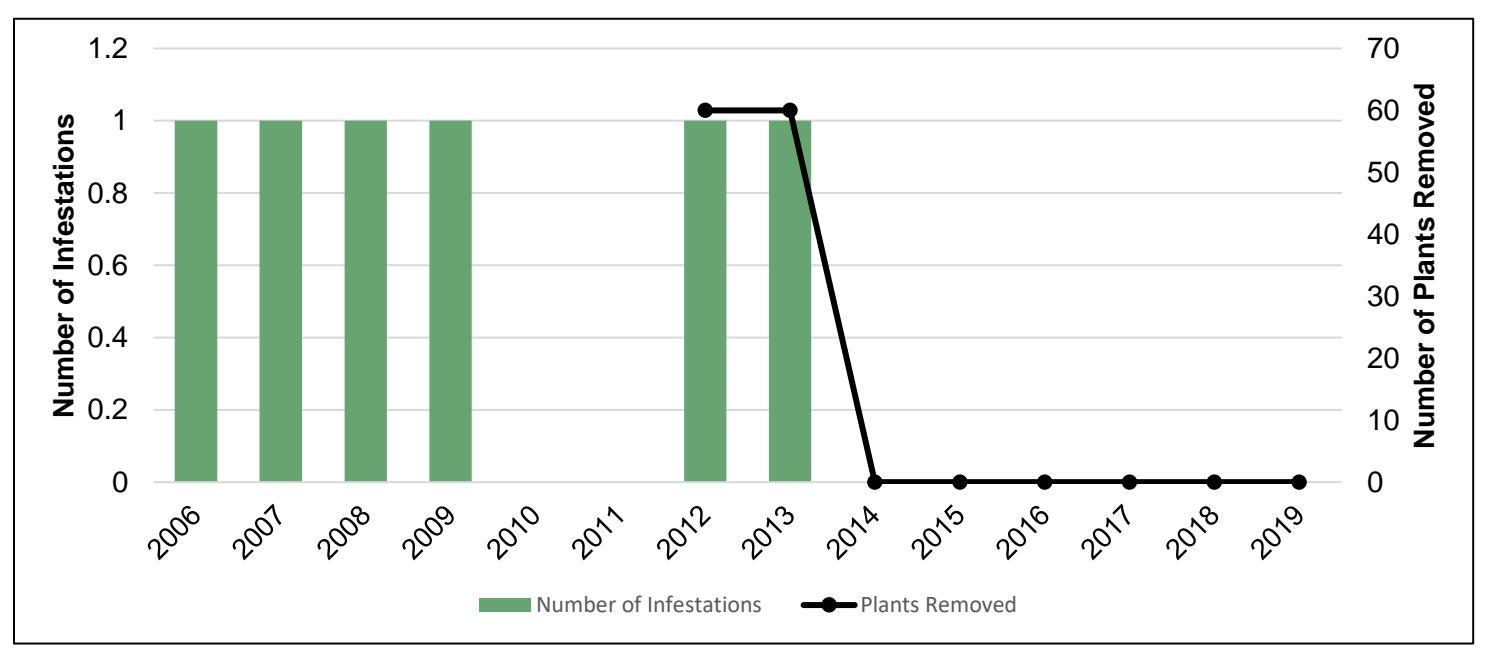
Figure 24. Garlic mustard distribution and management progress at Meadowbrook Campground.

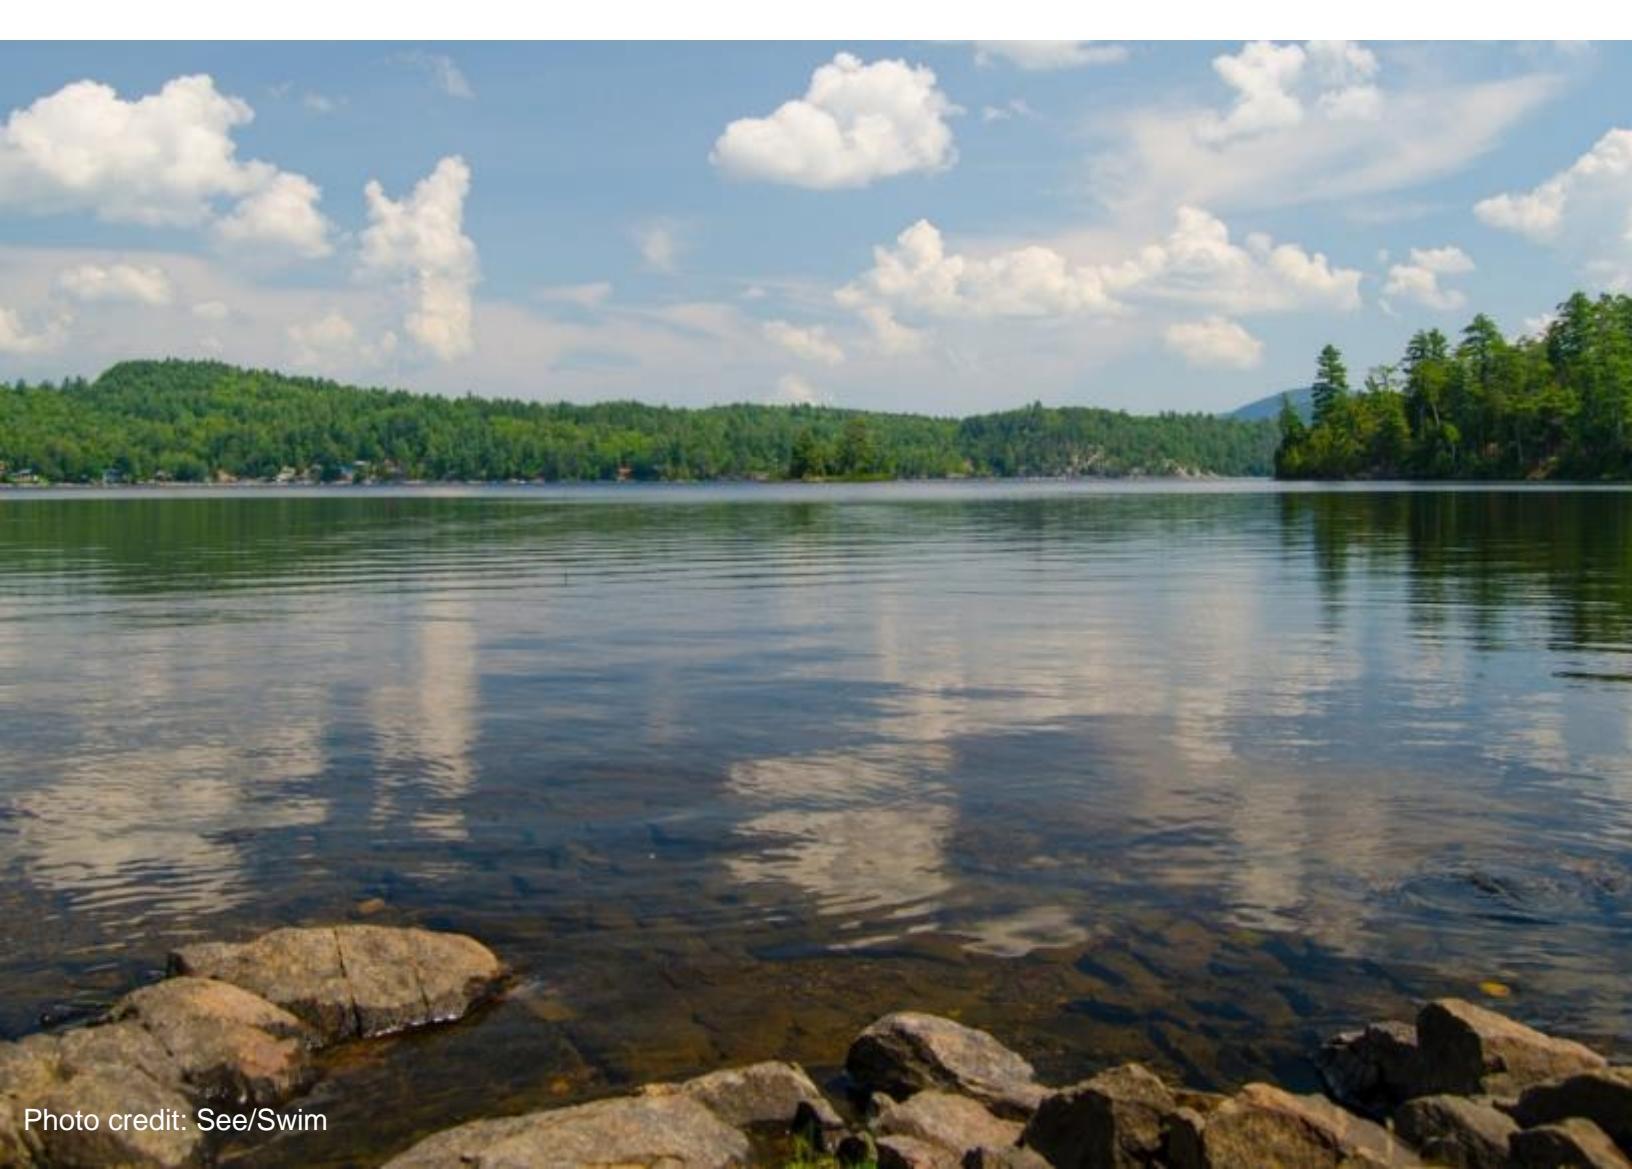
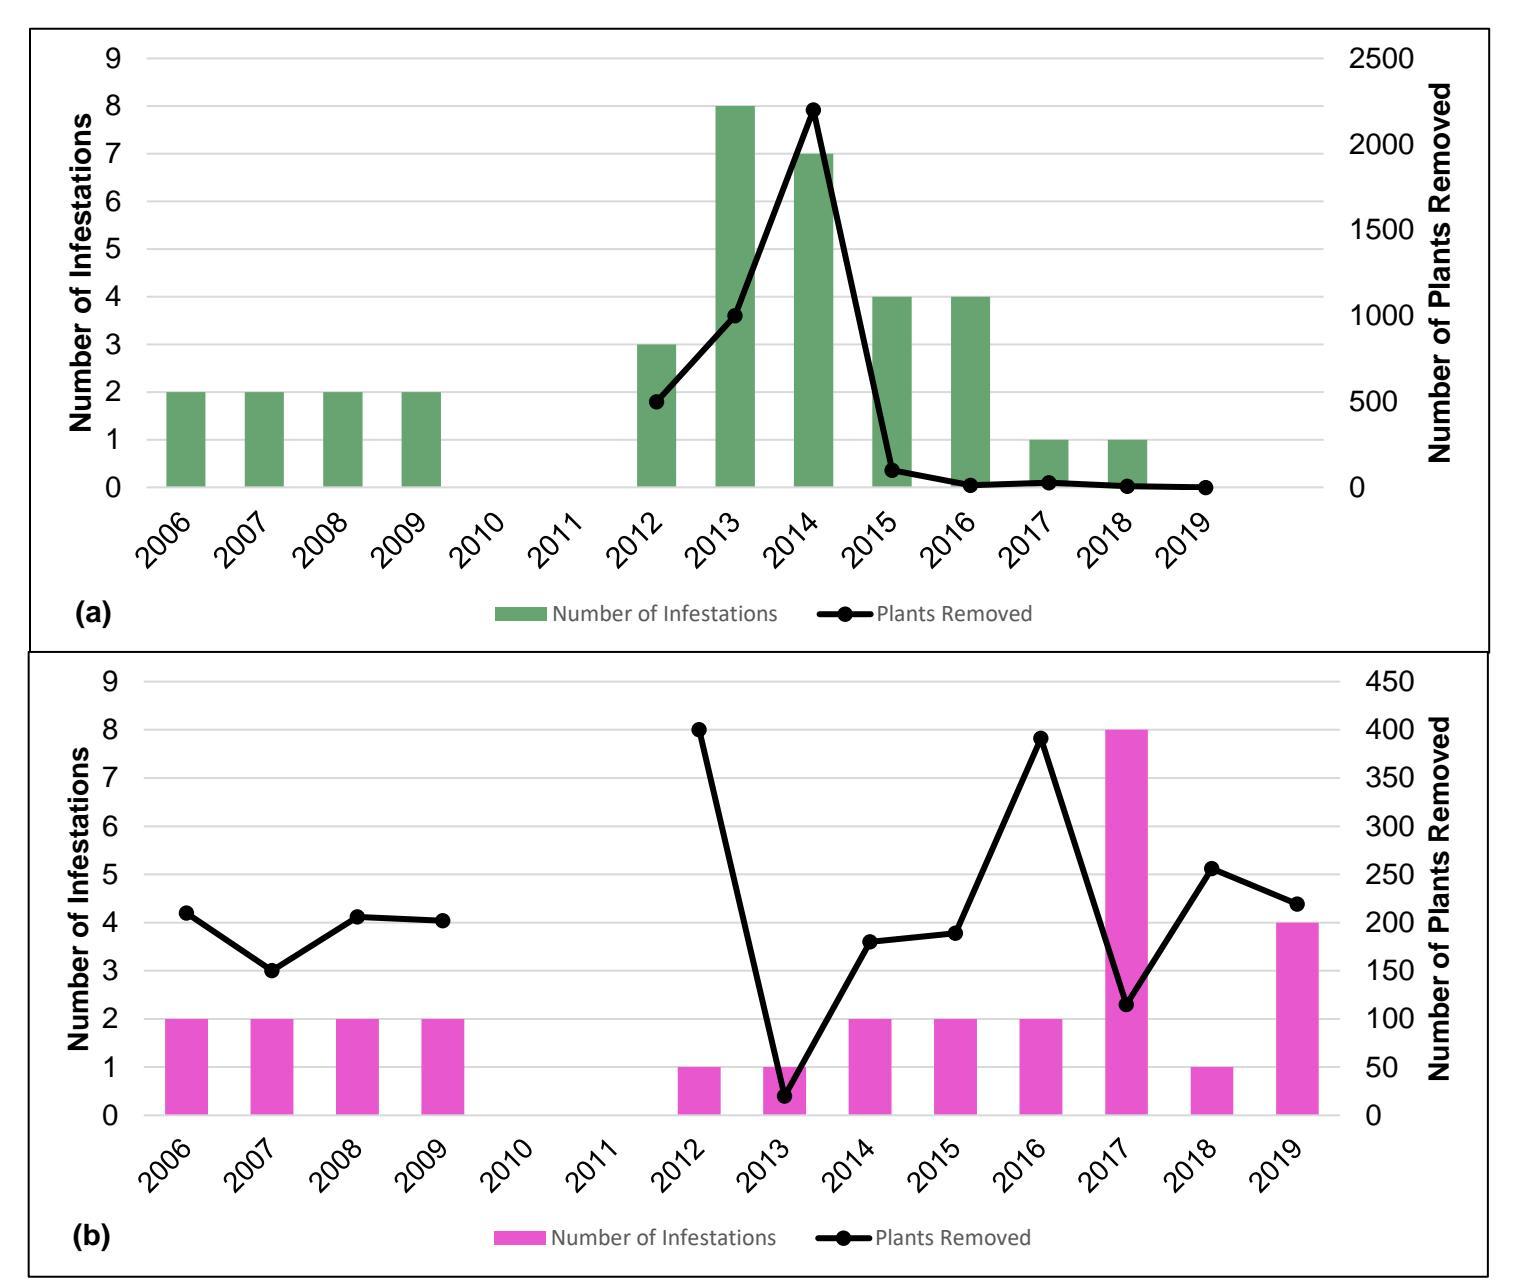
Figure 25 a-b. Garlic mustard (a) and purple loosestrife (b) distribution and management progress at Paradox Lake Campground.

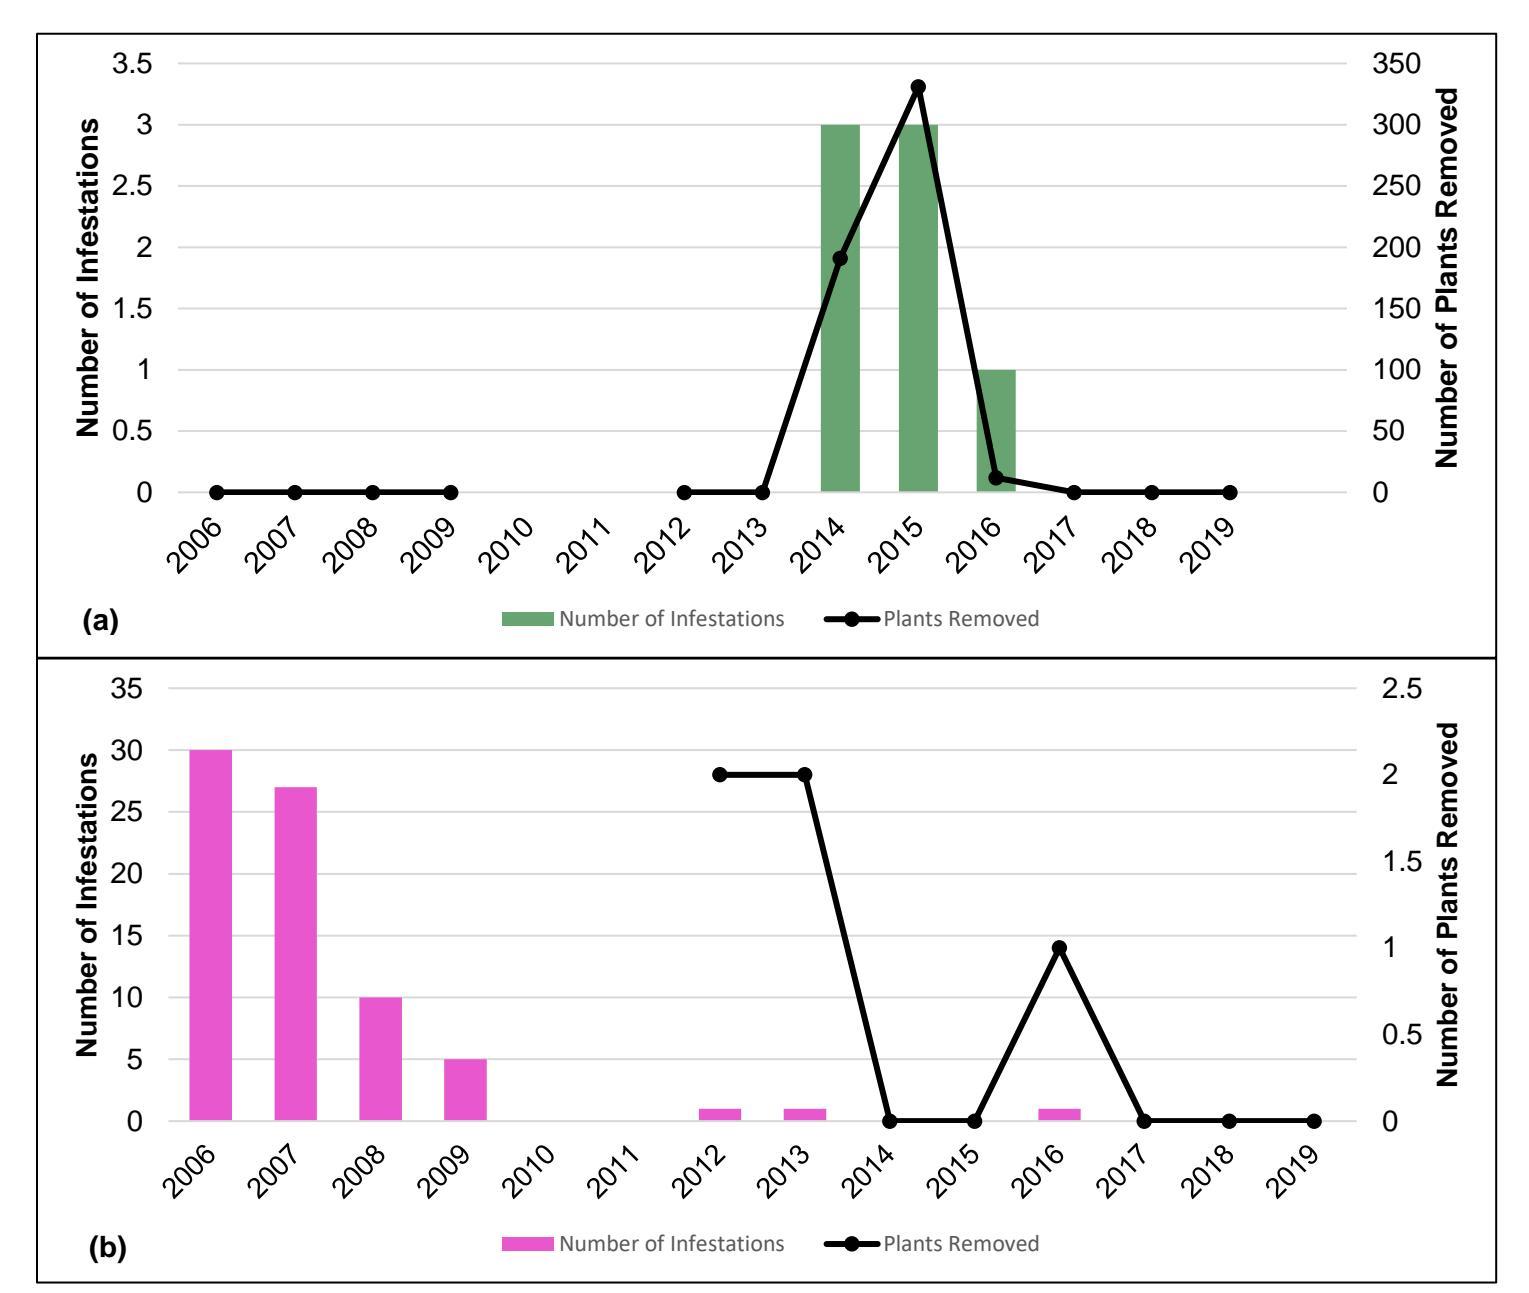
Figure 26 a-b. Garlic mustard (a) and purple loosestrife (b) distribution and management progress at Putnam Pond Campground.

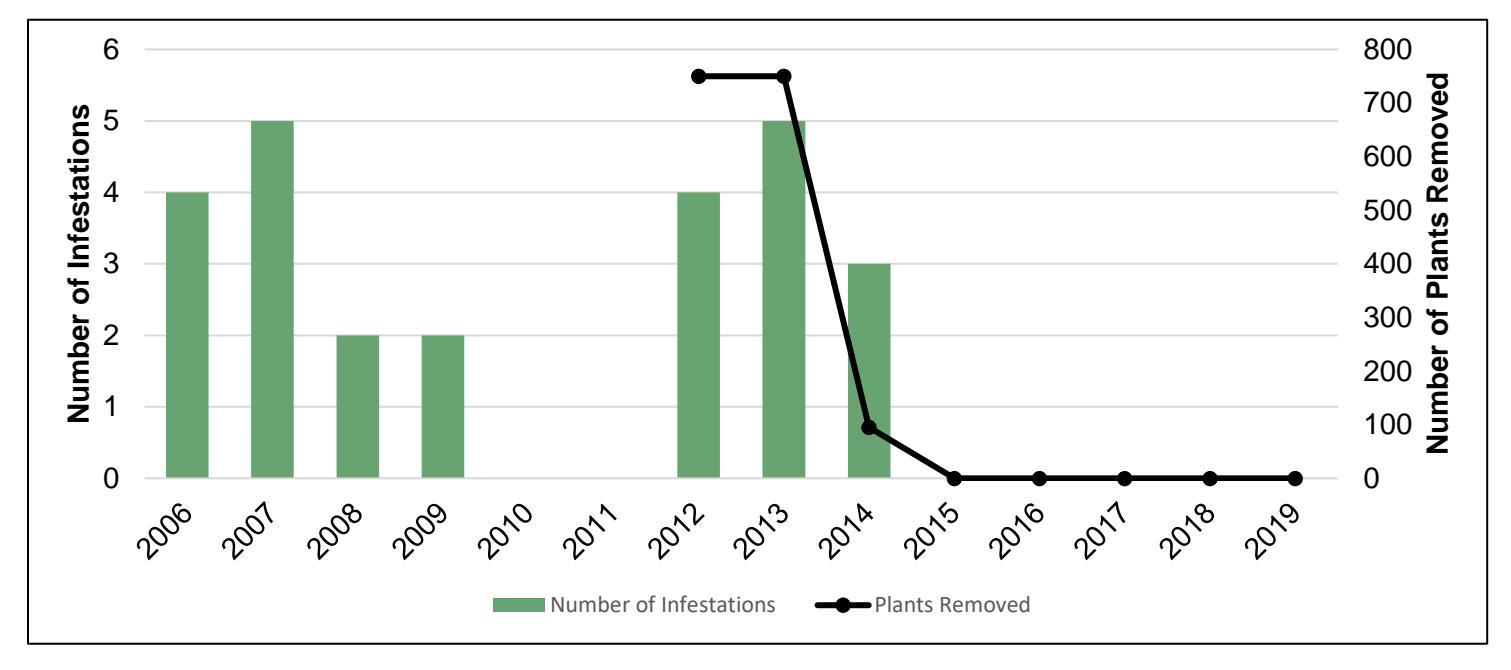
Figure 27. Garlic mustard distribution and management progress at Rollins Pond Campground.

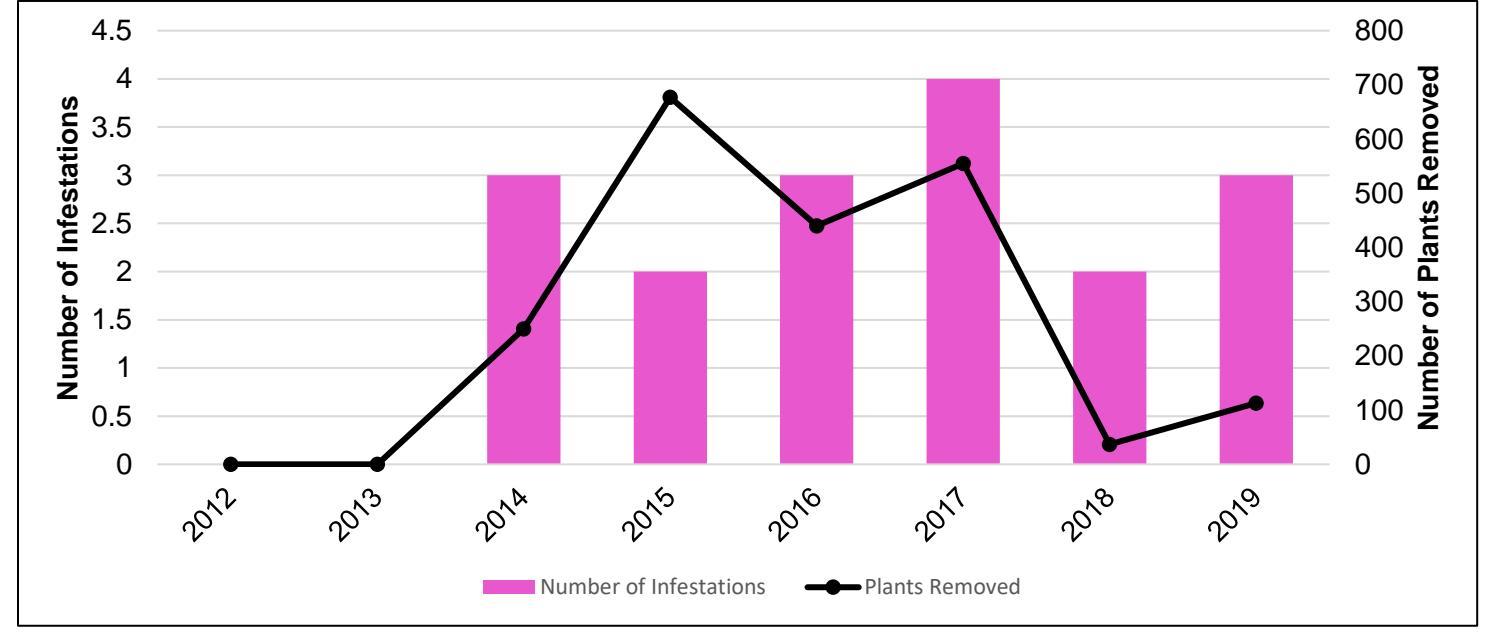
Figure 28. Purple loosestrife distribution and management progress at Sharp Bridge Campground.

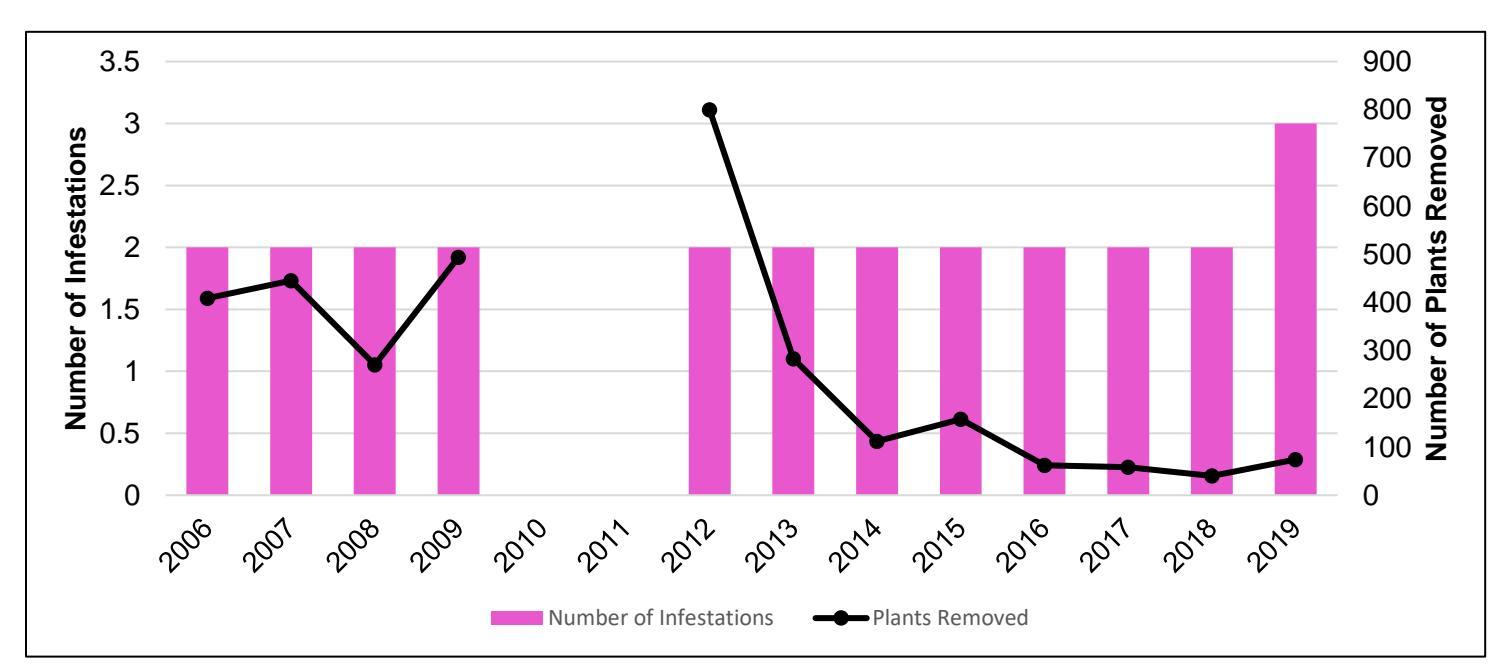
Figure 29. Purple loosestrife distribution and management progress at Taylor Pond Campground.

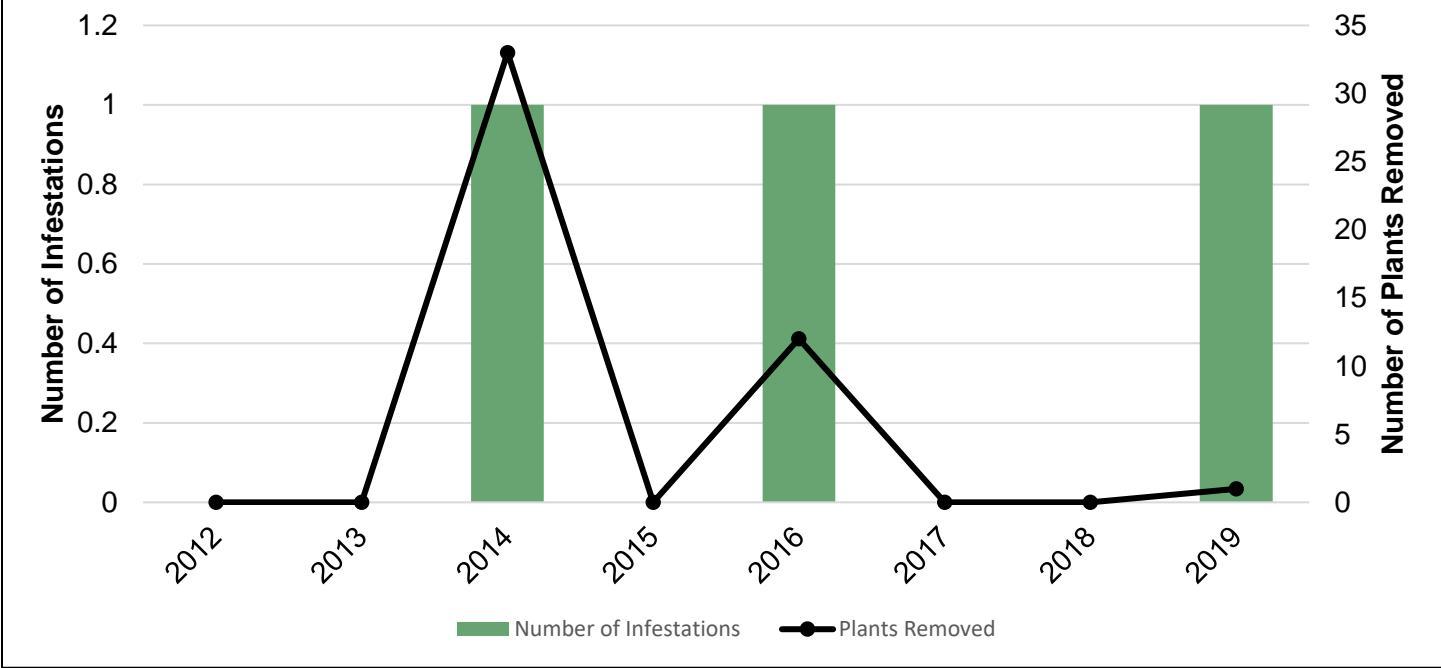
Figure 30. Garlic mustard distribution and management progress at Eagle Point Campground.

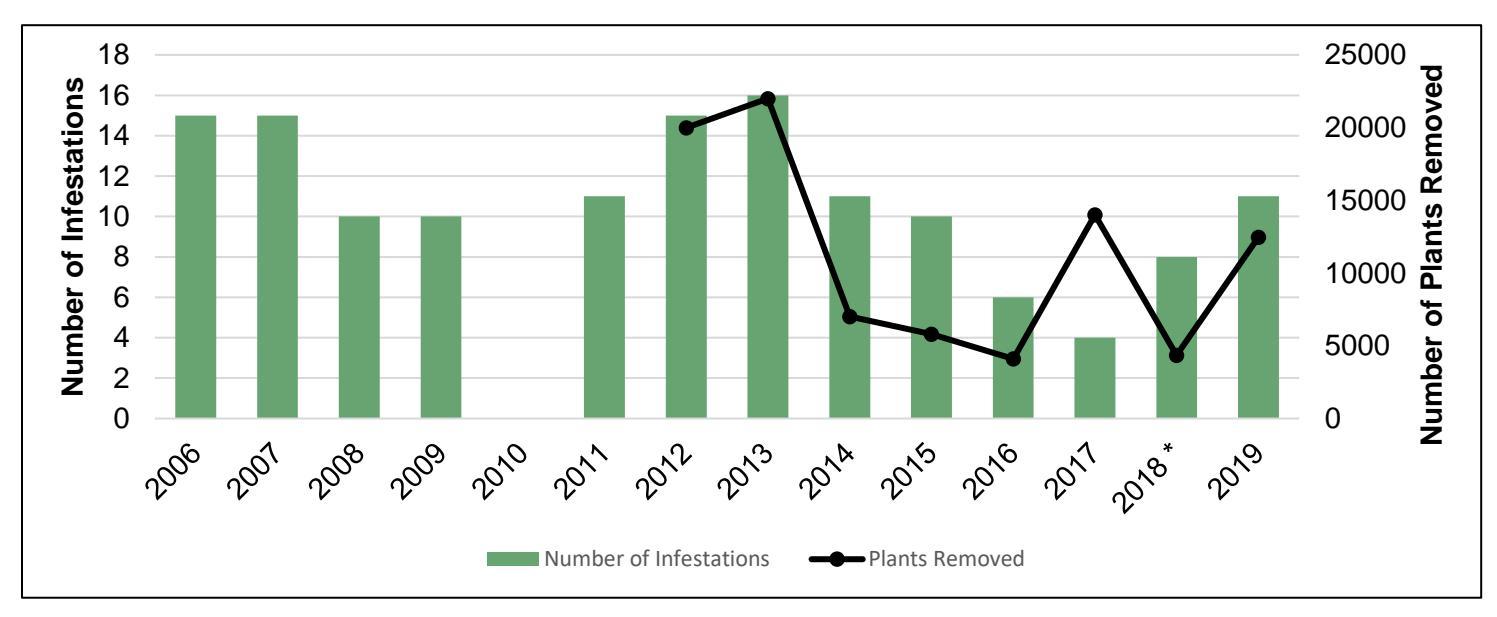
Figure 32. Garlic mustard distribution and management progress at Lake George Battleground Campground. * indicates years in which control of all known infestations was not completed.
