## Fulton Chain Lakes, Second Lake

**Survey Date:** June 24, 2019

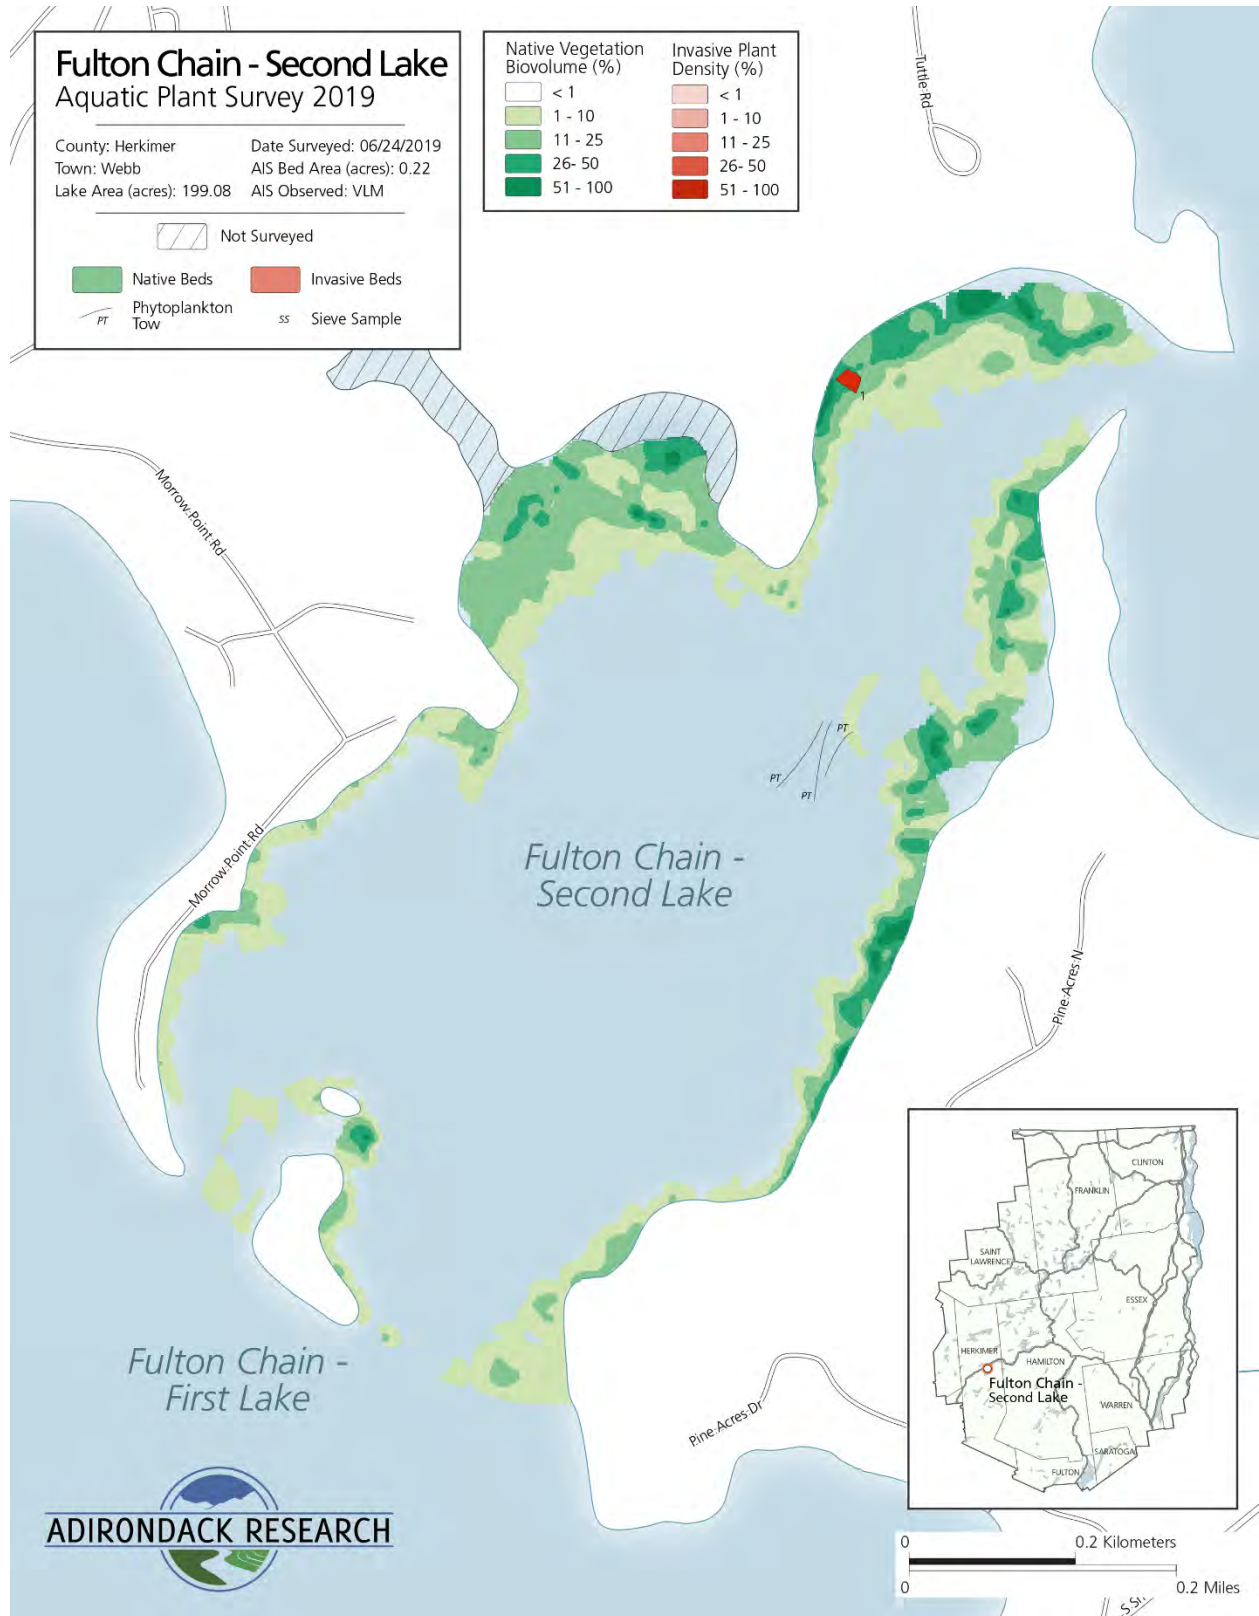
### Invasive Species Percent Cover (See map on adjacent page)

Beds of *Myriophyllum heterophyllum* (variable leaf milfoil) were detected in the lake. In total, 1 bed of *Myriophyllum heterophyllum* was mapped and was located along the northern shore of the lake, near the channel from Third Lake.

Bed	Variable Leaf Milfoil			Asian Clam	Spiny Waterflea
	Size (Ac.)	Size (Sq. Ft.)	% Cover	Present (Y/N)	Present (Y/N)
1	.22	9499.41	51-100	No	No
