## Fulton Chain Lakes, Seventh Lake

**Survey Date:** July 2, 2019

### Fulton Chain - Seventh Lake Aquatic Plant Survey 2019

County: Hamilton      Date Surveyed: 07/02/2019  
 Town: Inlet              AIS Bed Area (acres): 4.08  
 Lake Area (acres): 834.52      AIS Observed: VLM & EWM

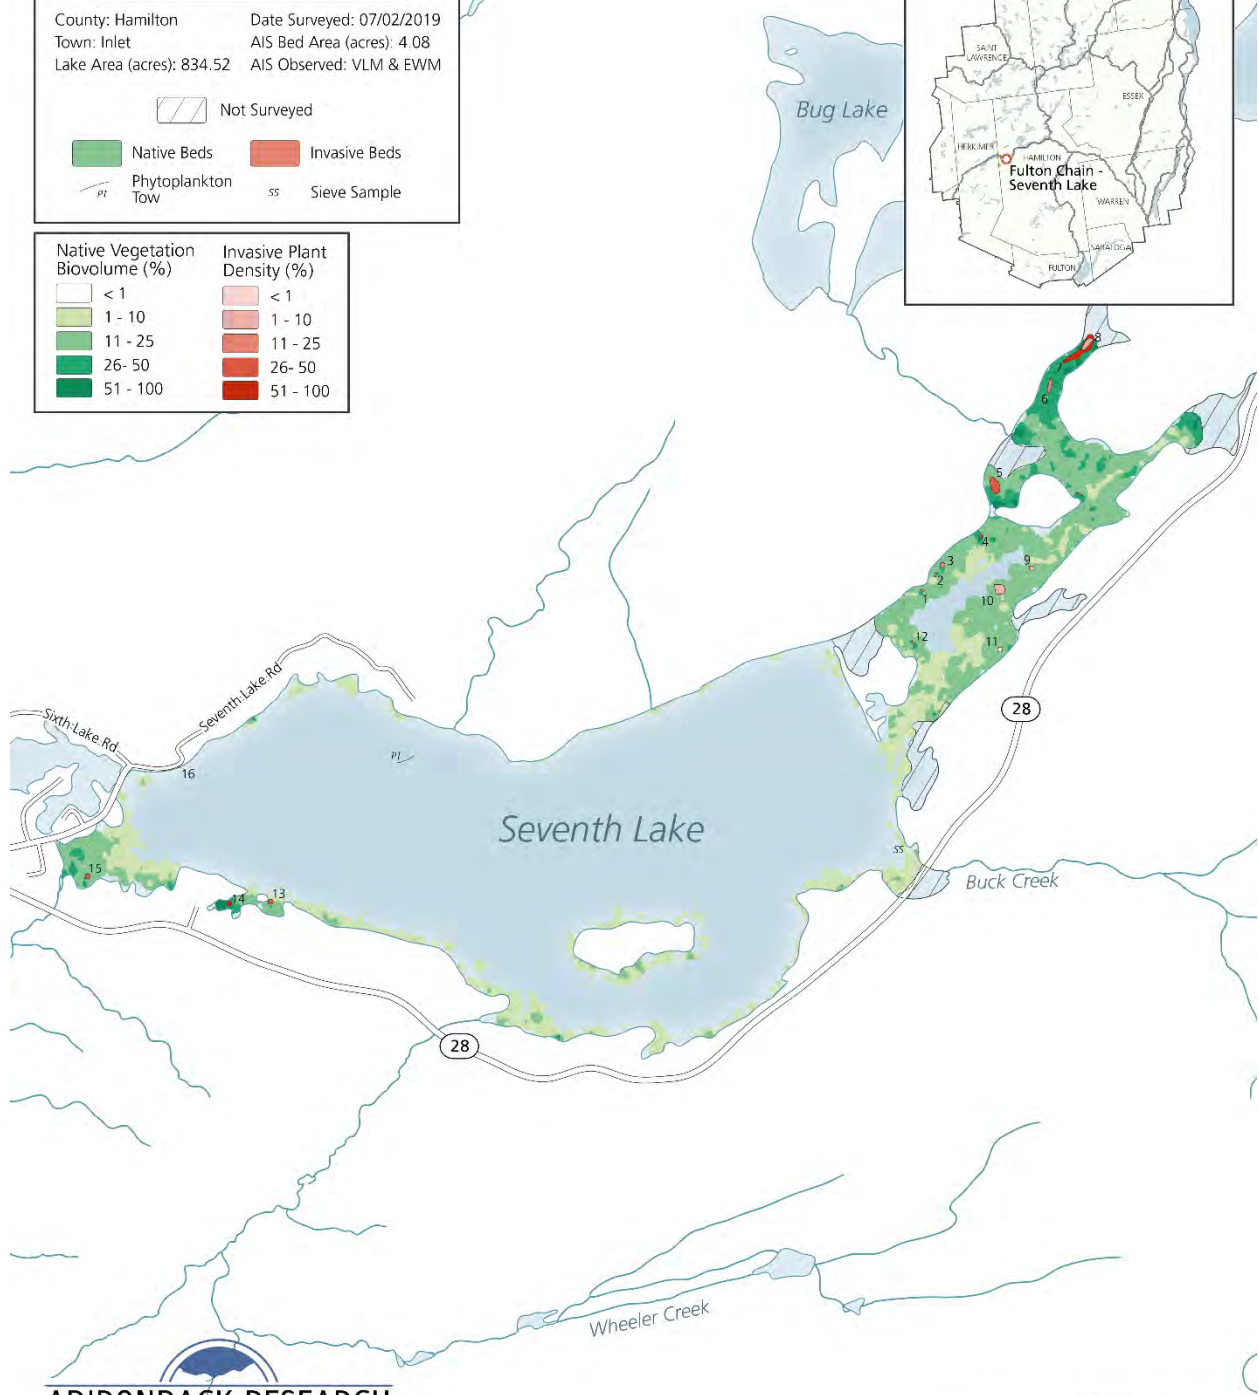
A total of 11 invasive *Myriophyllum spicatum* (Eurasian watermilfoil) plant beds were mapped. Five invasive *Myriophyllum heterophyllum* (variable leaf milfoil) plant beds were also detected and mapped. The heaviest concentrations were on the north-eastern side of the lake, near the canoe carry into Eighth Lake.
