Little Wolf Pond

Survey Date: June 11, 2019

Little Wolf Pond Aquatic Plant Survey 2019

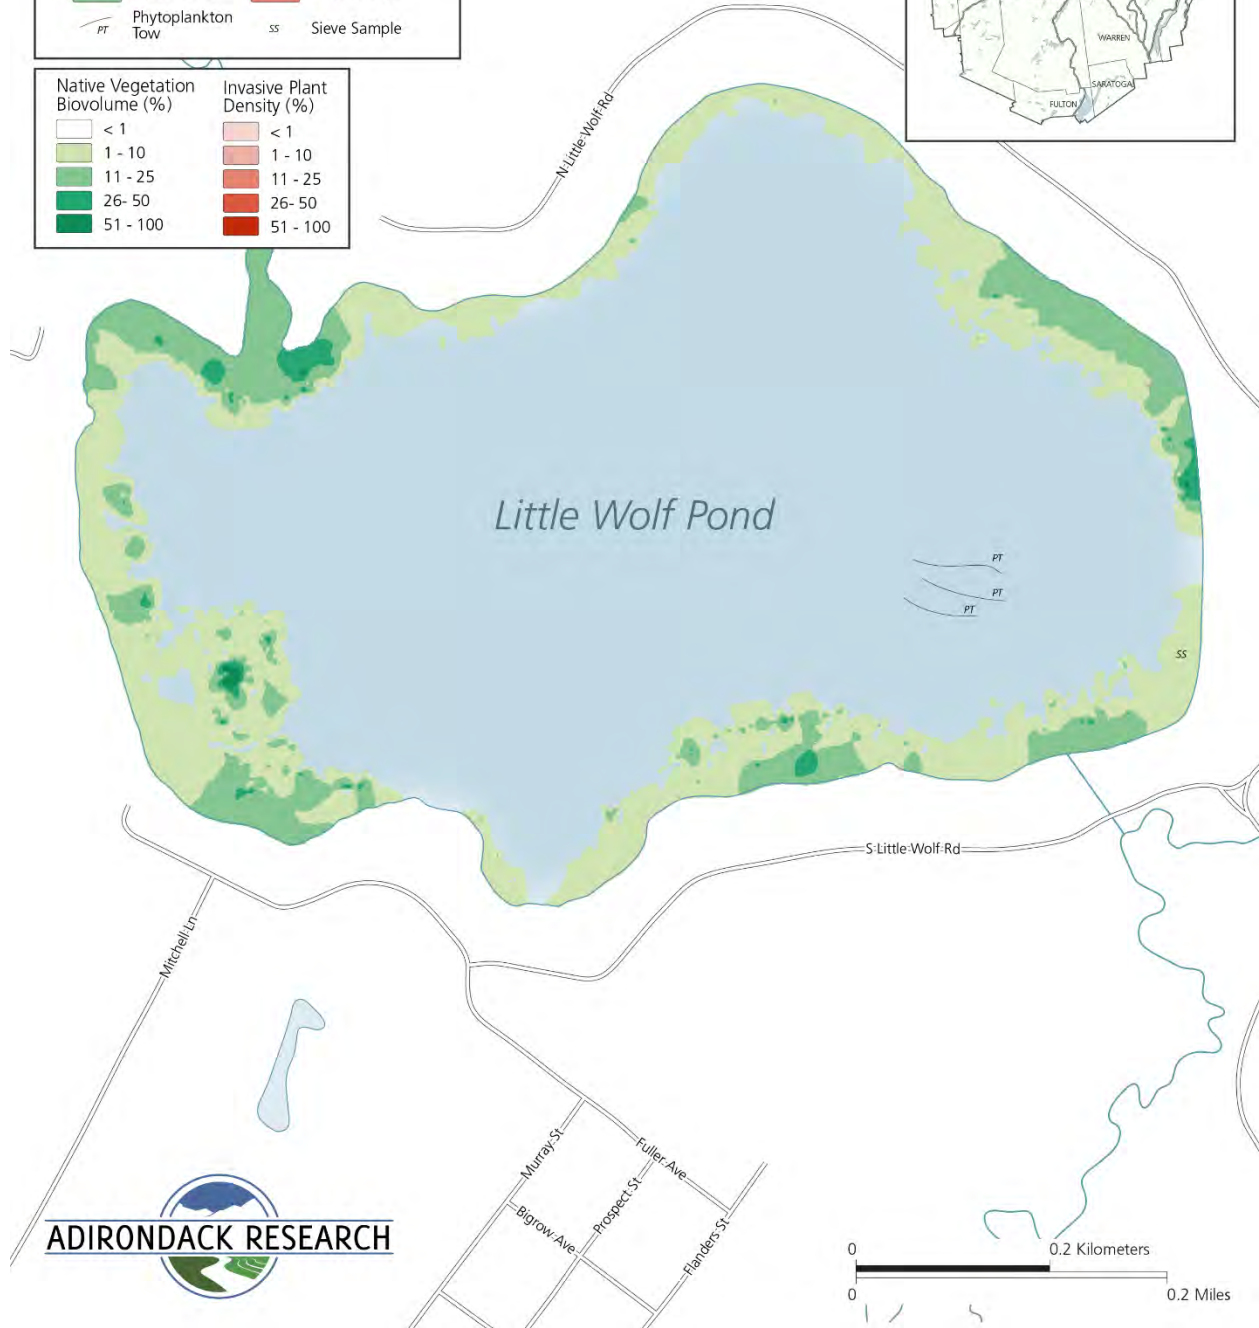
County: Franklin Date Surveyed: 06/11/2019
 Town: Tupper Lake AIS Bed Area (acres): 0
 Lake Area (acres): 159.18 AIS Observed:

Native Vegetation Biovolume (%)	Invasive Plant Density (%)

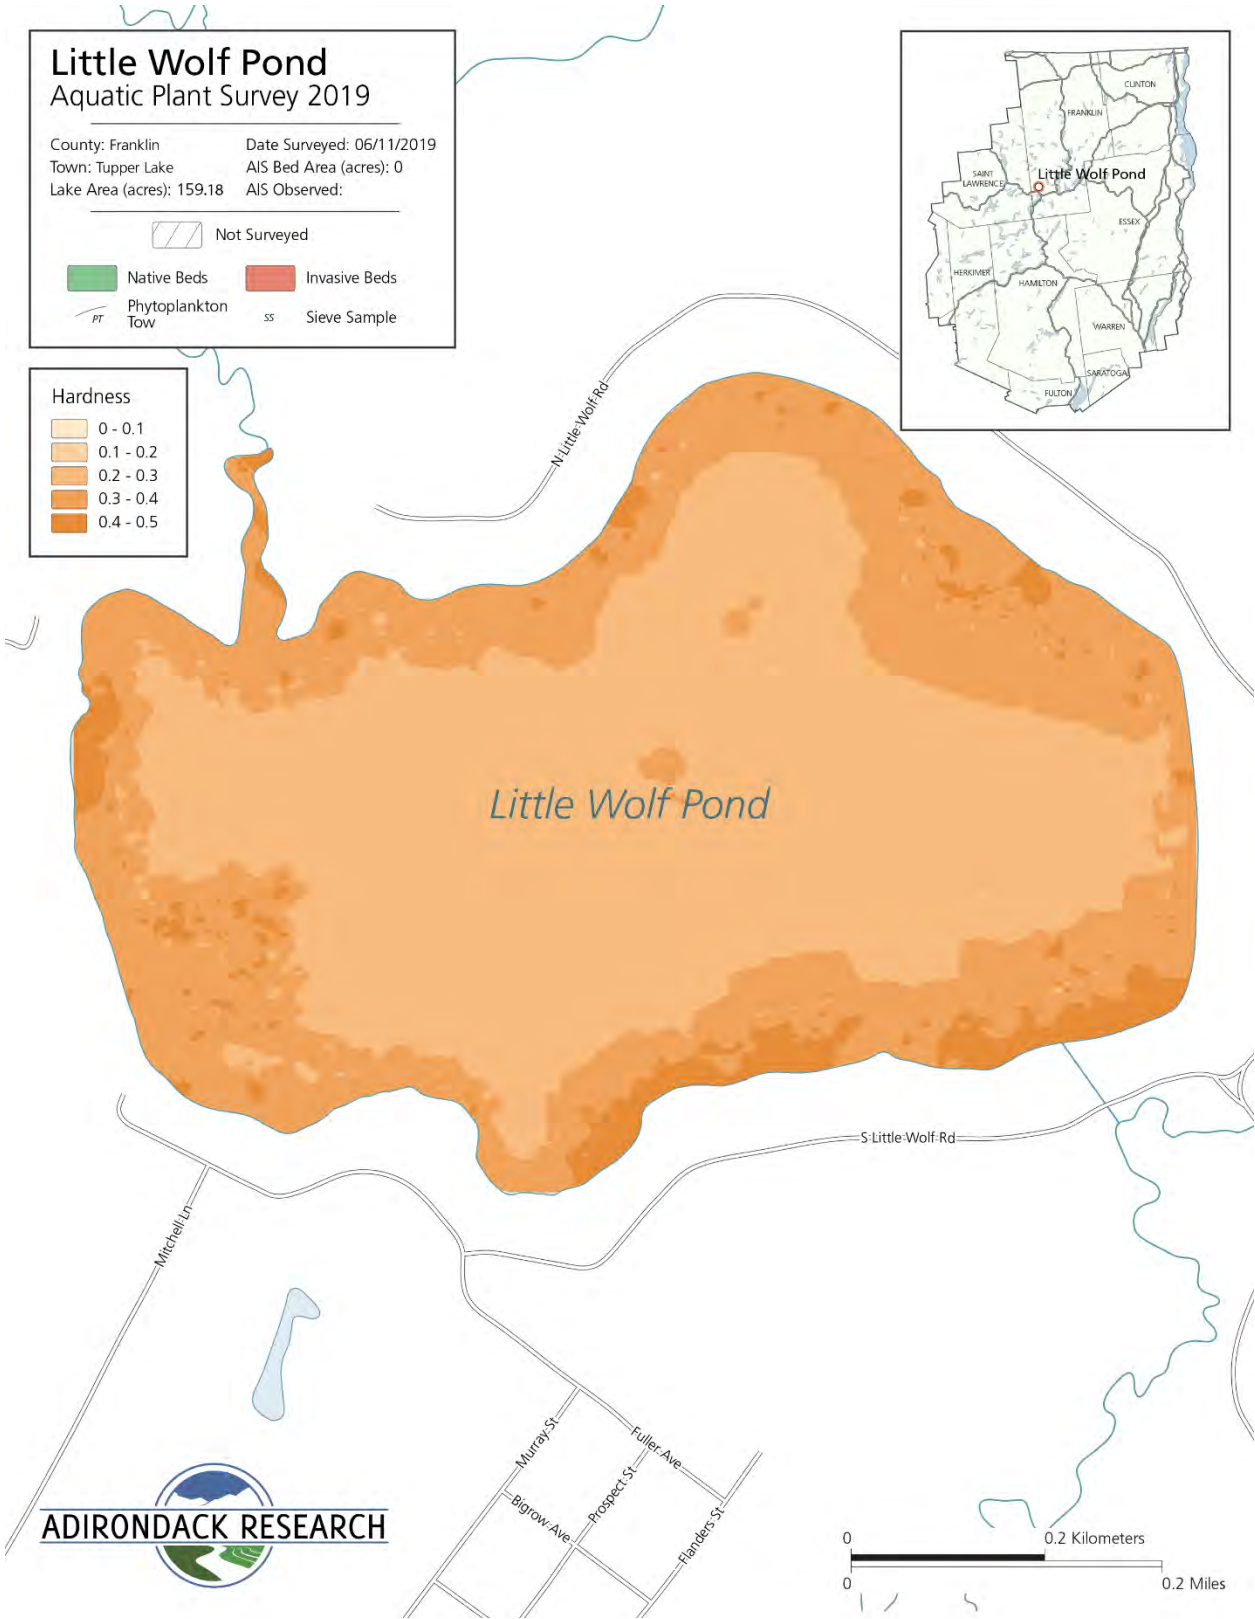
Little Wolf Pond
Aquatic Plant Survey 2019

County: Franklin Date Surveyed: 06/11/2019
 Town: Tupper Lake AIS Bed Area (acres): 0
 Lake Area (acres): 159.18 AIS Observed:

Hardness

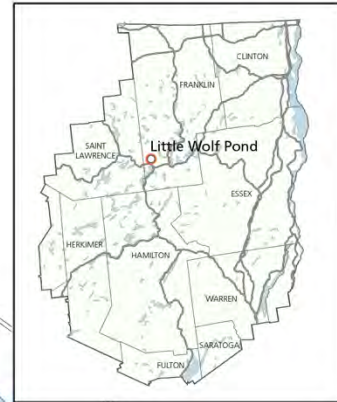
Little Wolf Pond Aquatic Plant Survey 2019

County: Franklin Date Surveyed: 06/11/2019
 Town: Tupper Lake AIS Bed Area (acres): 0
 Lake Area (acres): 159.18 AIS Observed:

Bathymetry (ft)
