Lake Narrative

Sacandaga Lake

Survey Date: August 13 & 15, 2018

Sacandaga Lake
 Aquatic Plant Survey 2018

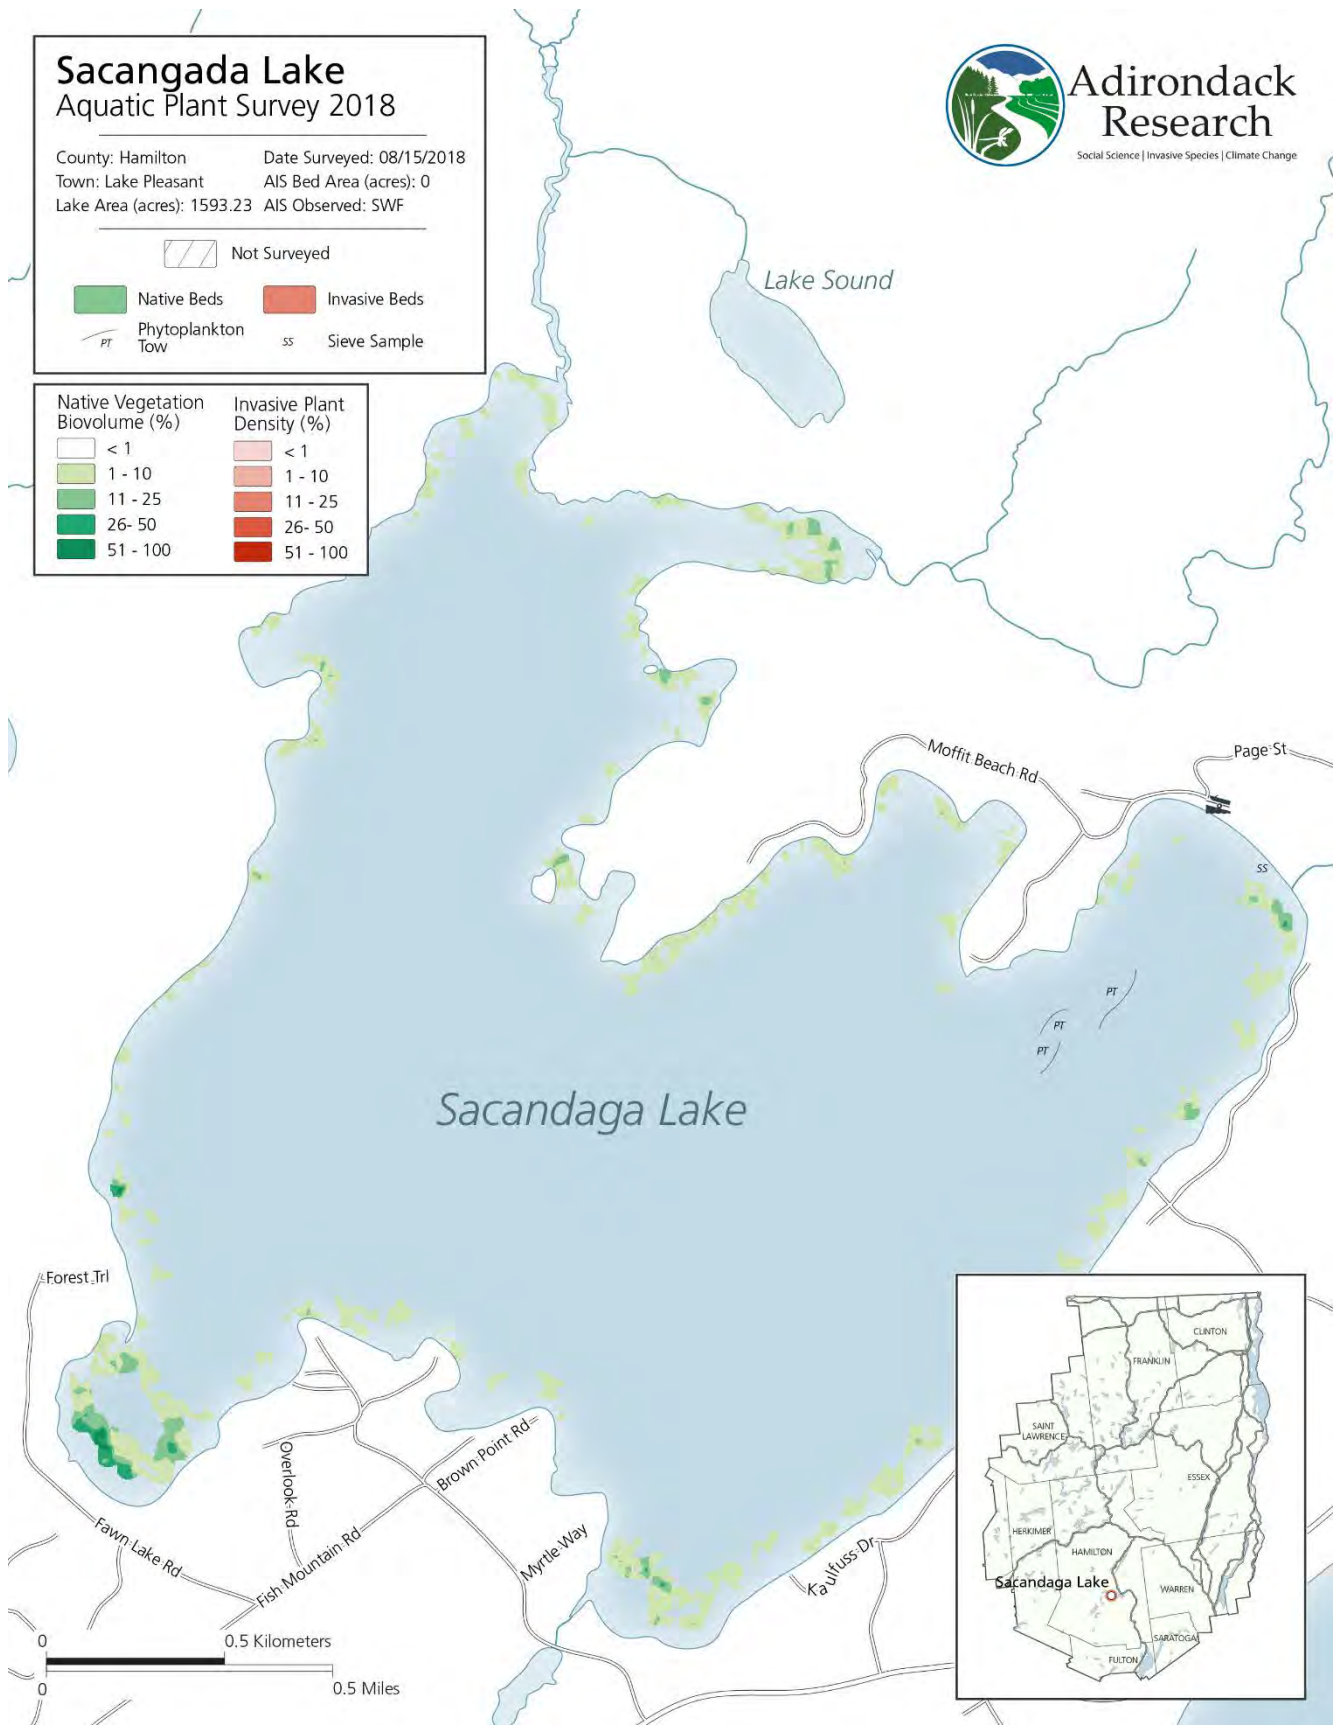
No invasive plants were detected.

Sediment sieves were taken to determine the presence of *Corbicula fluminea* (Asian clams). None were found. Three plankton tows were conducted with each returning *Bythotrephes longimanus* (Spiny waterflea). *Bythotrephes longimanus* is an invasive zooplankton and has been documented in the lake since 2010.

County: Hamilton Date Surveyed: 08/15/2018
 Town: Lake Pleasant AIS Bed Area (acres): 0
 Lake Area (acres): 1593.23 AIS Observed: SWF
